LEVEL 2

Your survey report

30 August 2023

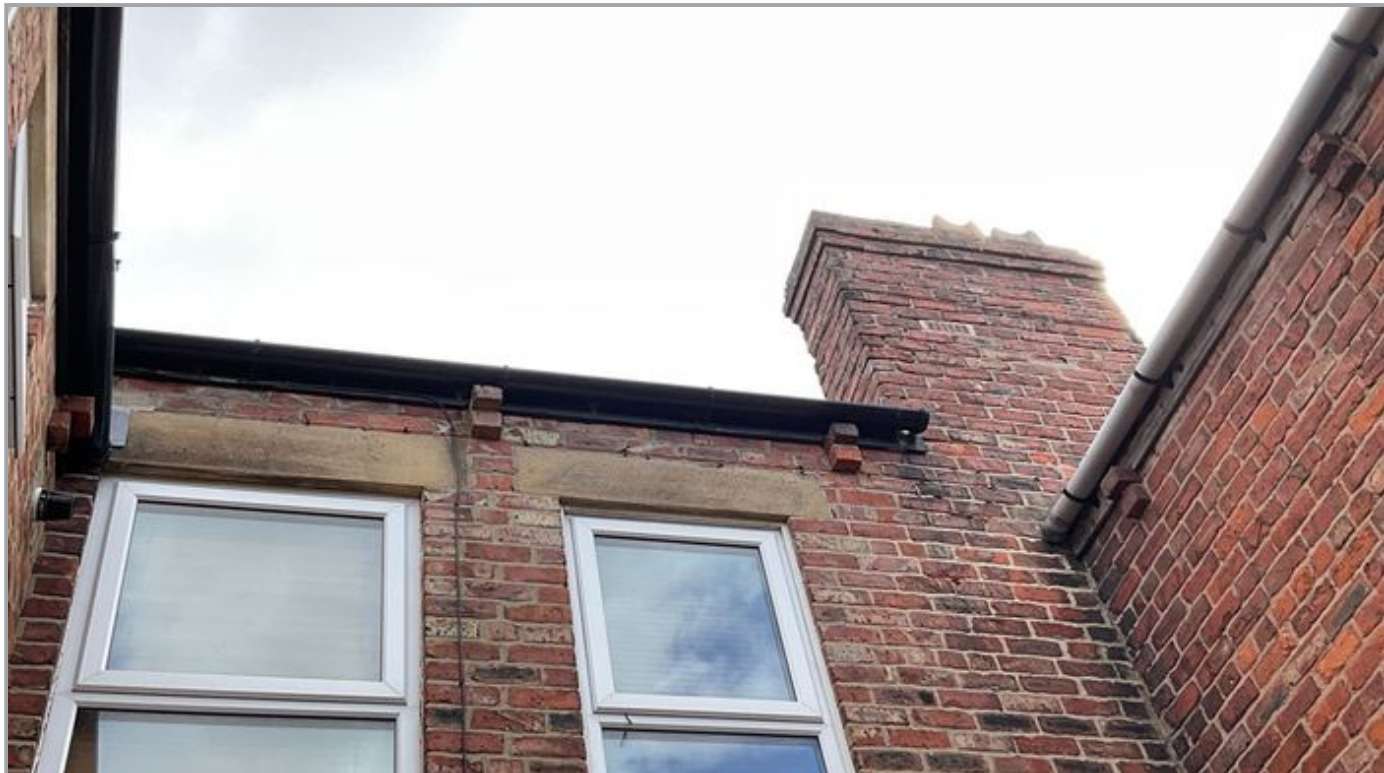
Shared Stack

As the chimney stacks to the rear are shared with the neighbouring properties, you should check with your legal adviser about your rights and obligations before carrying out any repairs/maintenance work and we refer you to our comments in Section H.

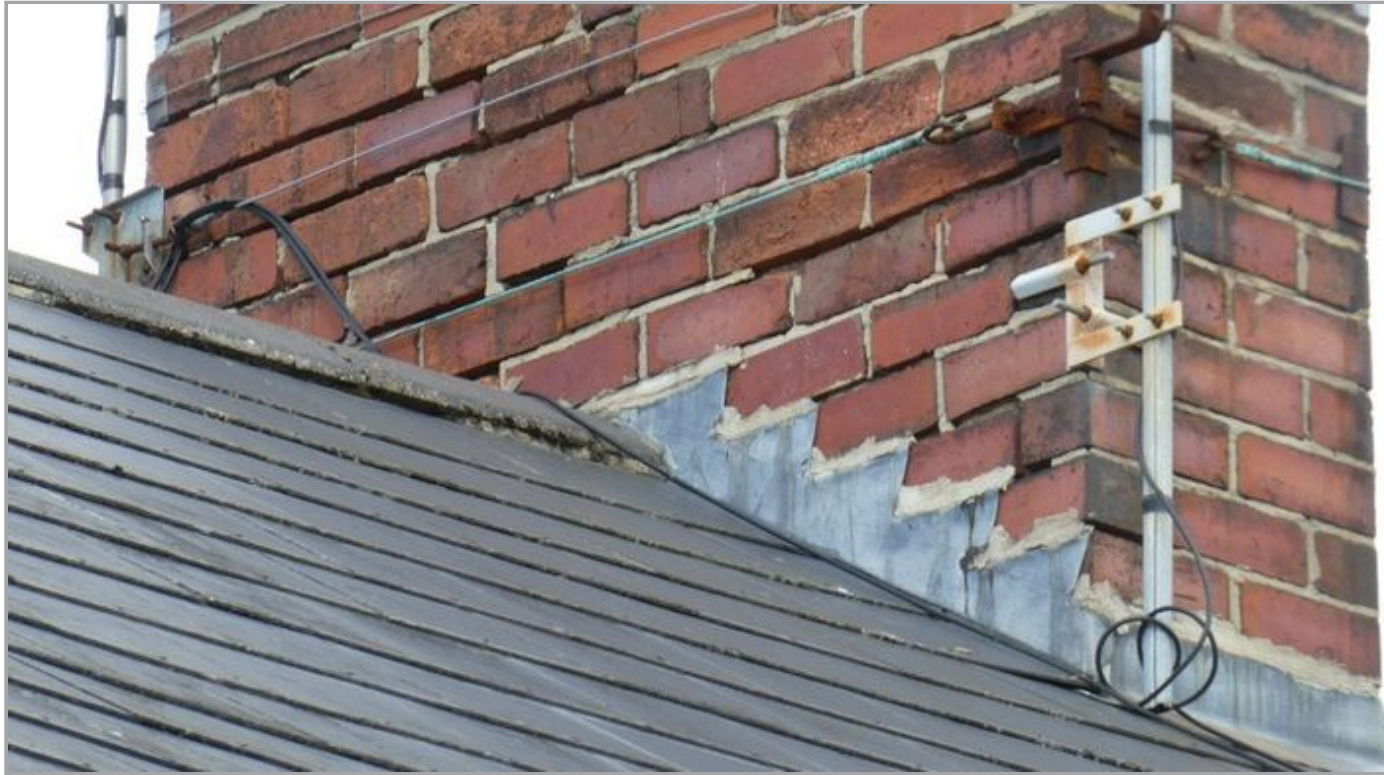
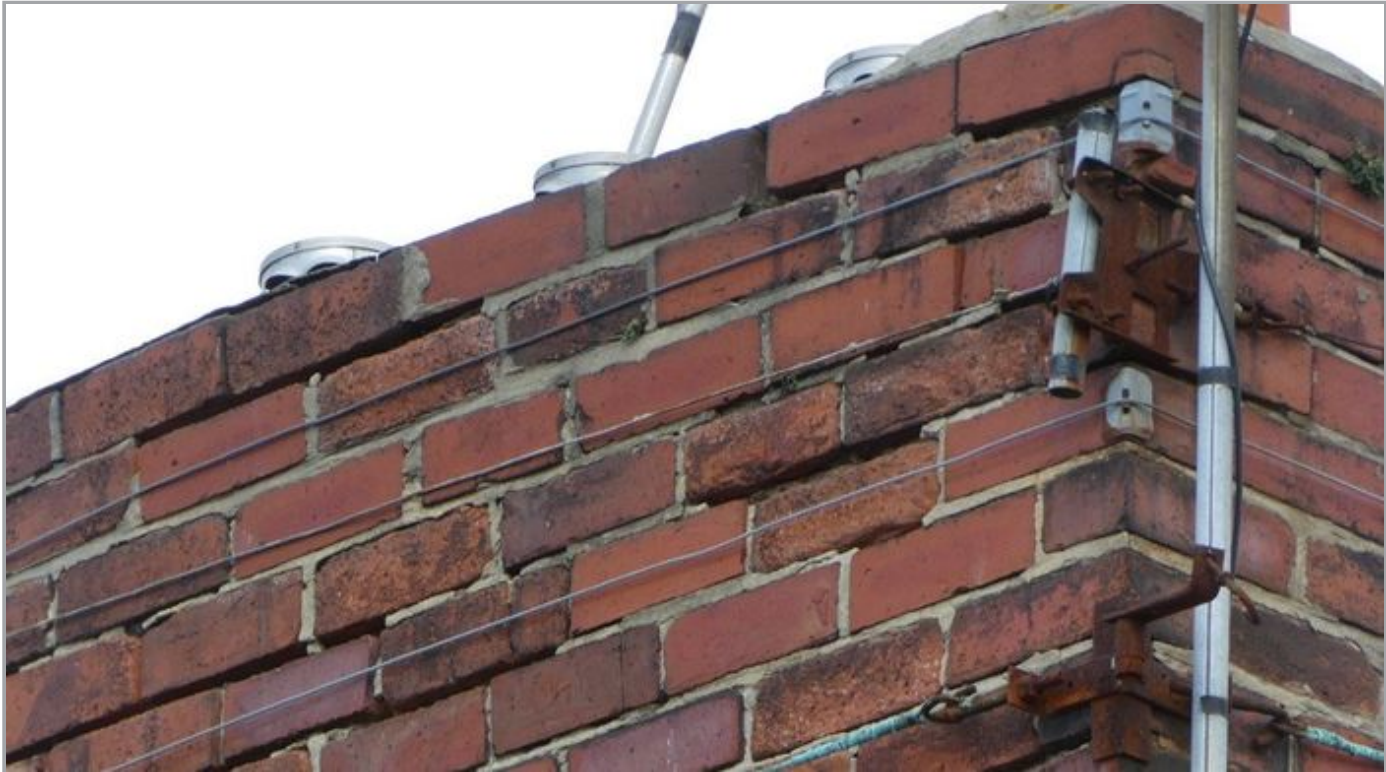
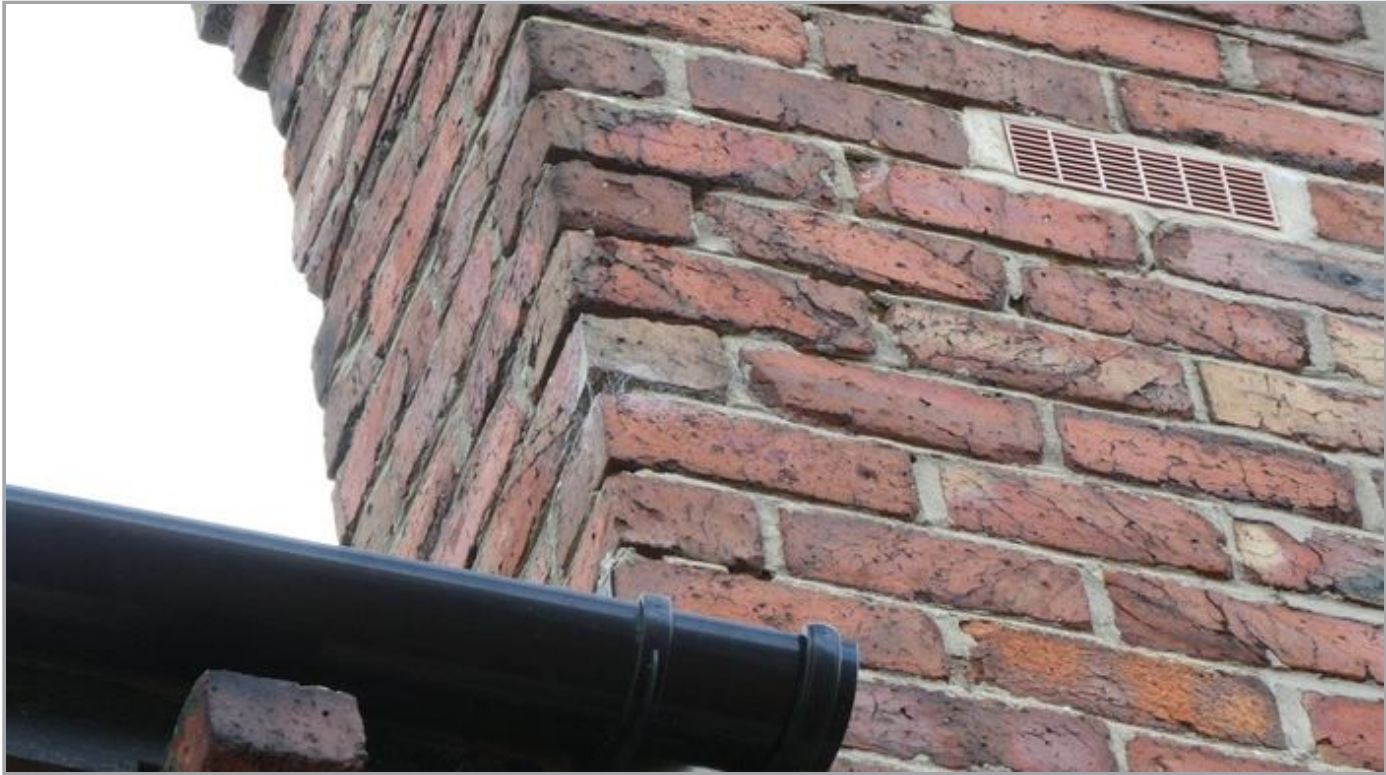
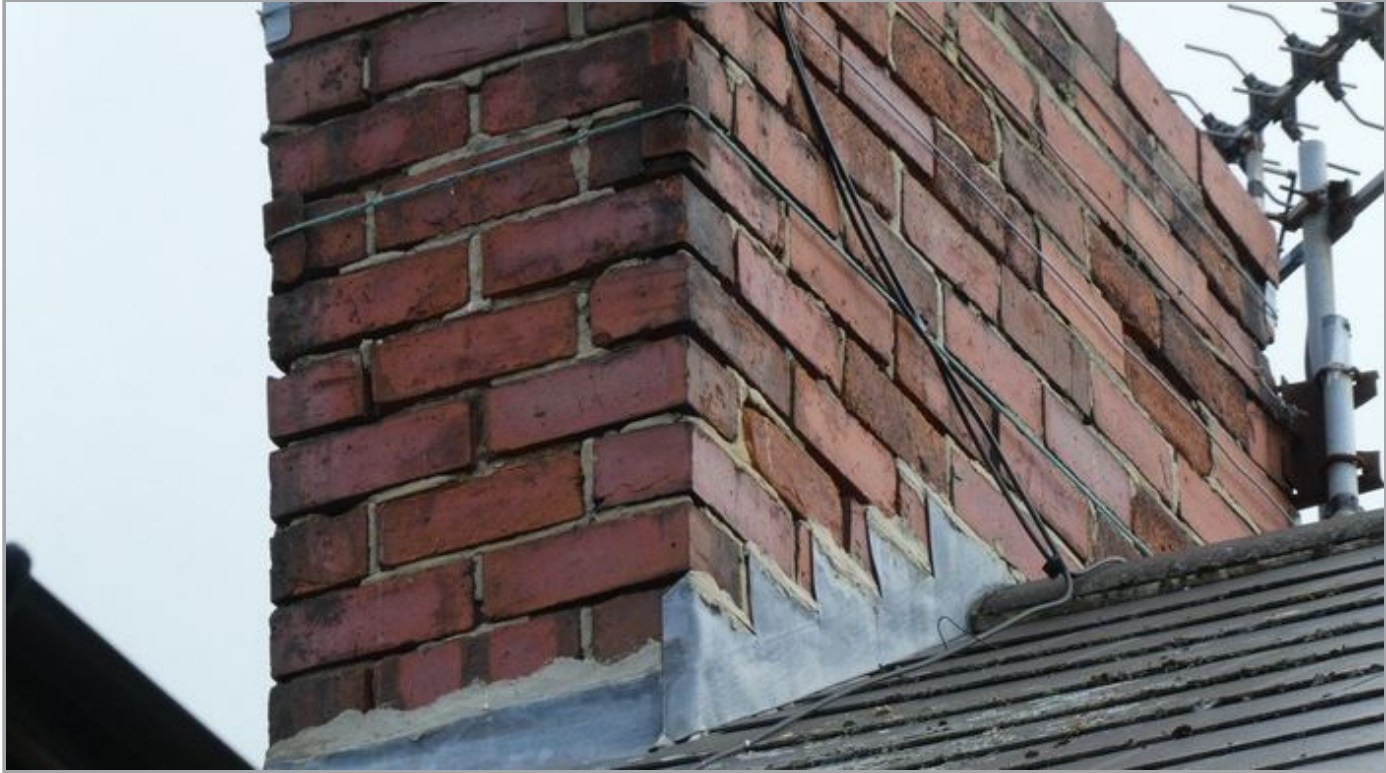
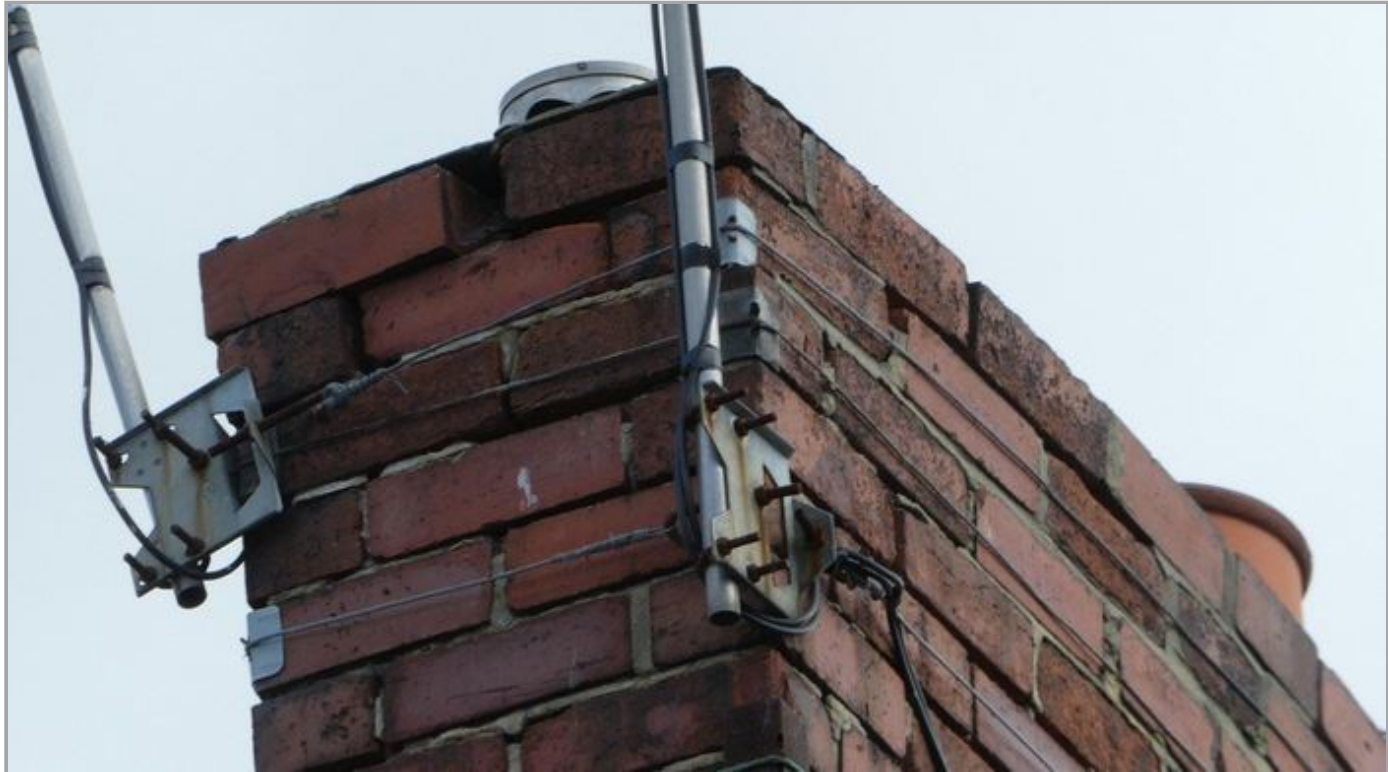
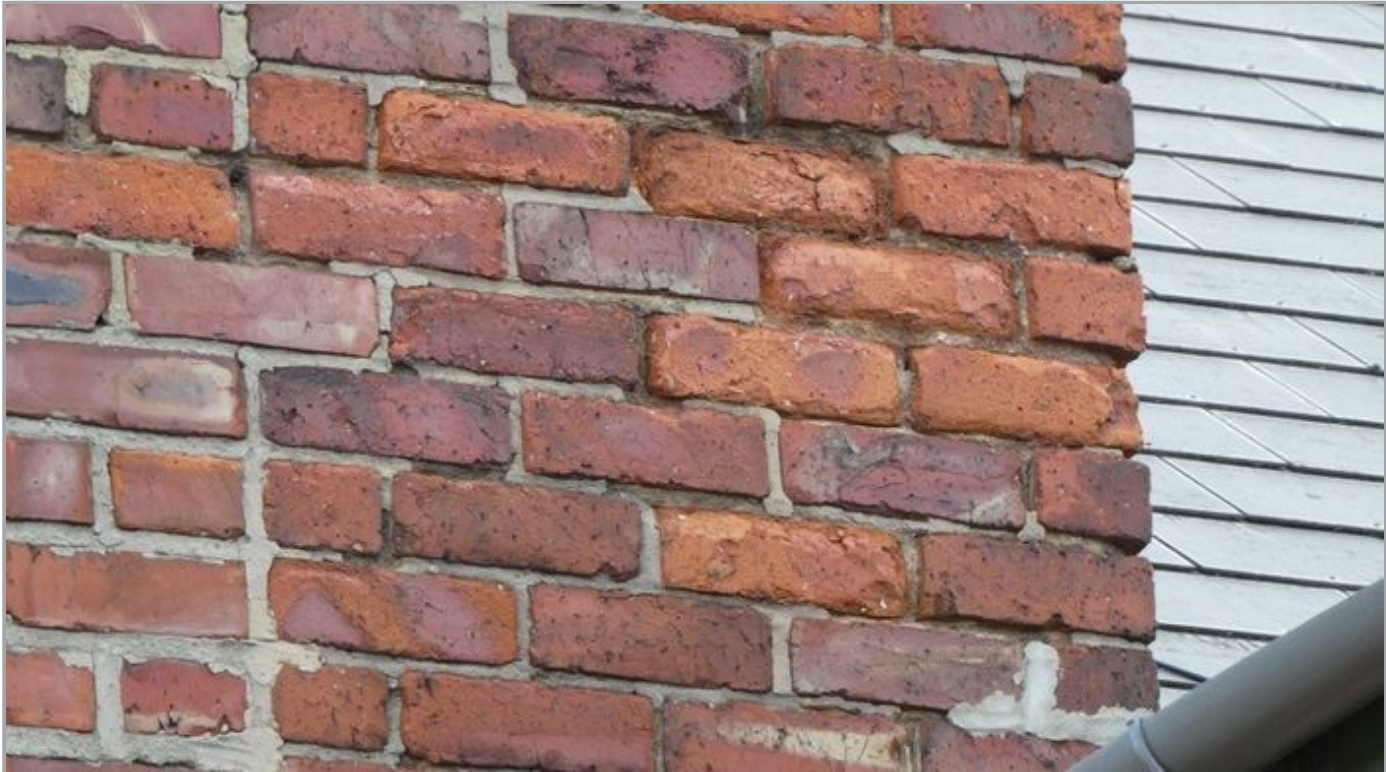
Eroding Pointing

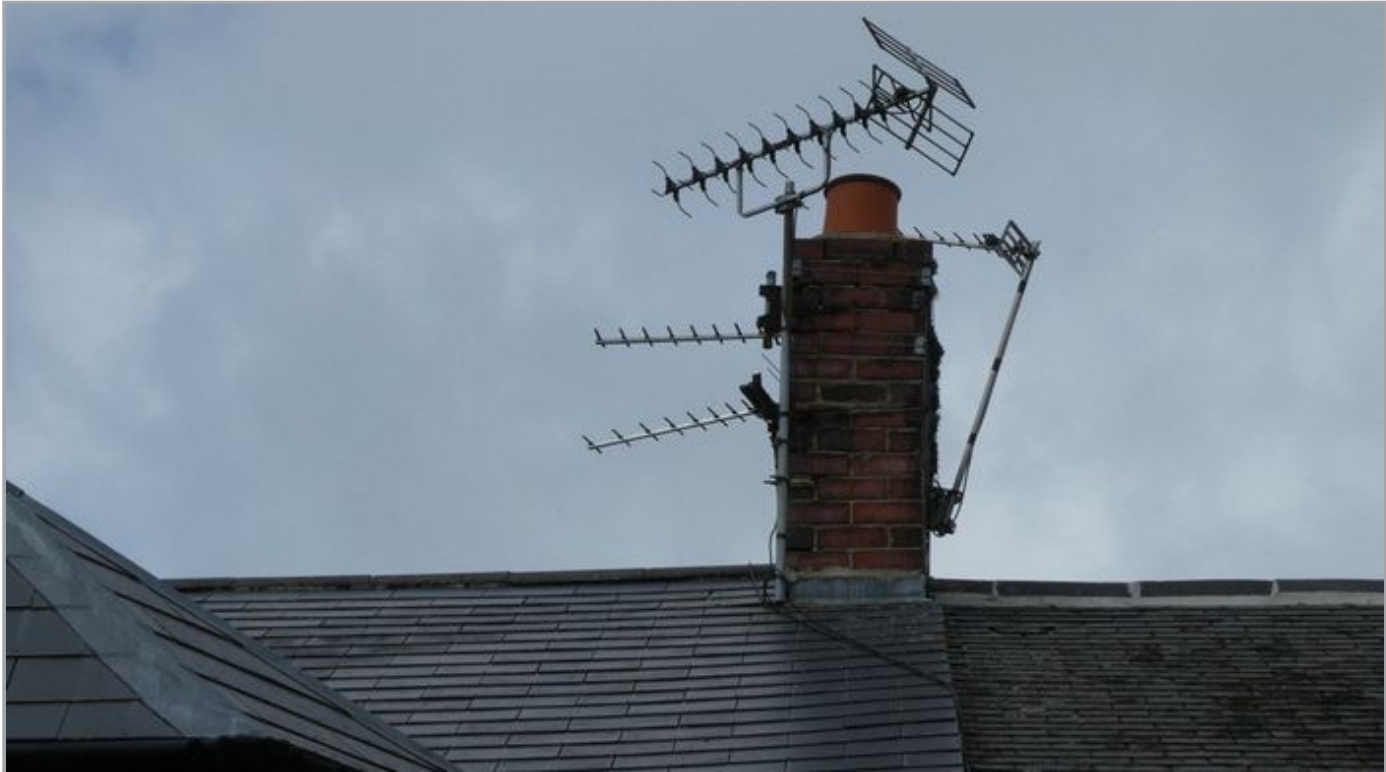
If the leaning becomes more pronounced and is associated with either eroded mortar pointing, loose brickwork or cracking to the mortar pointing at regular intervals, you should then have this investigated further as these defects are indicative of sulphate attack, which can be a serious structural problem and a potential safety concern.

Stack Leaning Ongoing Monitoring

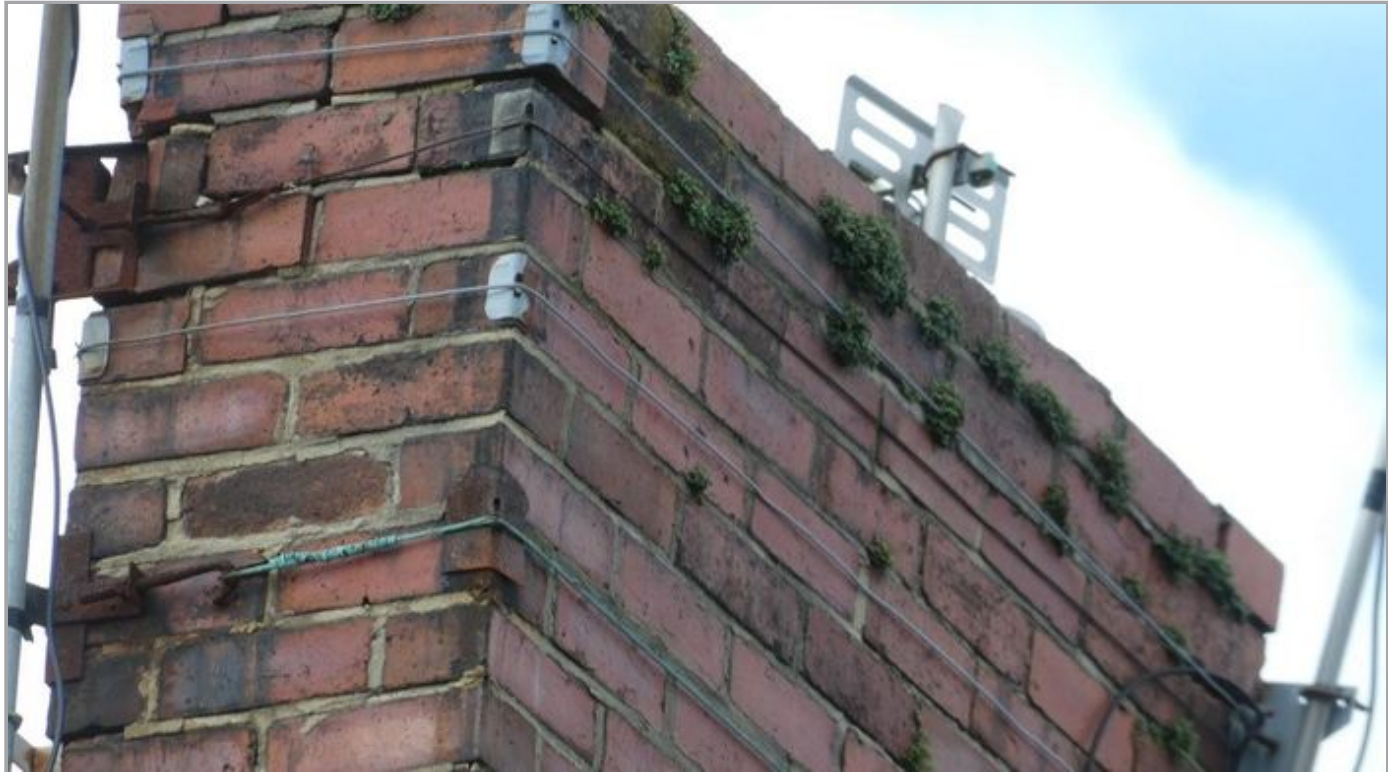
There was visible evidence of moss/algae build-up. This should be removed periodically to prevent accelerated deterioration of the brickwork surfaces and mortar pointing.

Moss/Algae

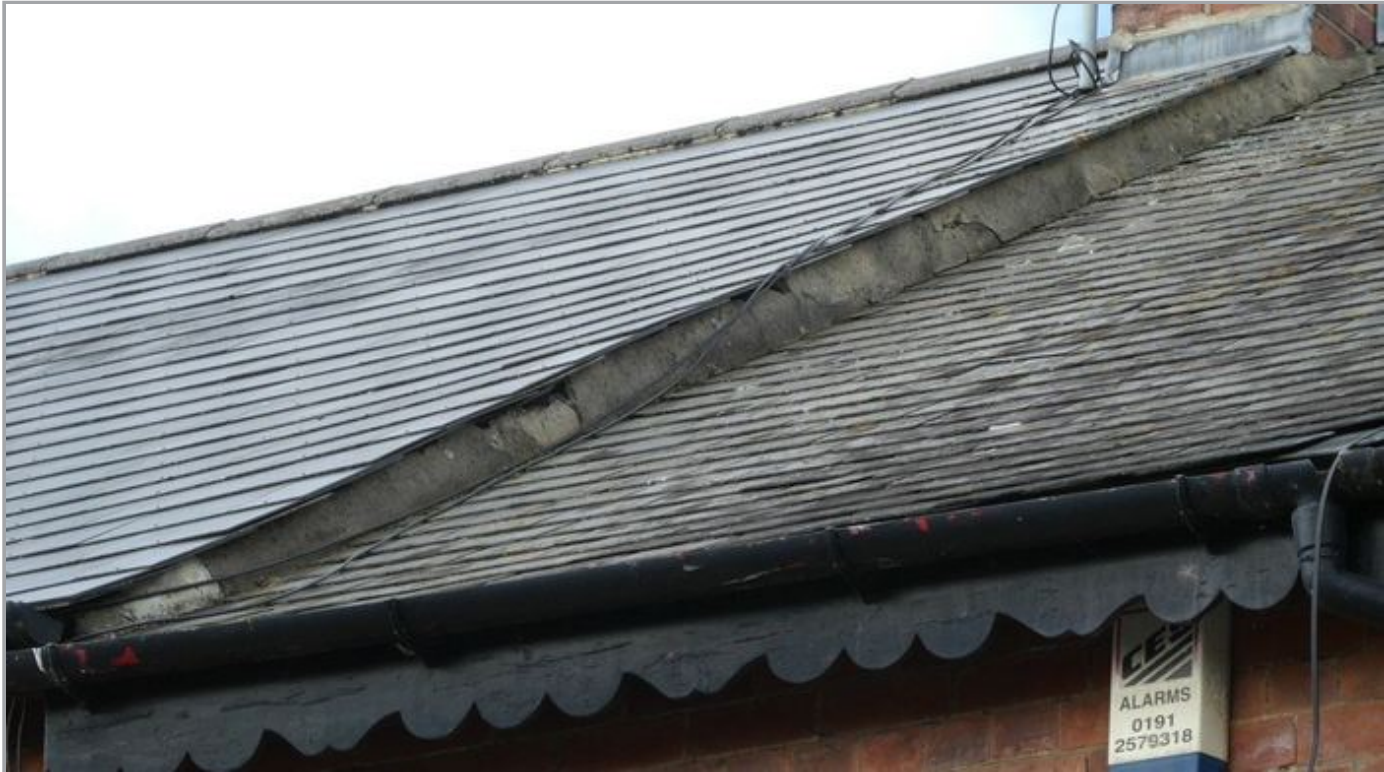
The junction to the main and neighbouring property roofs is sealed with mortar flashing and this was found to be cracking/eroding and for a temporary repair, it should be repointed. This type of flashing detail is inferior compared with lead and until remedial work is carried out, this area will now be more vulnerable to water ingress and problems associated with damp.

Inadequate Junction

You should consider repairing with a stepped lead flashing, as this will offer much better weatherproofing and requires minimal maintenance once installed. 3

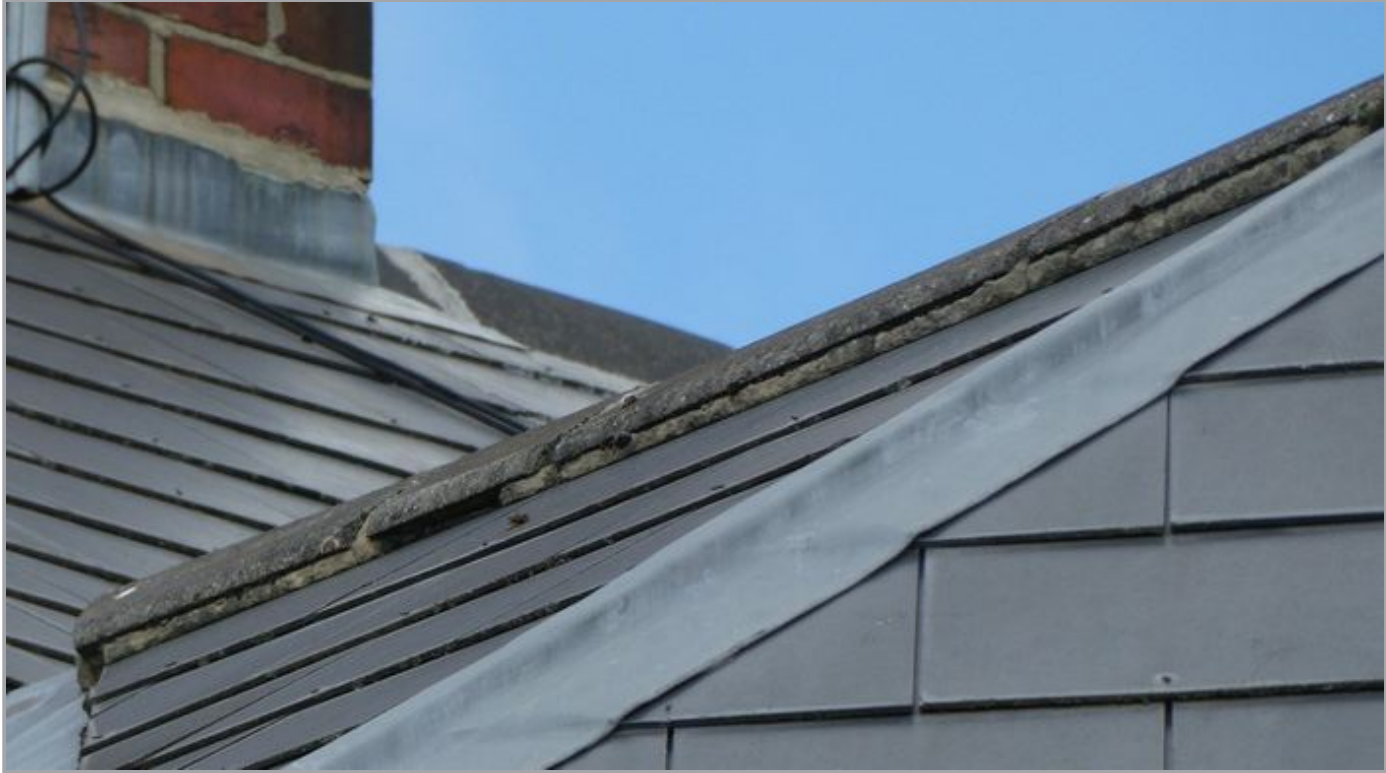
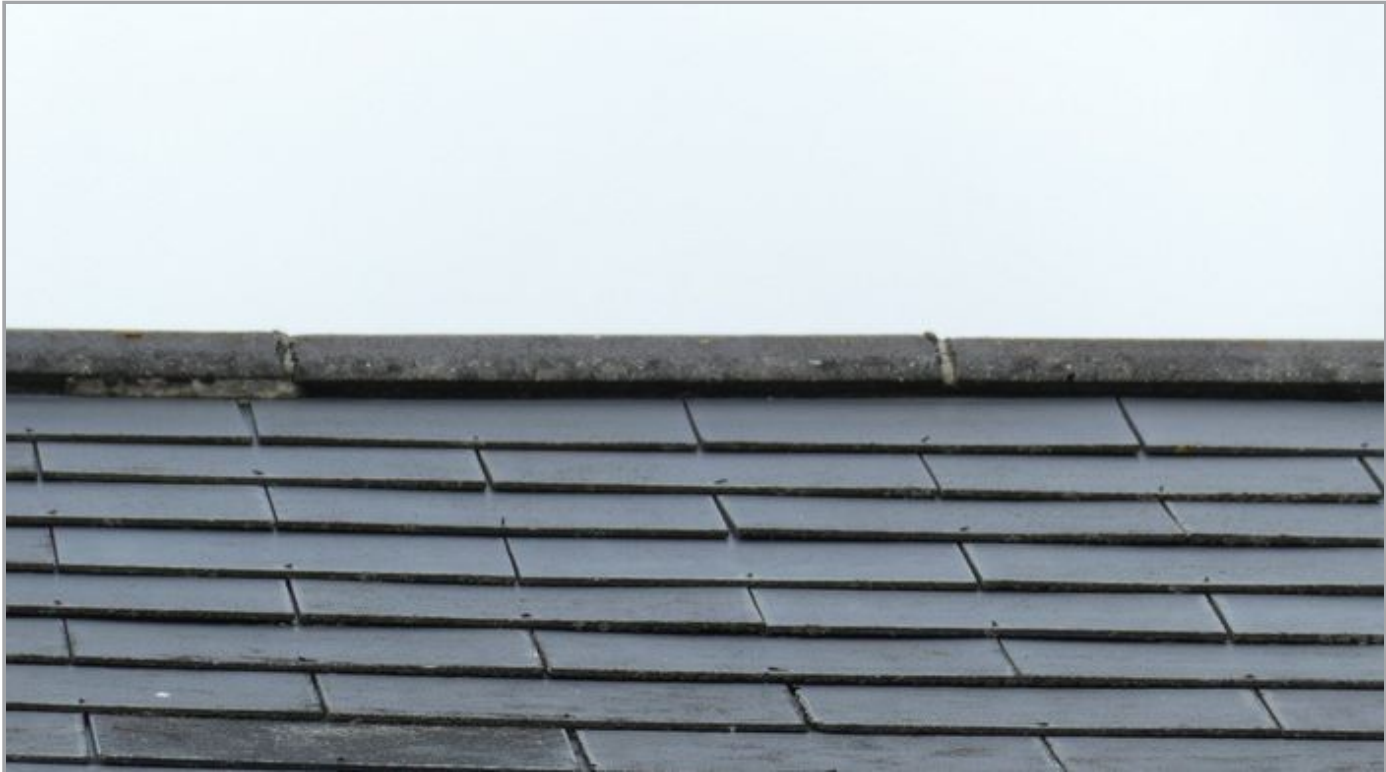
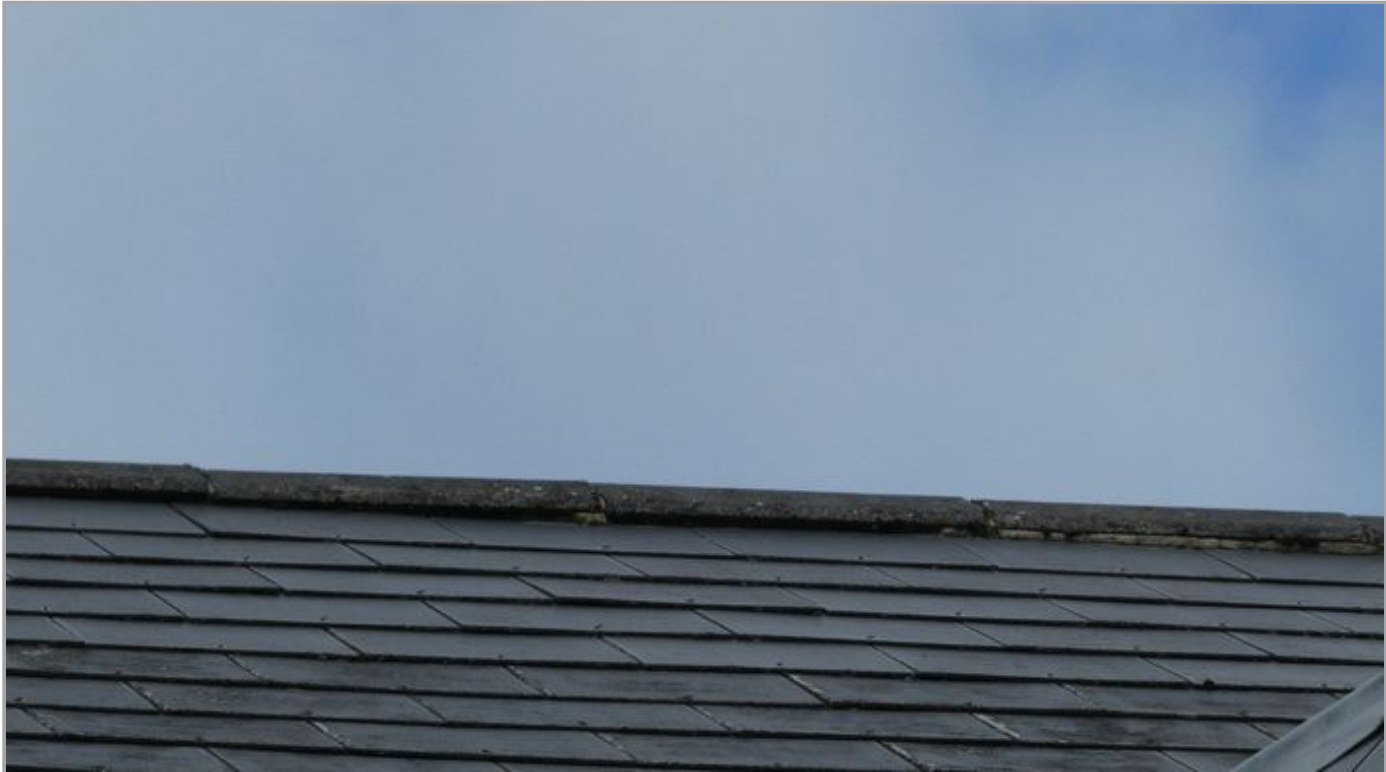
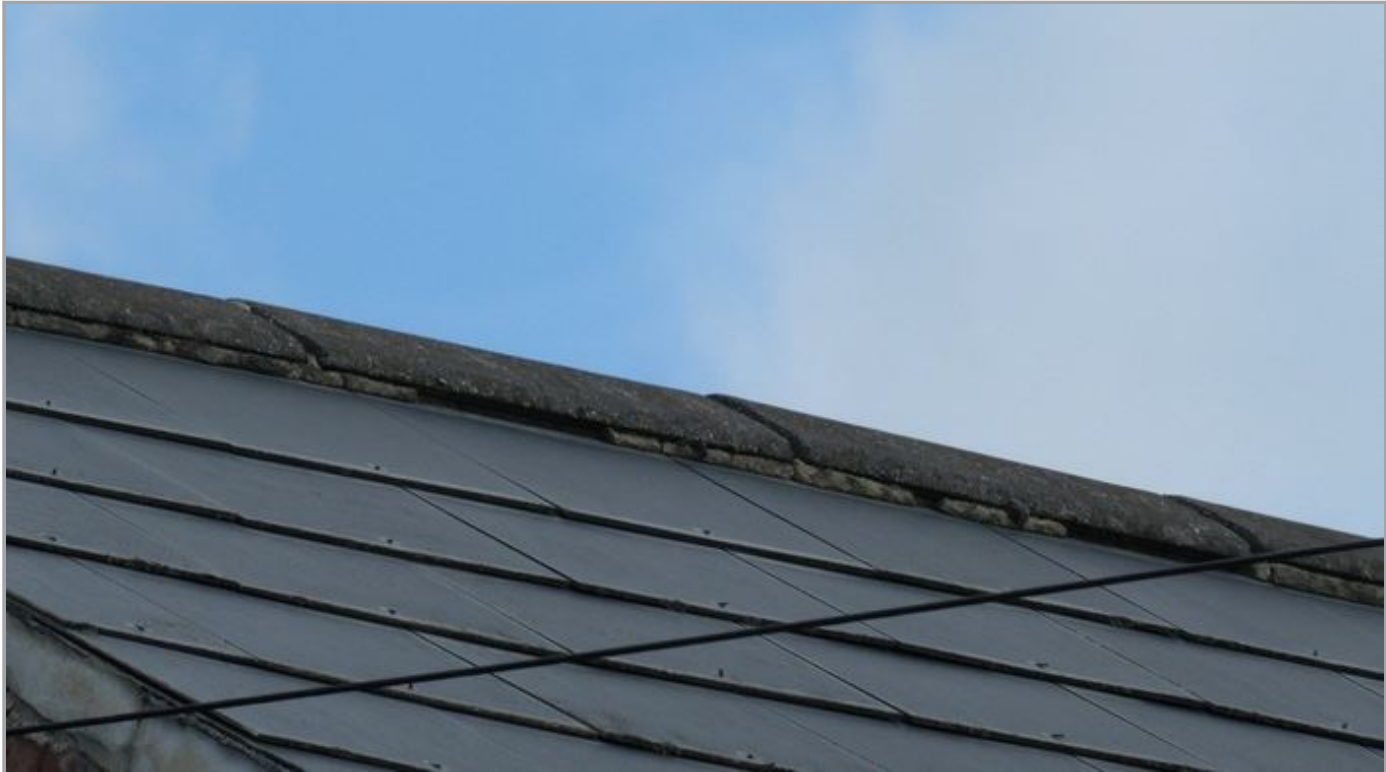
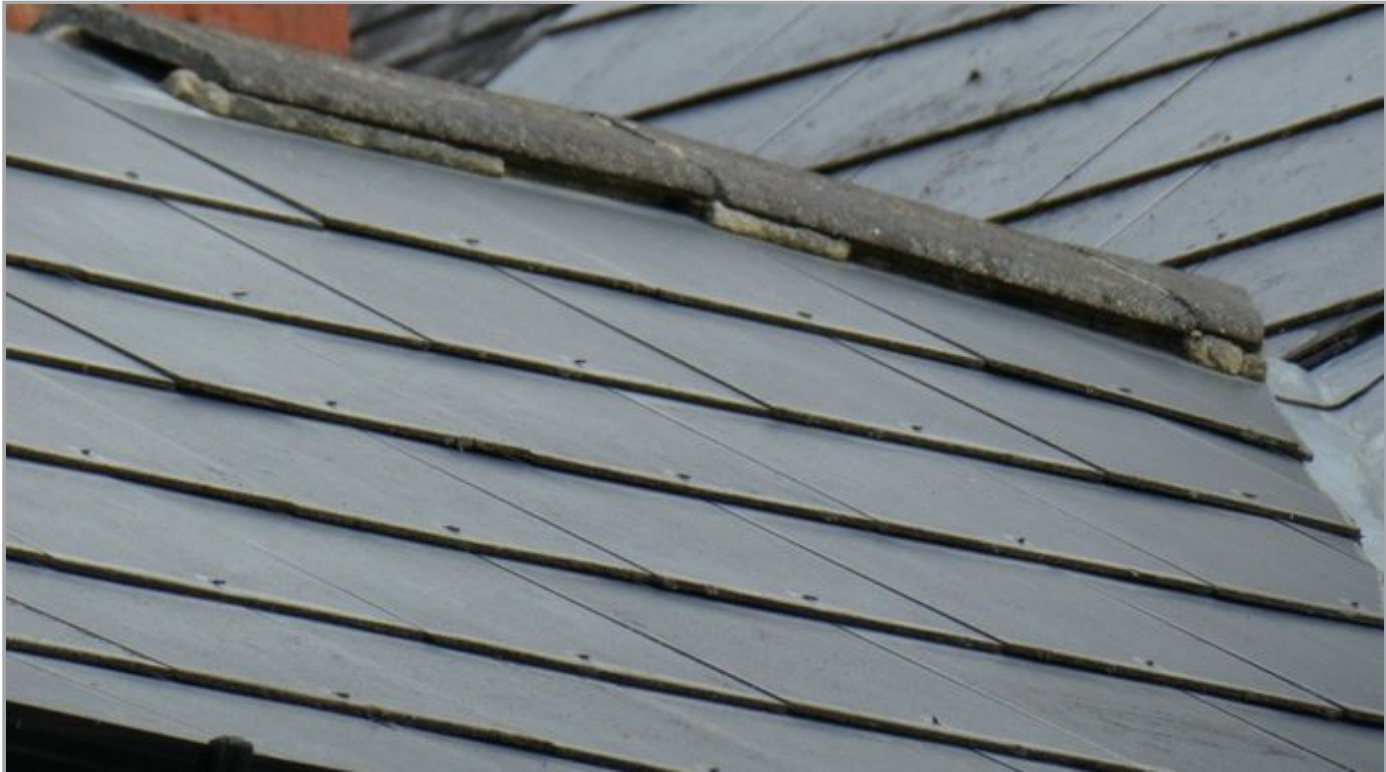
The tiles on the top of the roof (known as ridge tiles) sit on a bed of mortar. The mortar bed has started to erode as a result of seasonal weathering and requires localised repointing to prevent water ingress. There are also a few missing ridge tiles that need to be replaced. Until this work is complete, the roof space will be more vulnerable to potential damp problems.

Eroding Ridge

However, it should be noted that whilst repointing is a suitable form of weatherproofing, you should consider installing a modern plastic interlocking system called a dry ridge system, if it is within your budget to do so, as it requires minimal maintenance once installed.

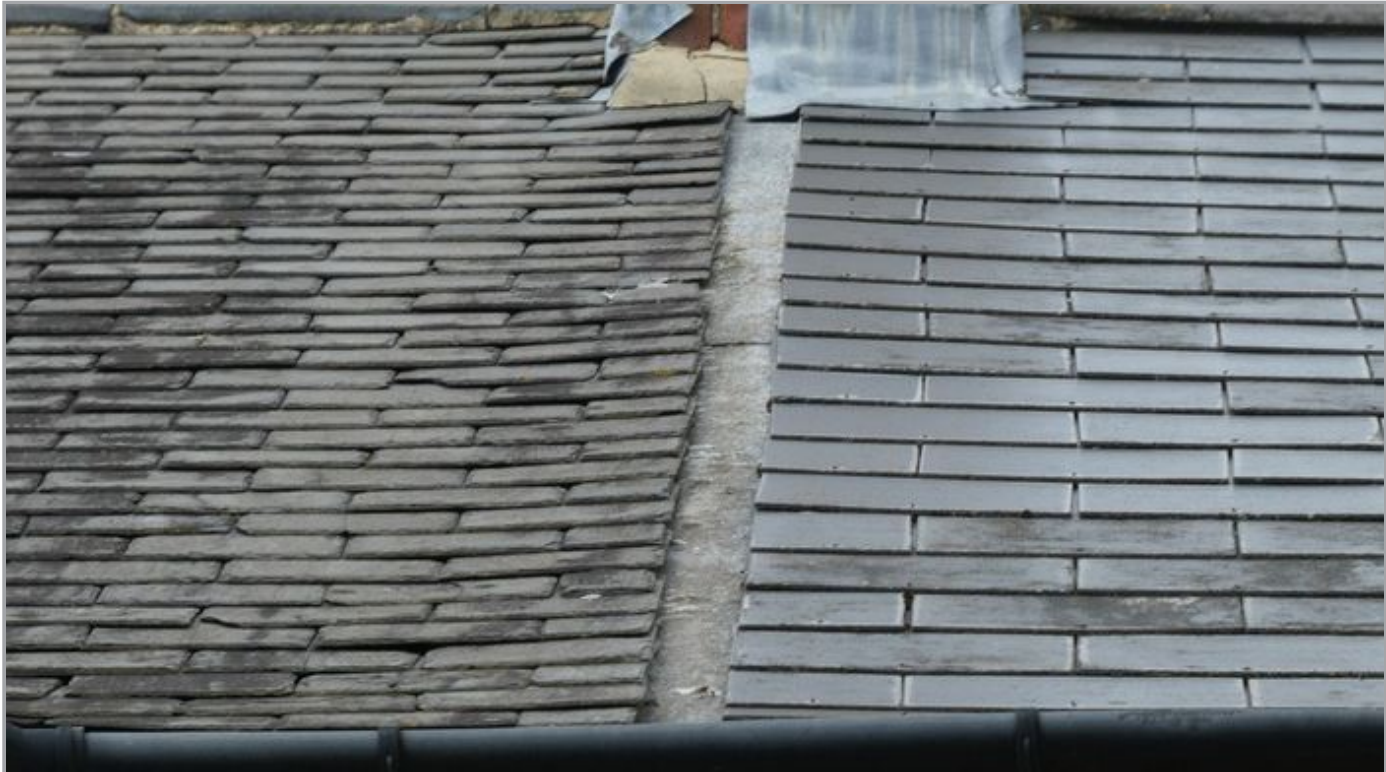
The installation of a bonding guttering could result in having to have a shared liability with the neighbouring property. Your legal adviser should check for the existence of any pre-arranged party agreements or shared liabilities as you may wish to have this in place, in the event of essential repairs to the adjoining roof coverings/details and we refer you to our comments in Section H.

Bonding Guttering/Shared Liabilities

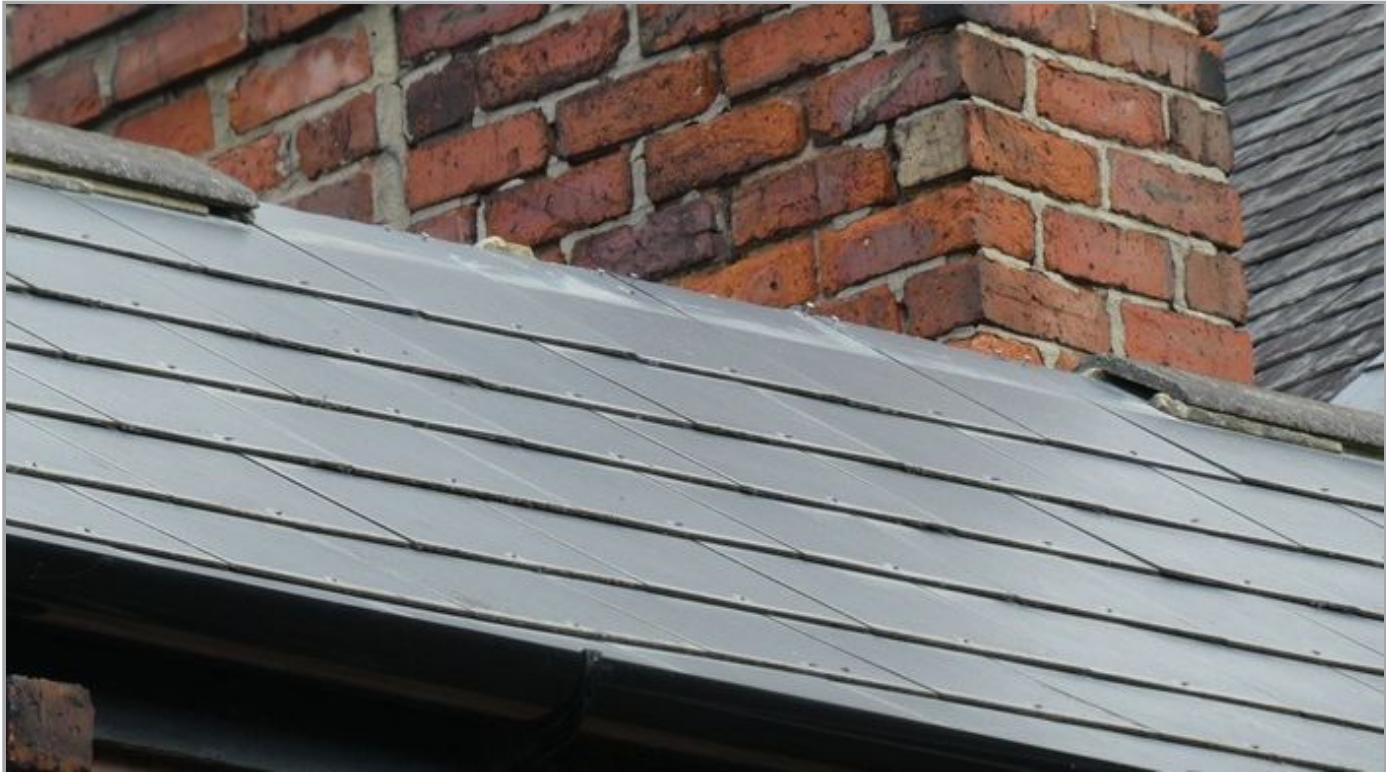
Missing Tiles

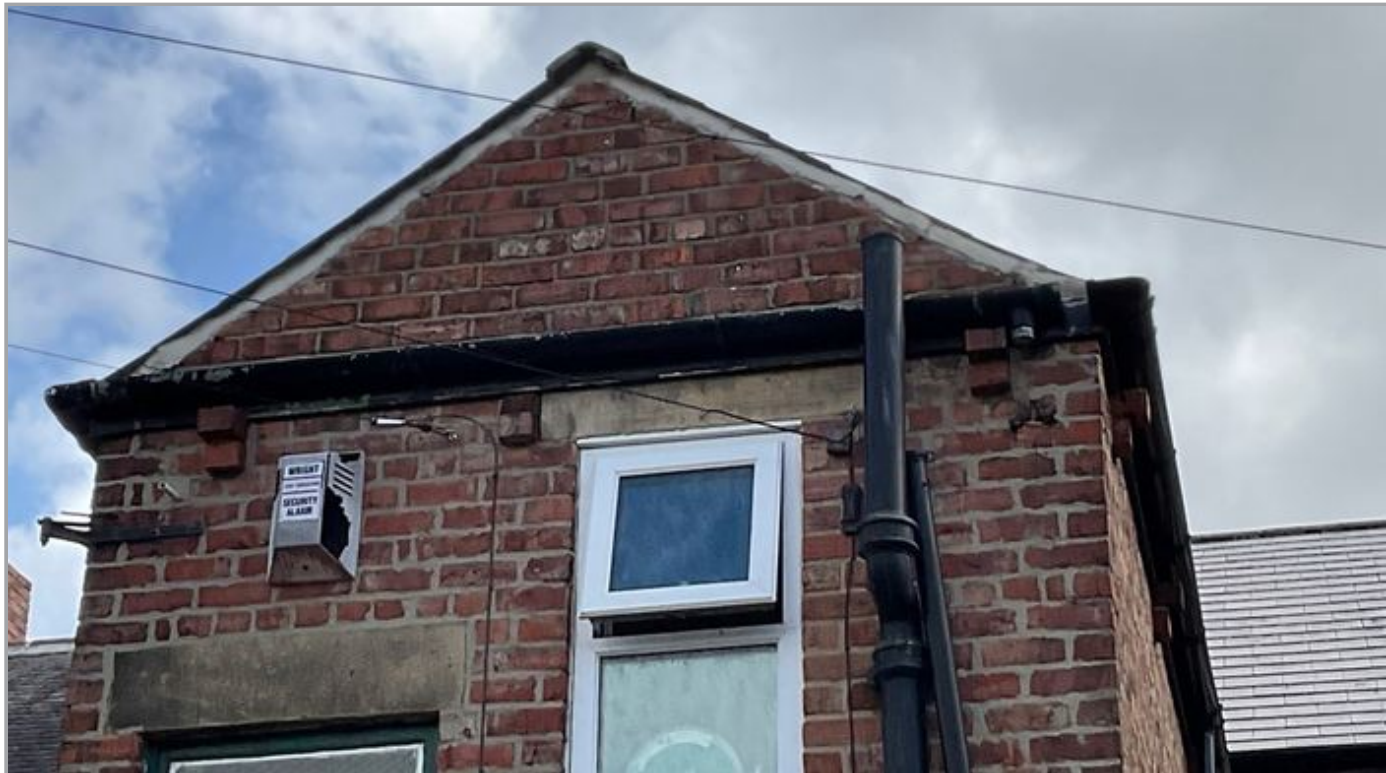
The cast-iron fittings to the rear are corroding and redecoration will be required as corroding rainwater goods are prone to leakage and need ongoing maintenance and repair, therefore they should be regularly inspected for serviceability. However, if it is within your budget to do so, you should consider replacing the existing rainwater goods to modern plastic, as they require less maintenance once installed. 3

Corroding Fittings

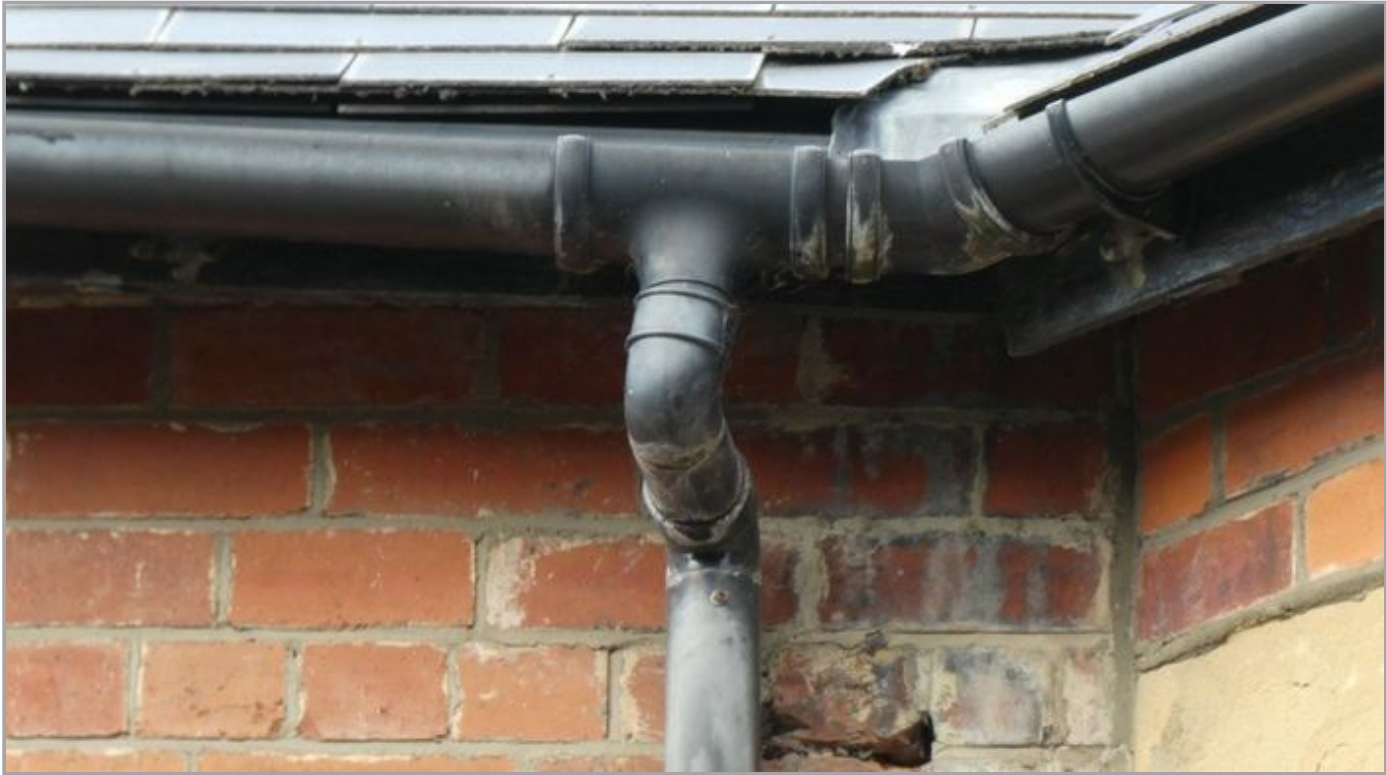
Staining/vegetation was noted at the joints between some sections of downpipes and guttering. You should be aware that plastic connection seals to the rainwater goods can fail unexpectedly causing leakage. The remaining fittings should be tested and replaced where necessary, to ensure adequate watertightness to the surface water drainage system.

Staining/Vegetation
