LEVEL 2

Your survey report

30 August 2023

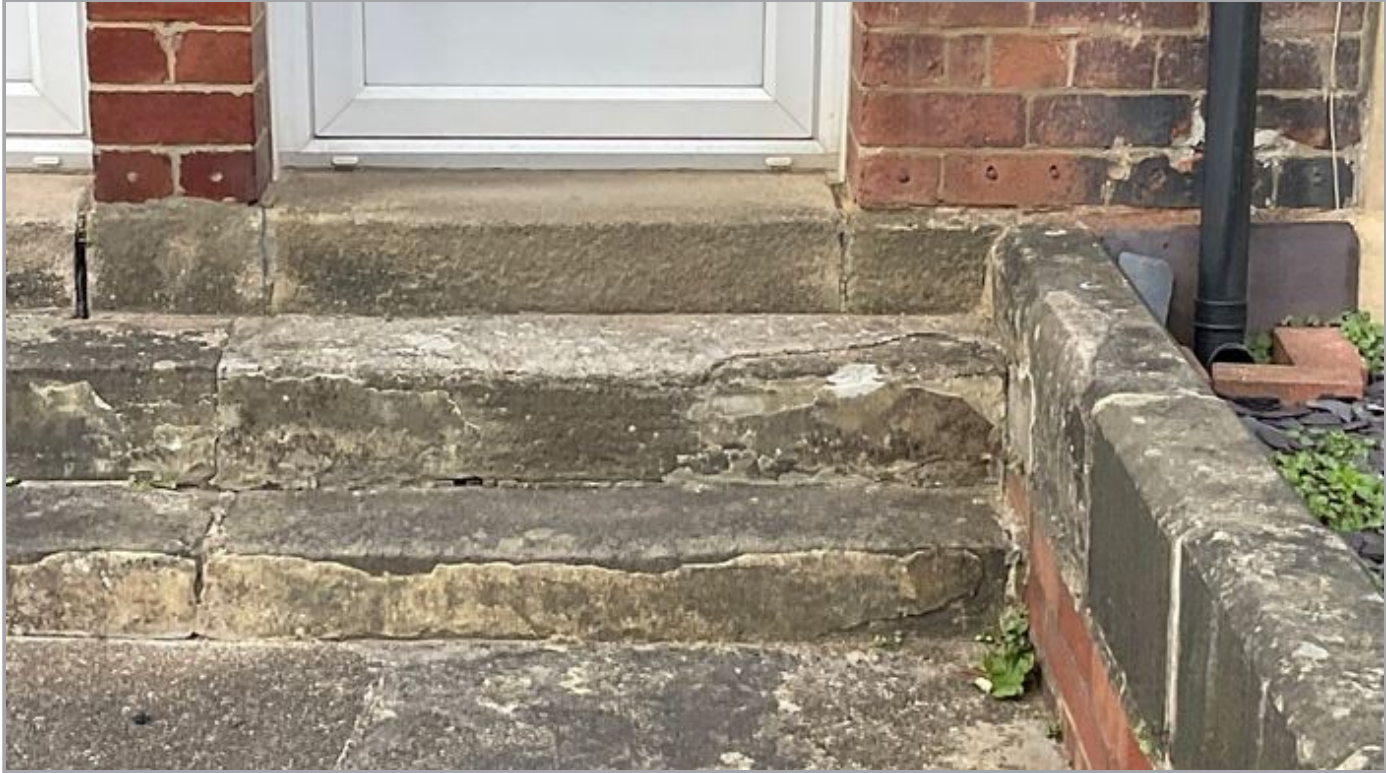
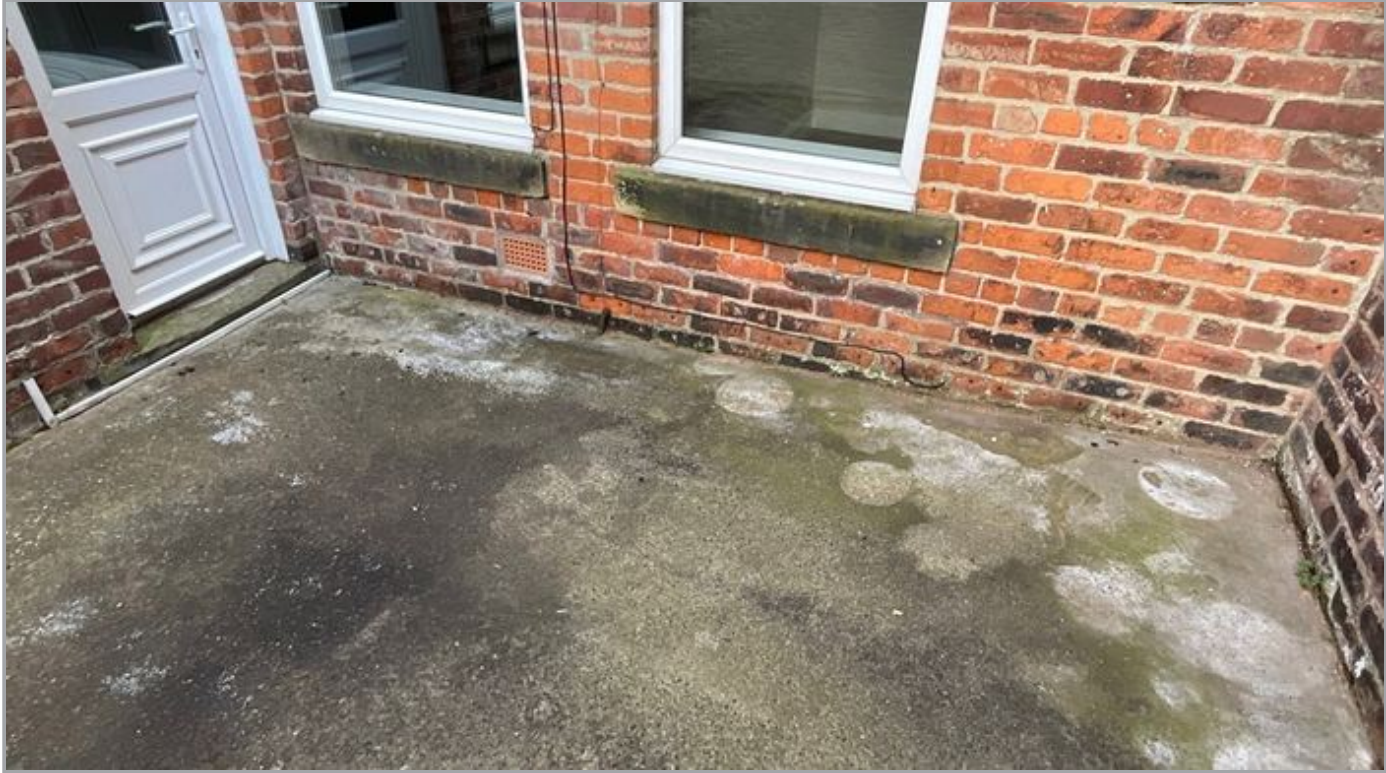
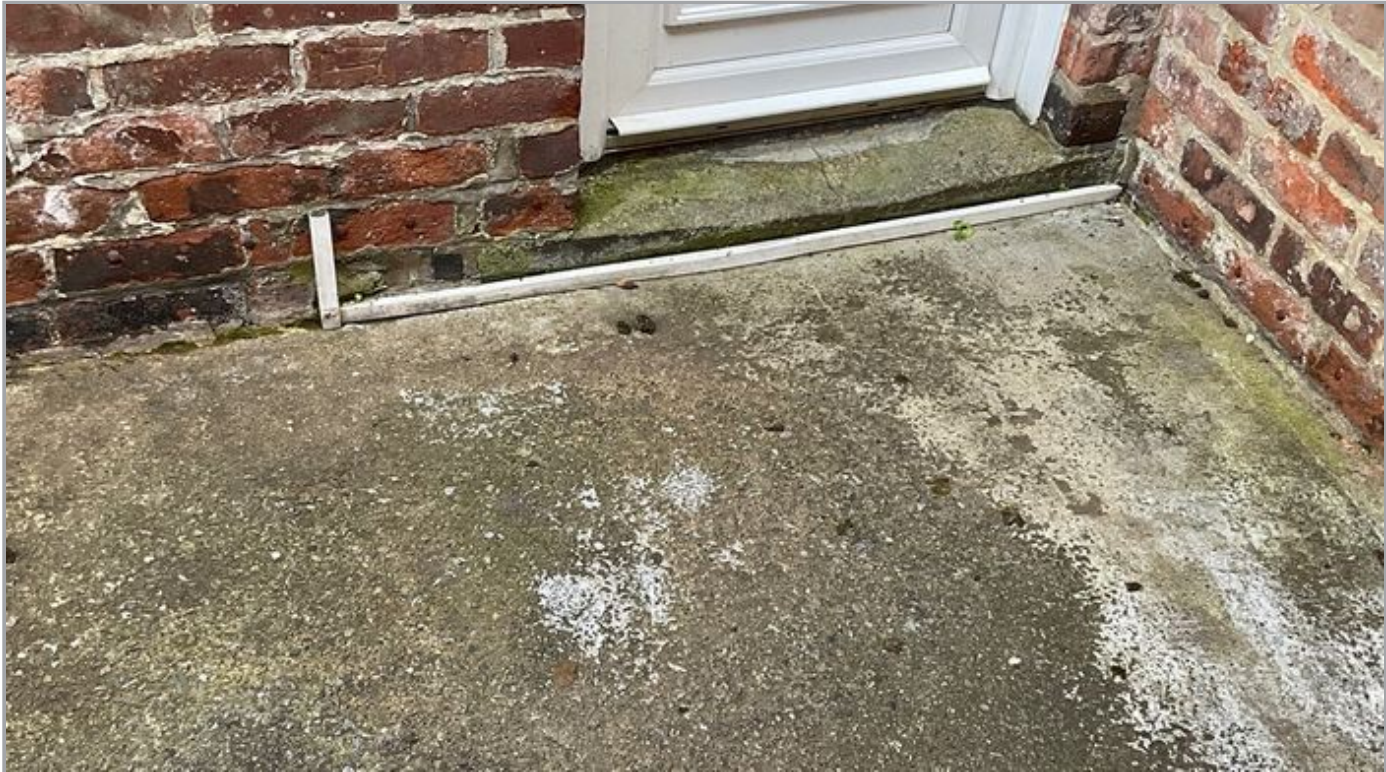
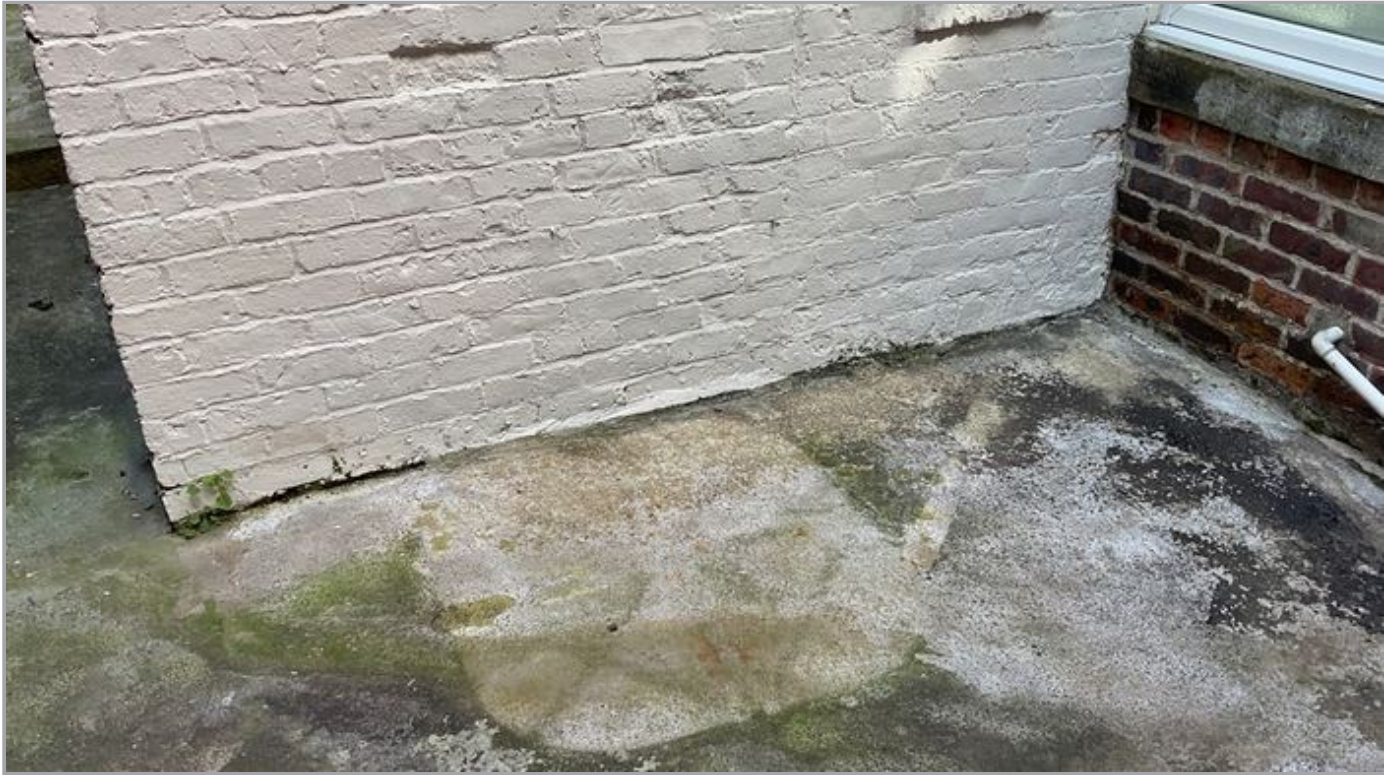
Bridging DPC

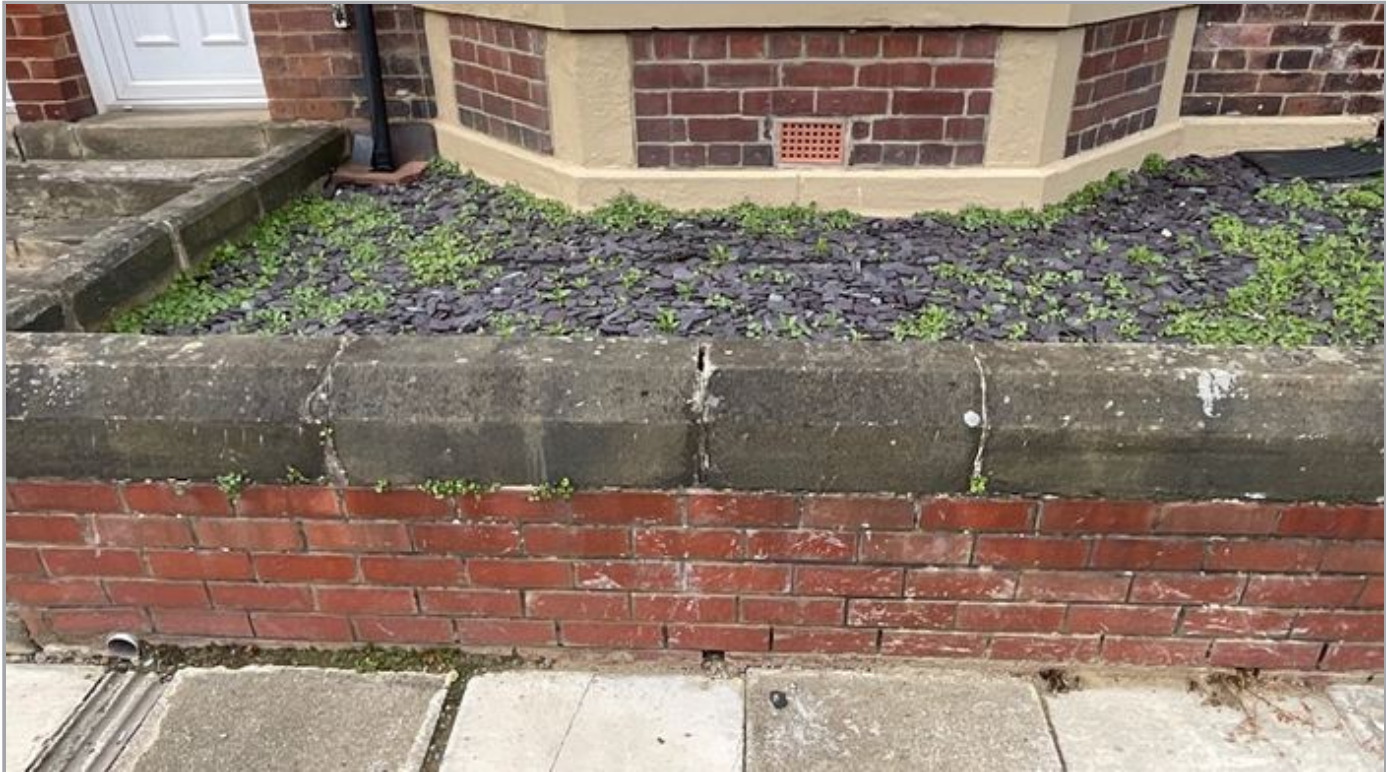
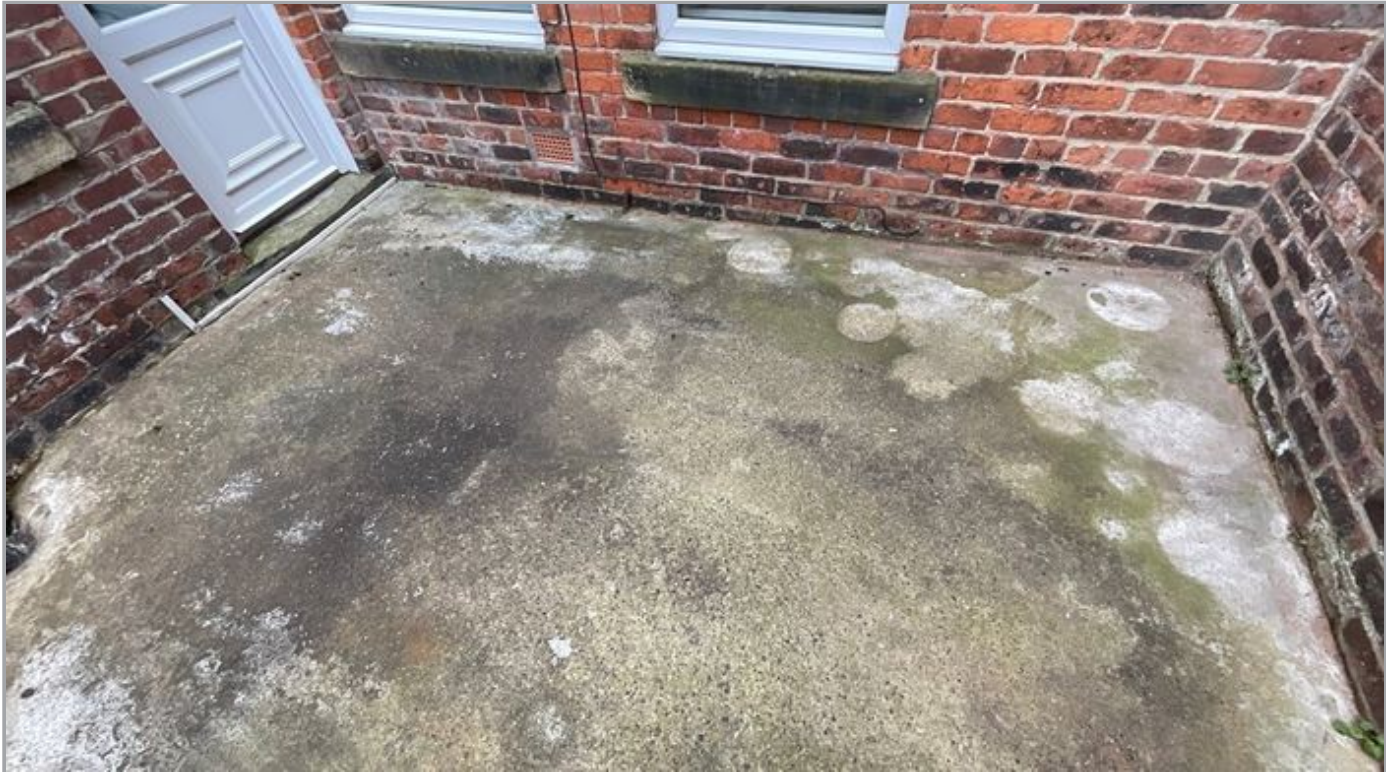
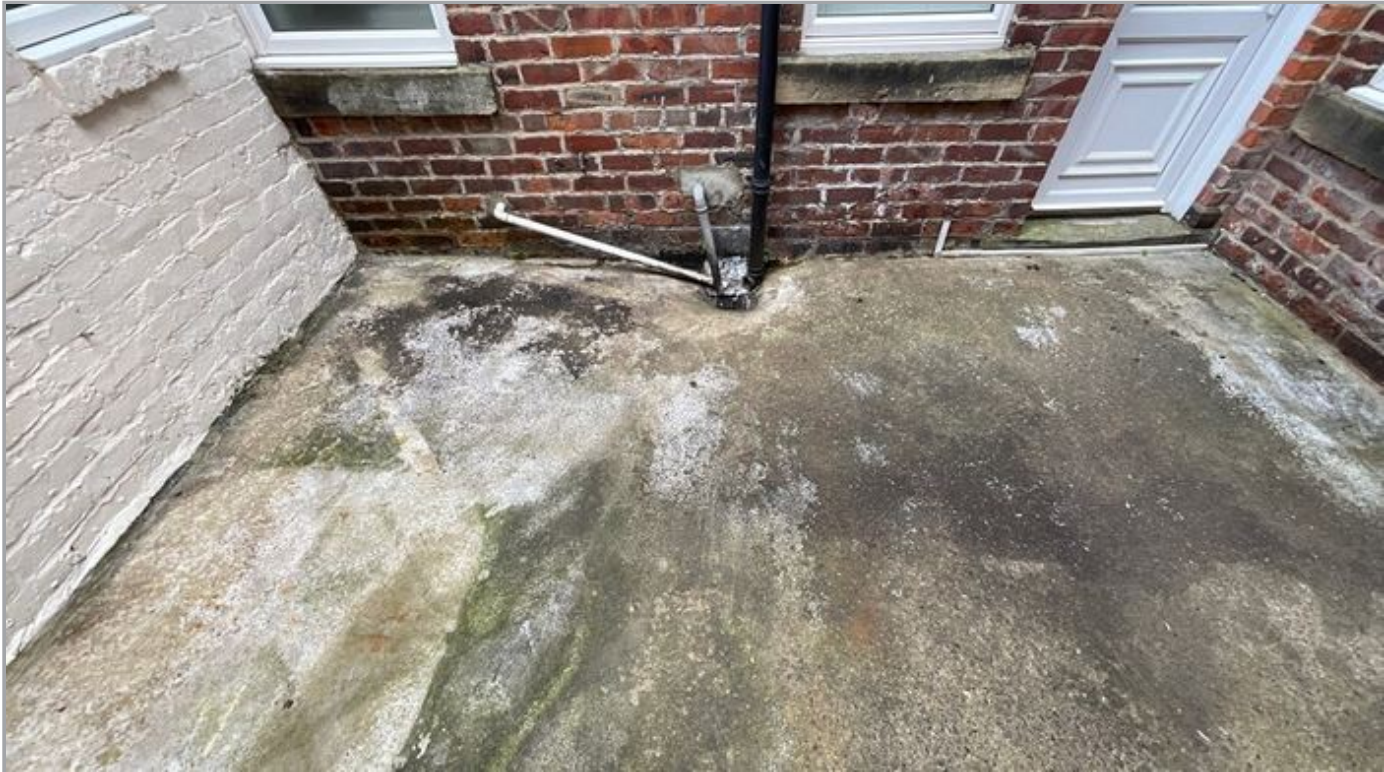
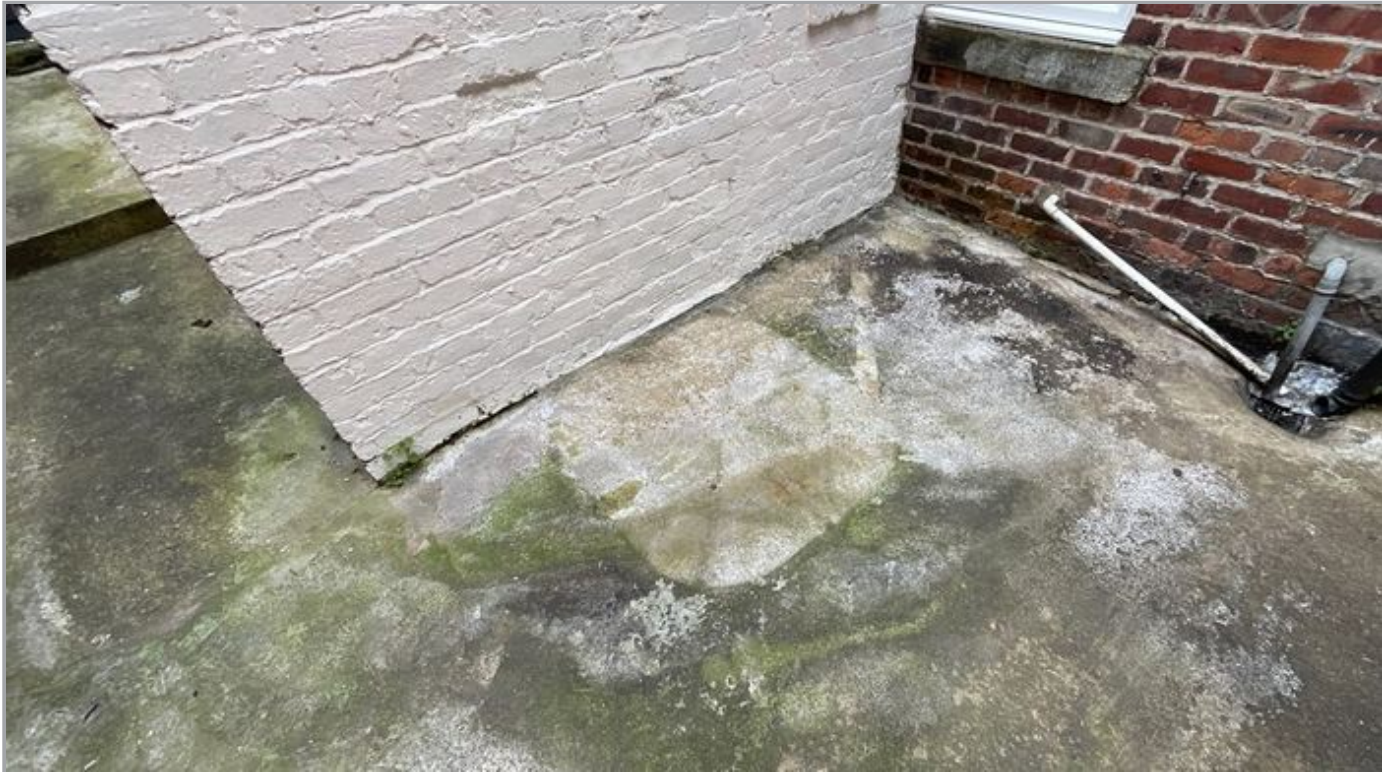
However, there doesn't appear to be enough adequate ventilation to the front and rear of the property, and this is reducing the effectiveness of the overall air flow to the ground floor. This will cause moisture laden air to build-up and increase the risk of condensation, mould, damp, and timber infestation to any timber flooring in the vicinity. You should consider having retrospective vents installed by a reputable building contractor.

Inadequate Ventilation

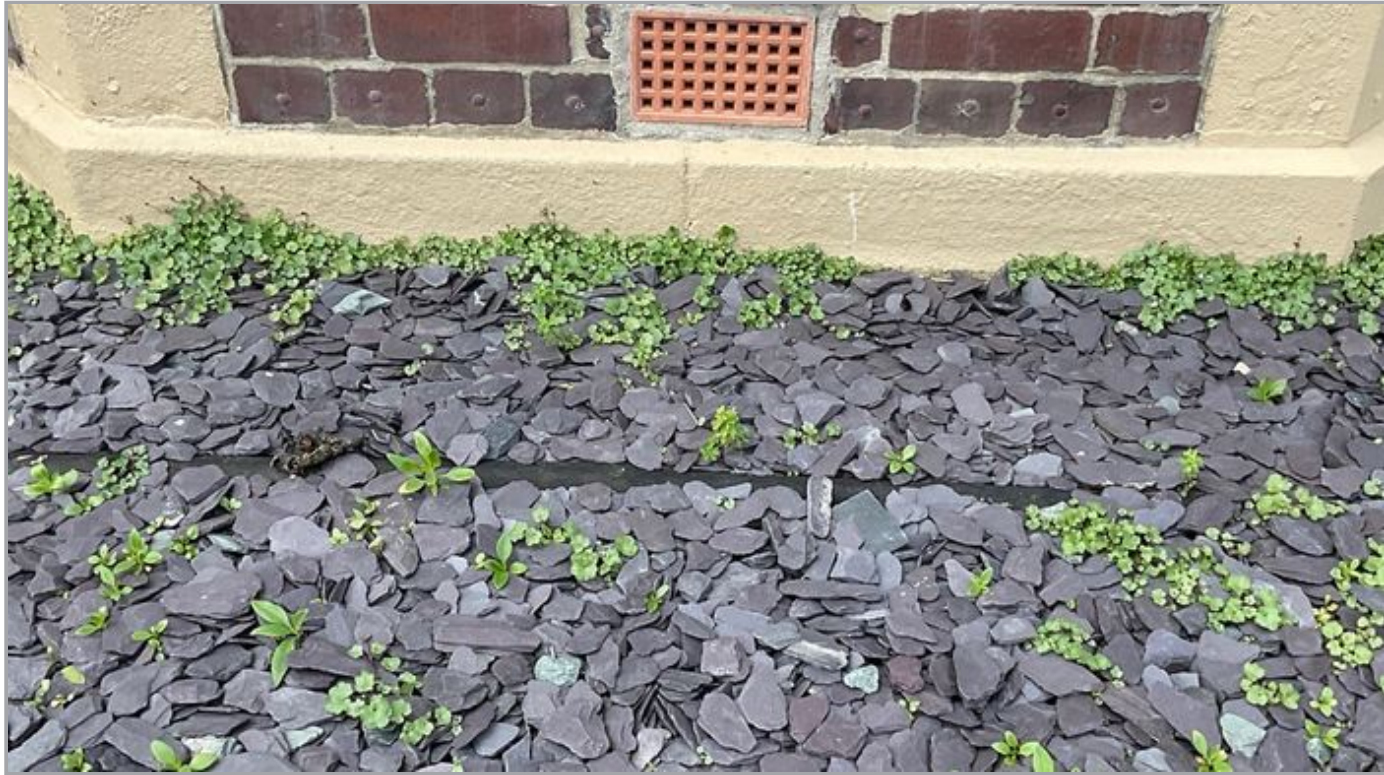
As is common with properties of this age, the external walls at low-level to the front have been finished with with a concrete painted plinth. These tend to bridge any existing damp-proof course and are often responsible for causing penetrating damp and rot to low-level internal walls and any timber flooring in the vicinity. They are also susceptible to de-bonding from the brickwork, allowing rainwater to accumulate behind and migrate through to the interior of the property, exacerbating any existing damp problems.

Plinths

You should consider full removal as this will limit ongoing maintenance, although you should be aware that this will likely cause damage to the brickwork and pointing beneath, therefore some repair work will be required.

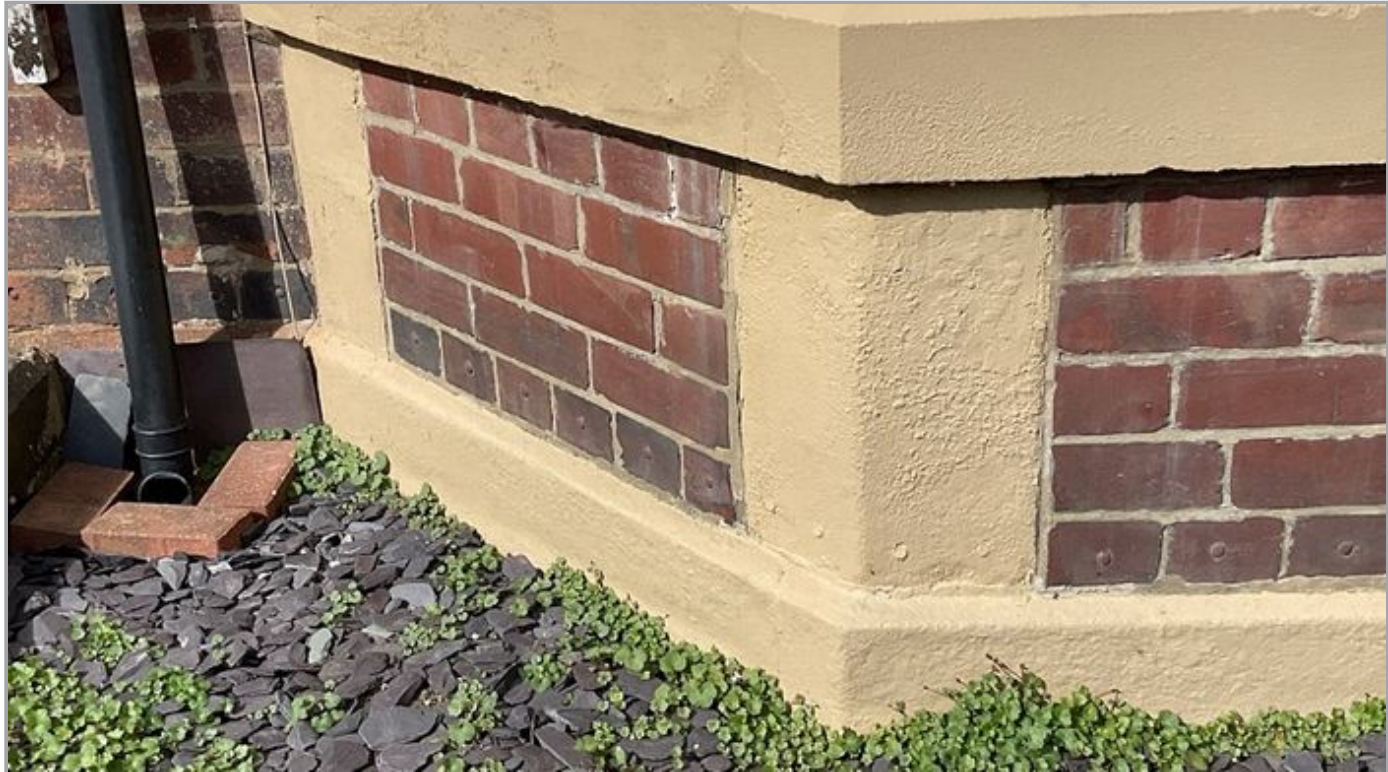
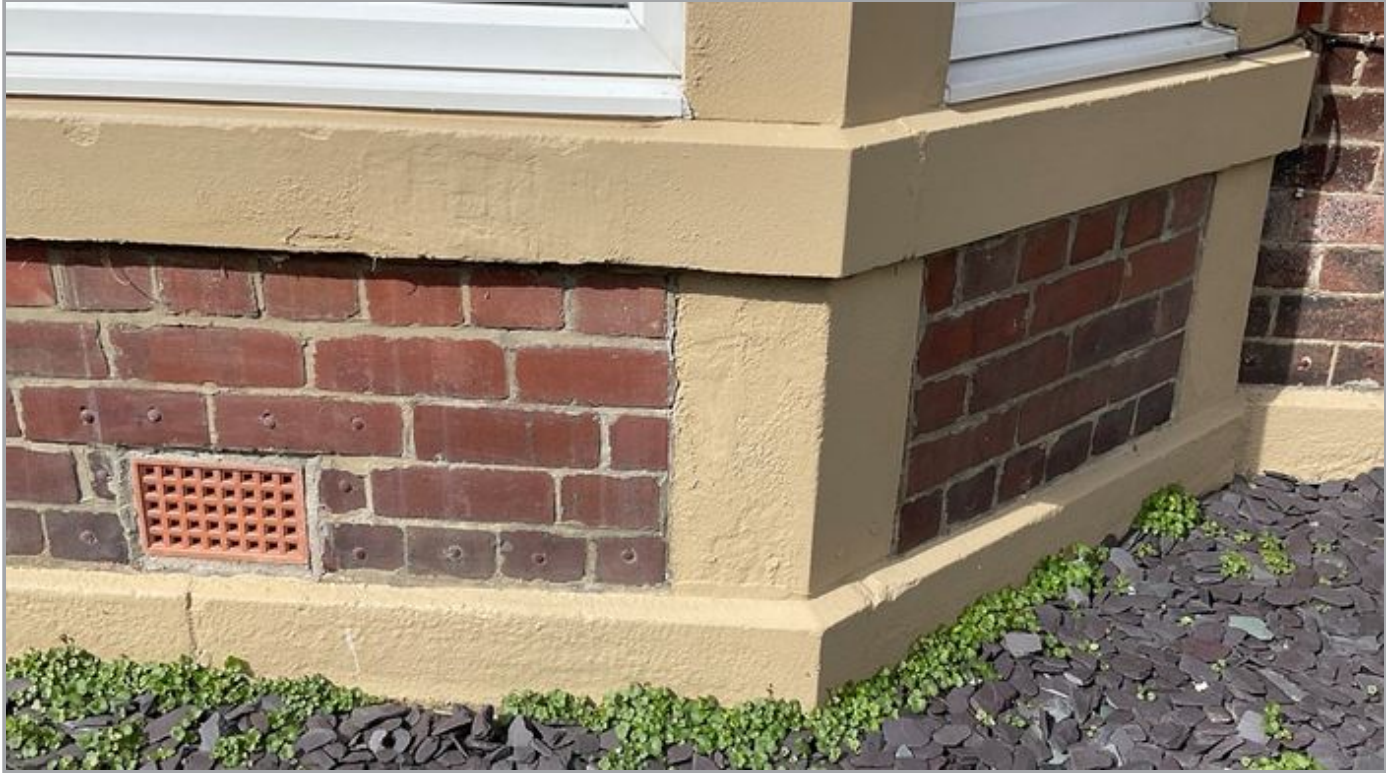
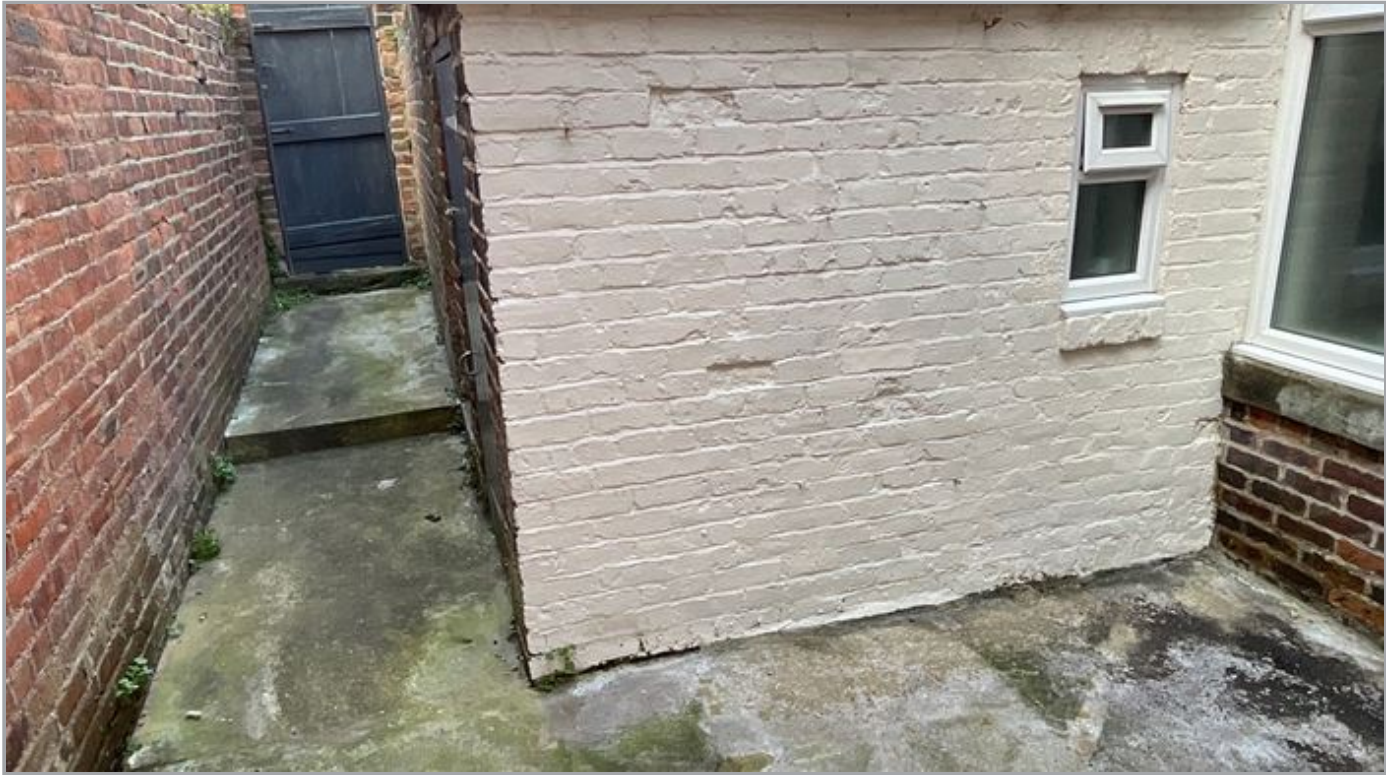
The front and rear of the property has been painted with what appears to be numerous coats of non-breathable paint. Once the paintwork cracks, moisture entering the openings will become trapped as it can't evaporate naturally, and this will increase the risk of penetrating damp, although this is dependent on the condition of the brickwork and mortar pointing beneath.

Painted Surfaces

The paintwork should be removed carefully, and any damaged areas beneath repaired accordingly.

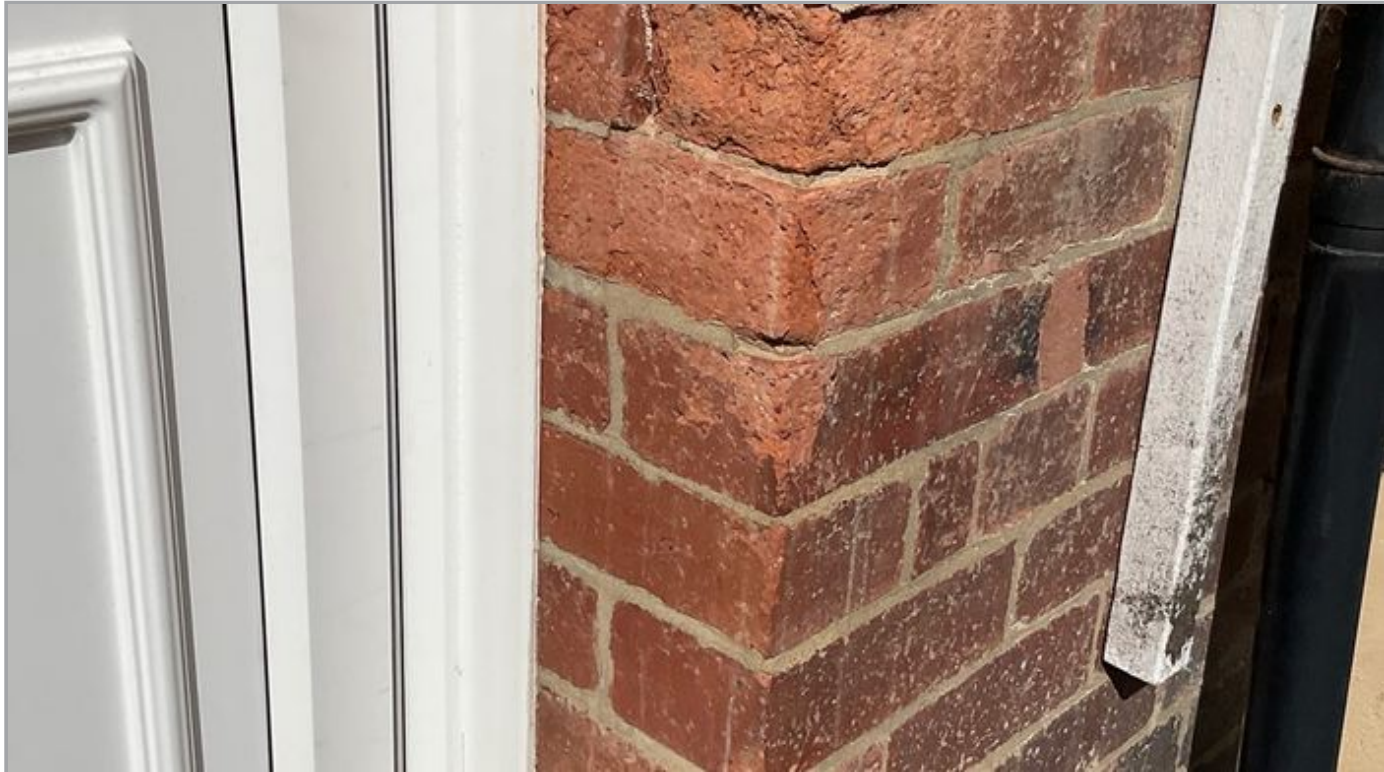
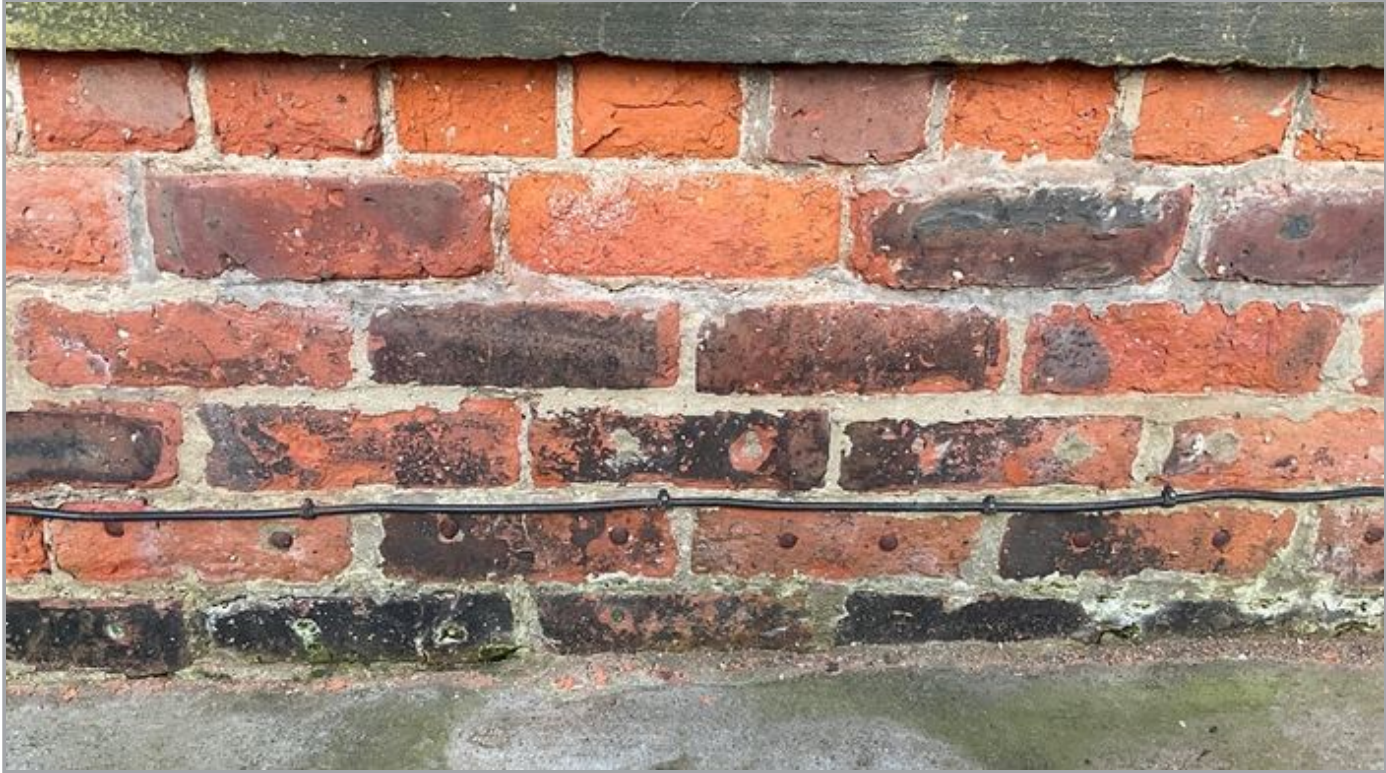
Some of the bricks are suffering from deterioration of the outer face, as a result of frost attack (also known as spalling) and this has been exacerbated by the repeated freeze/thaw cycles from seasonal weathering. This eventually causes total disintegration of the brick, and the affected bricks should be removed and replaced with a suitably graded equivalent.

Spalling Brickwork

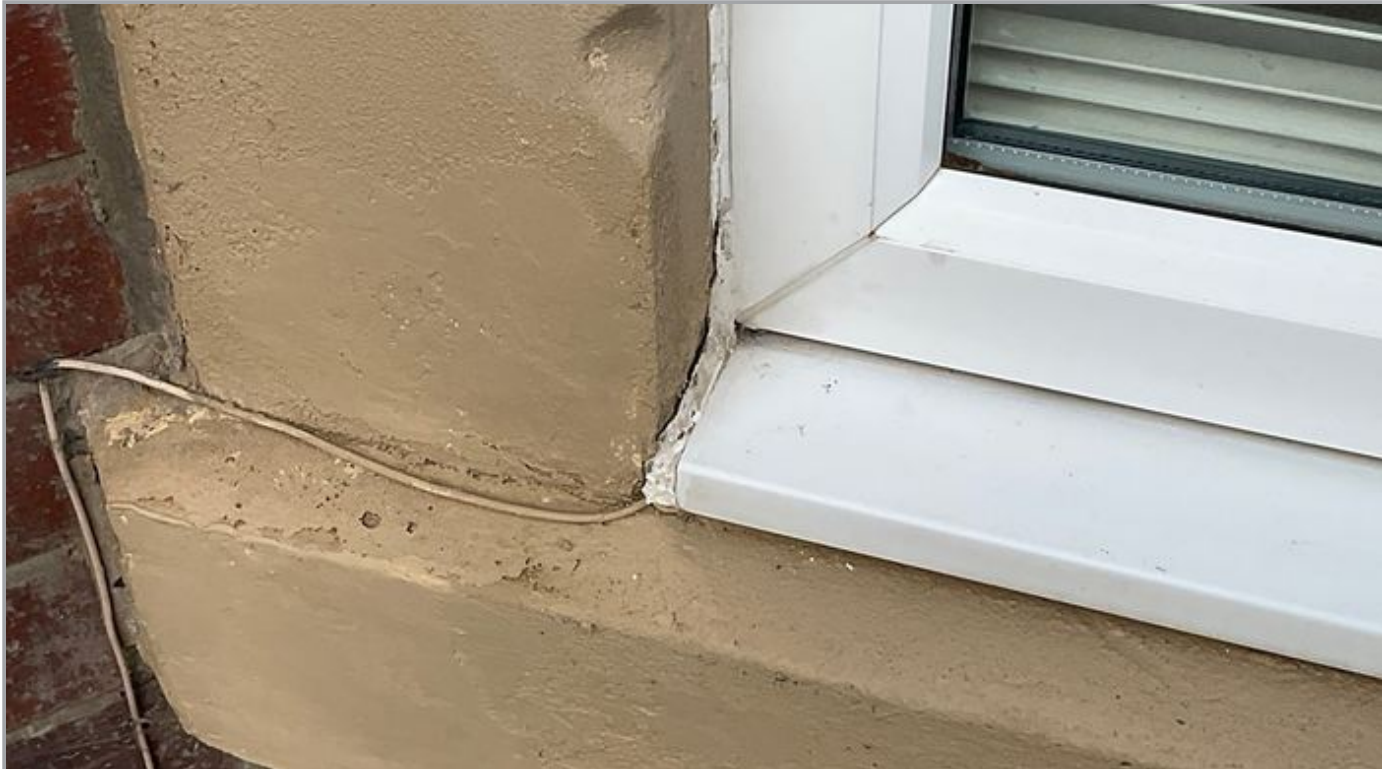
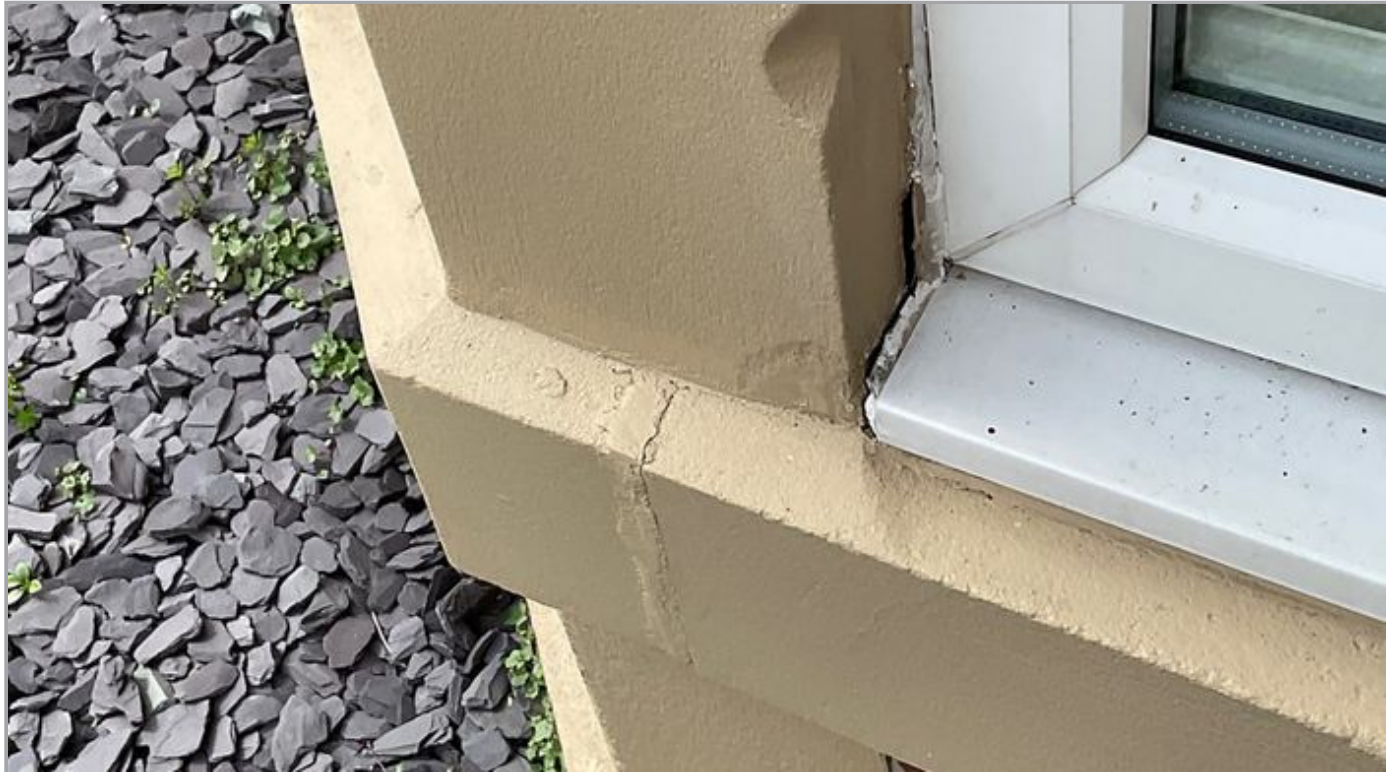
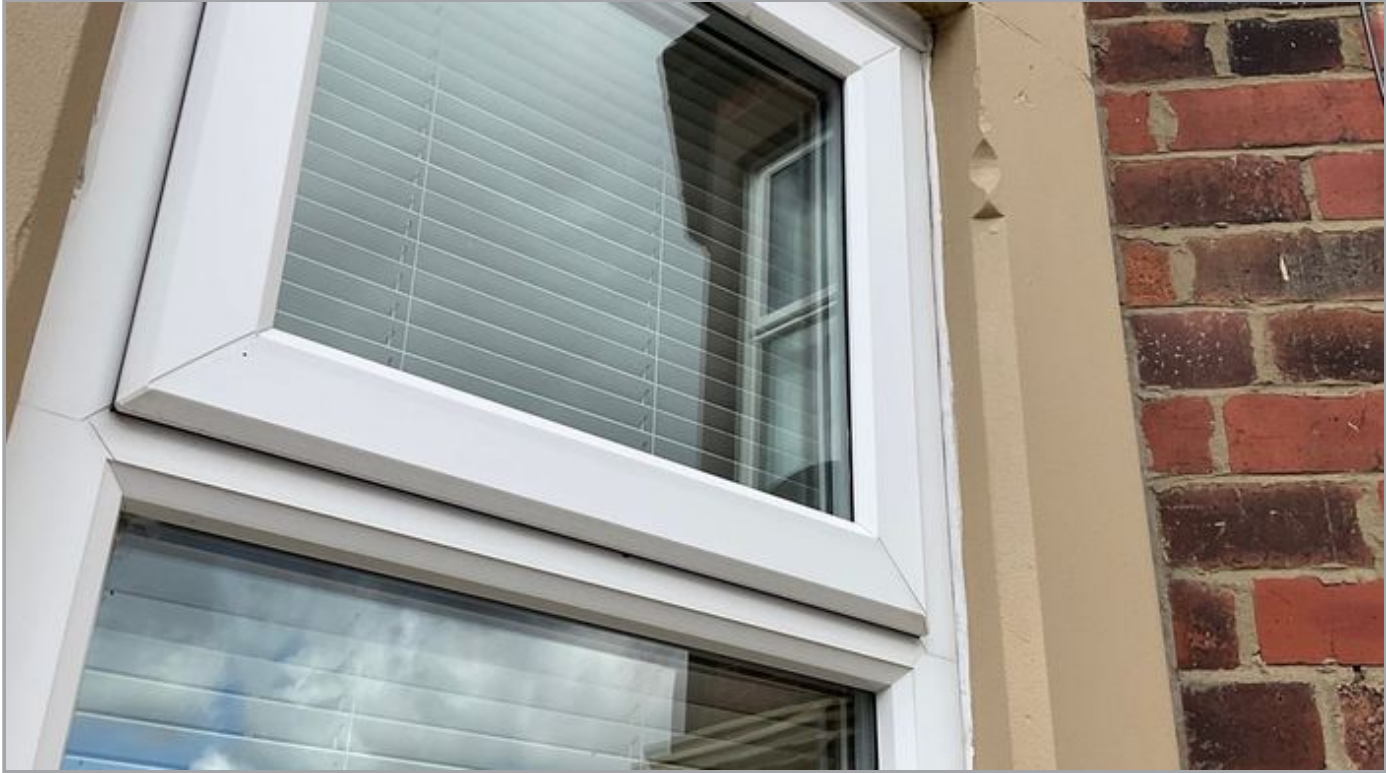
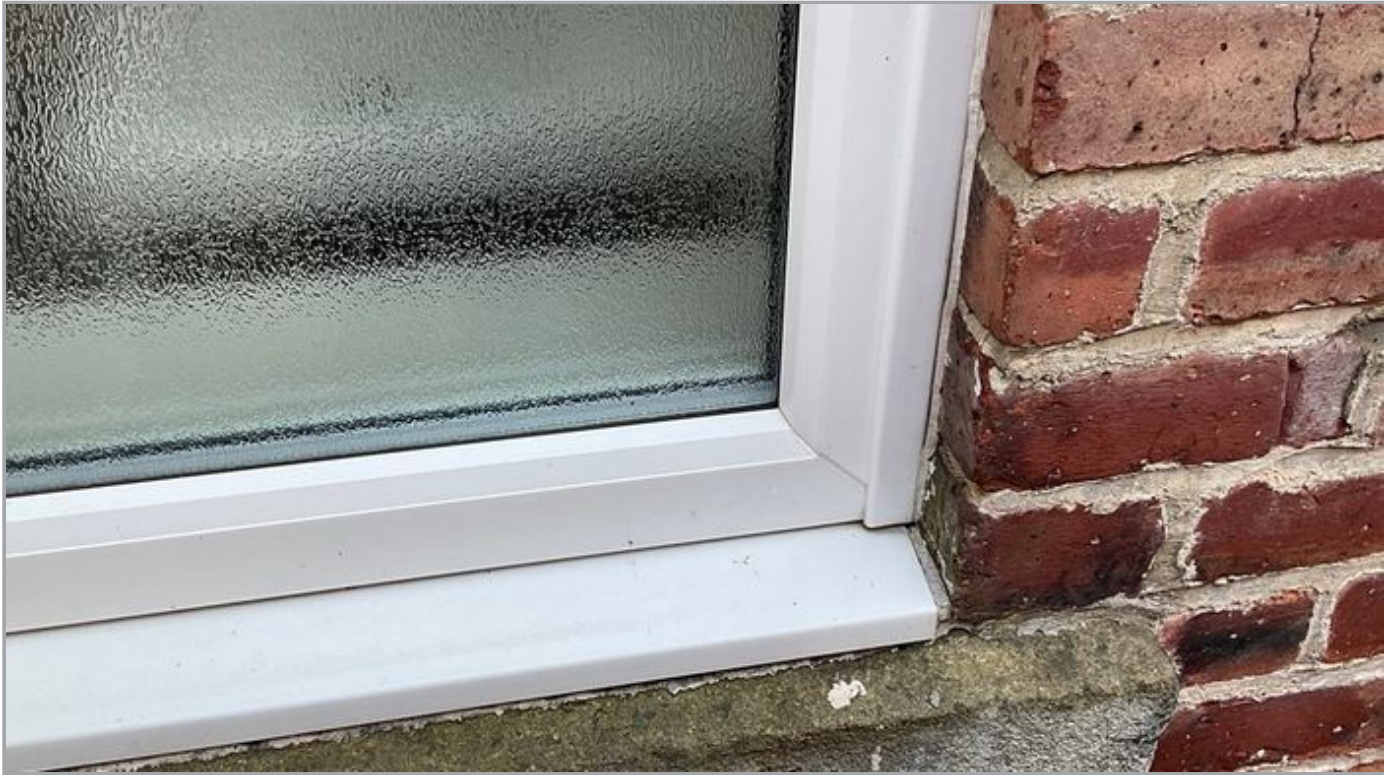
The mastic to some of the windows is loose/missing, and this should be replaced/repointed. The remaining window junctions should be regularly inspected and maintained.

Protective Sealant

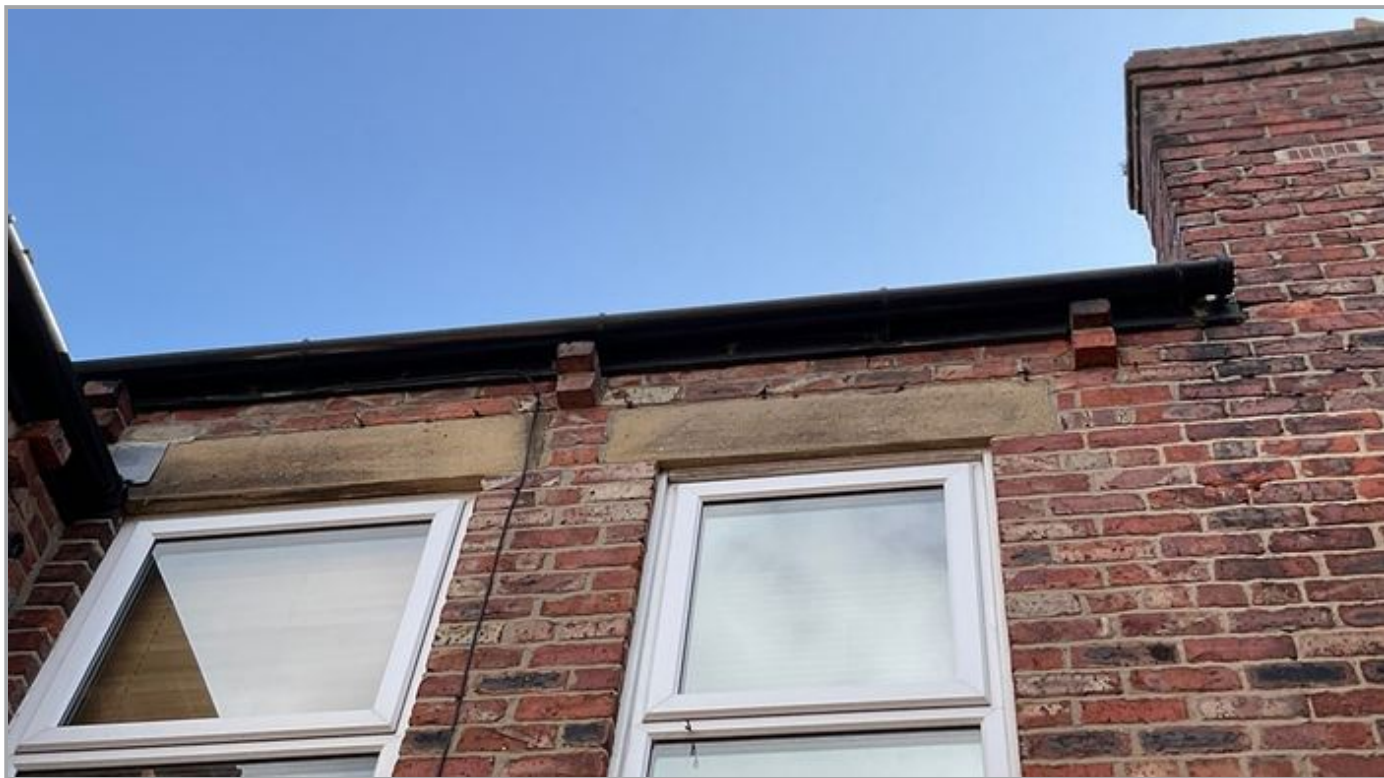
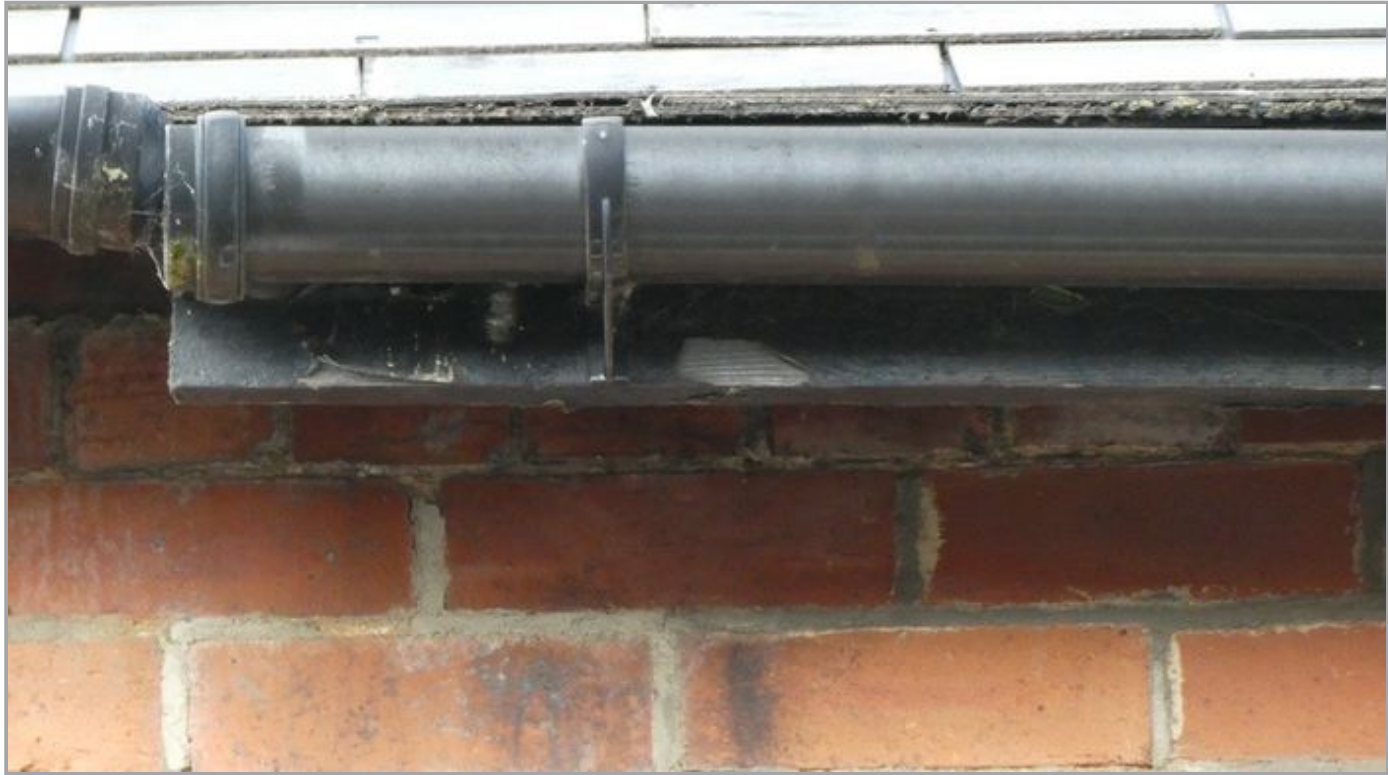
The external joinery is weathered in places. This requires redecoration to prevent further deterioration and more costly repair work. Alternatively, if it is within your budget to do so, you should consider replacing timber joinery to modern plastic as this requires minimal maintenance once installed.

Weathered
