LEVEL 2

Your survey report

30 August 2023

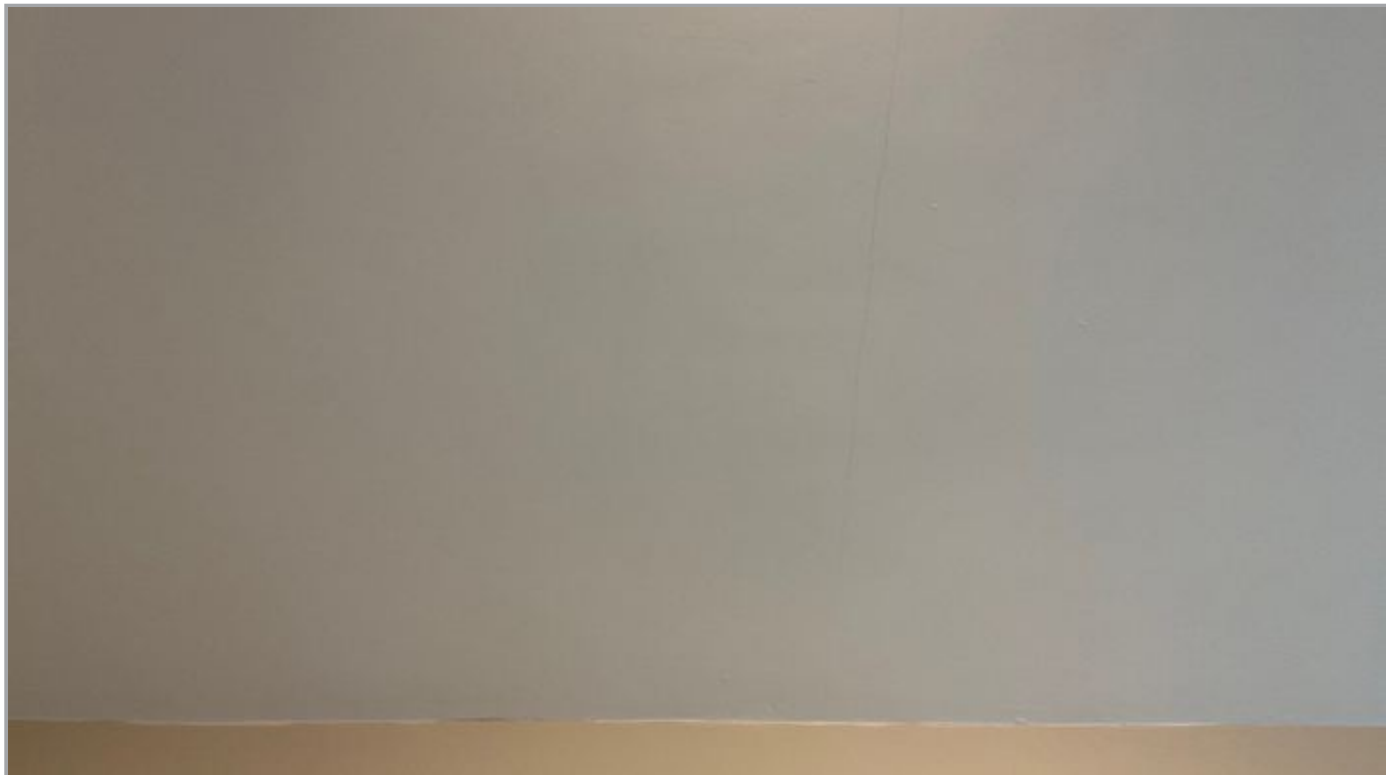
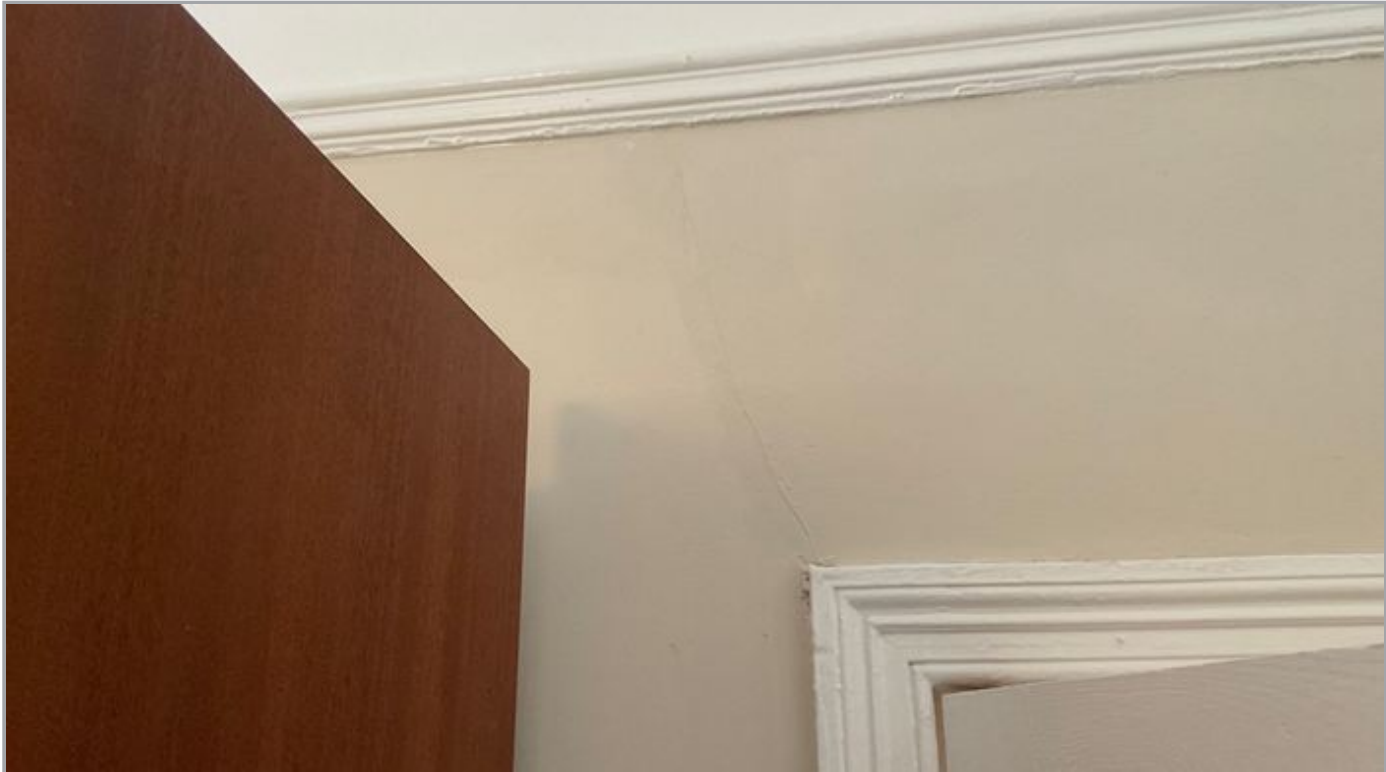
Cracking in modern plastered ceilings is often from the following most common causes; from human activity on the flooring above, the installation of timber boarding/insulation to the roof space, the general ageing of the material/loss of adhesion over time, normal shrinkage of the material, and the slight movement between individual sheets of plasterboard.

Common Cracking

This type of cracking is not considered serious or significant, and hairline cracks should be filled and refinished. If any cracking becomes deeper within the plaster or reopens, replacement or re-skimming will be necessary for better aesthetics and to help with the long-term saleability of the property in future resales.

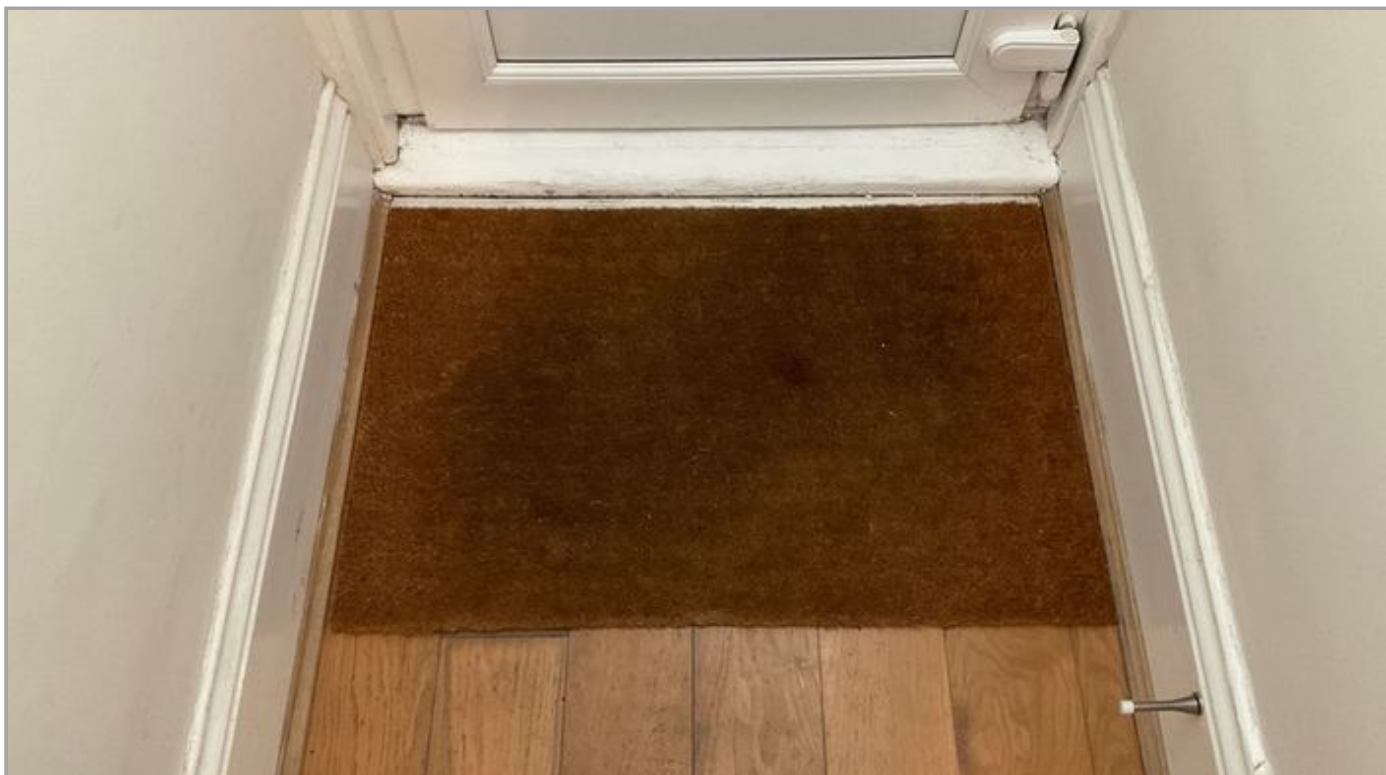
As the subfloor ventilation is inadequate to the ground floor, the quality of the support to the suspended timber flooring in the vicinity is suspect. This will leave the floors vulnerable to rot and timber infestation, therefore we refer you to our comments in Section D4 for more detailed information and the necessary remedial work.

Springy Flooring Hallway

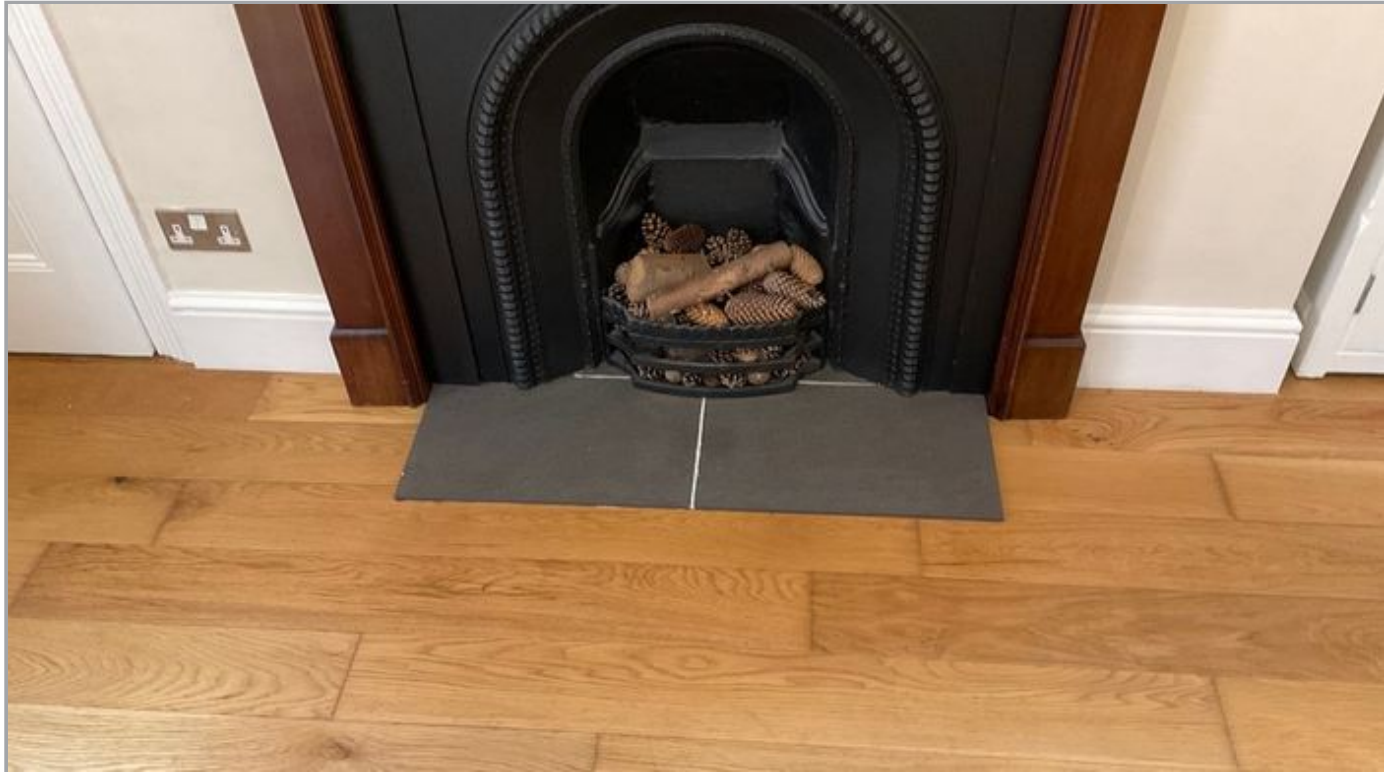
The chimney breast to the lounge has no ventilation vent. This should be installed to allow for better airflow and help prevent defects in relation to condensation, damp, and rot occurring to internal areas within the property, particularly to the base of the chimney and to nearby timber construction in the vicinity, such as skirting and flooring.

Inadequate Ventilation

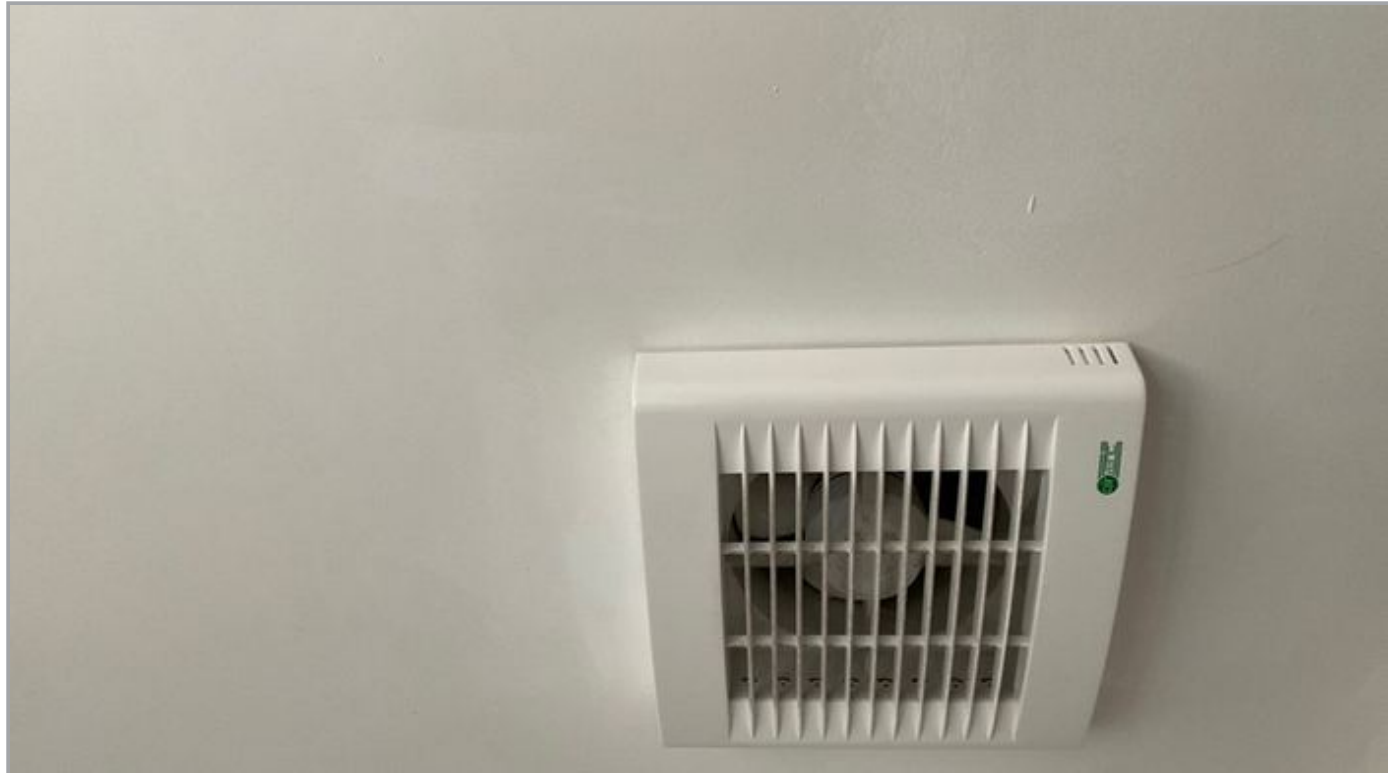
To continue working effectively at removing excess water vapour in the air and help prevent condensation/mould build-up to surfaces, the existing mechanical extractor fan in the bathroom should be regularly cleaned and maintained, to ensure full effectiveness. We refer you to our comments in Section E9 on condensation/mould and how to better control it within the home. 1

Extractor Maintenance

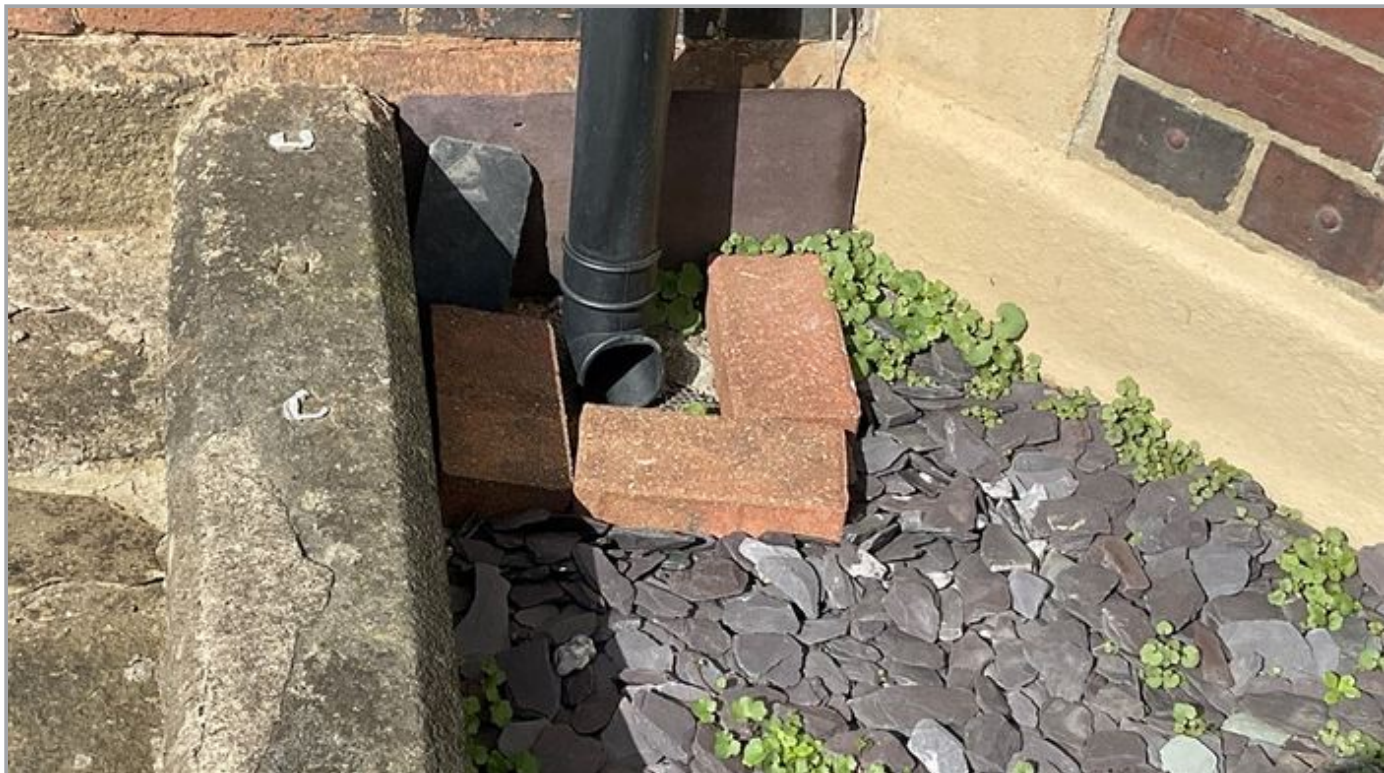
Open Gully

All drainage that is easily accessible, such as drainage gullies, should be inspected and cleaned periodically, with plastic covers properly secured in place to prevent blockages, where necessary.

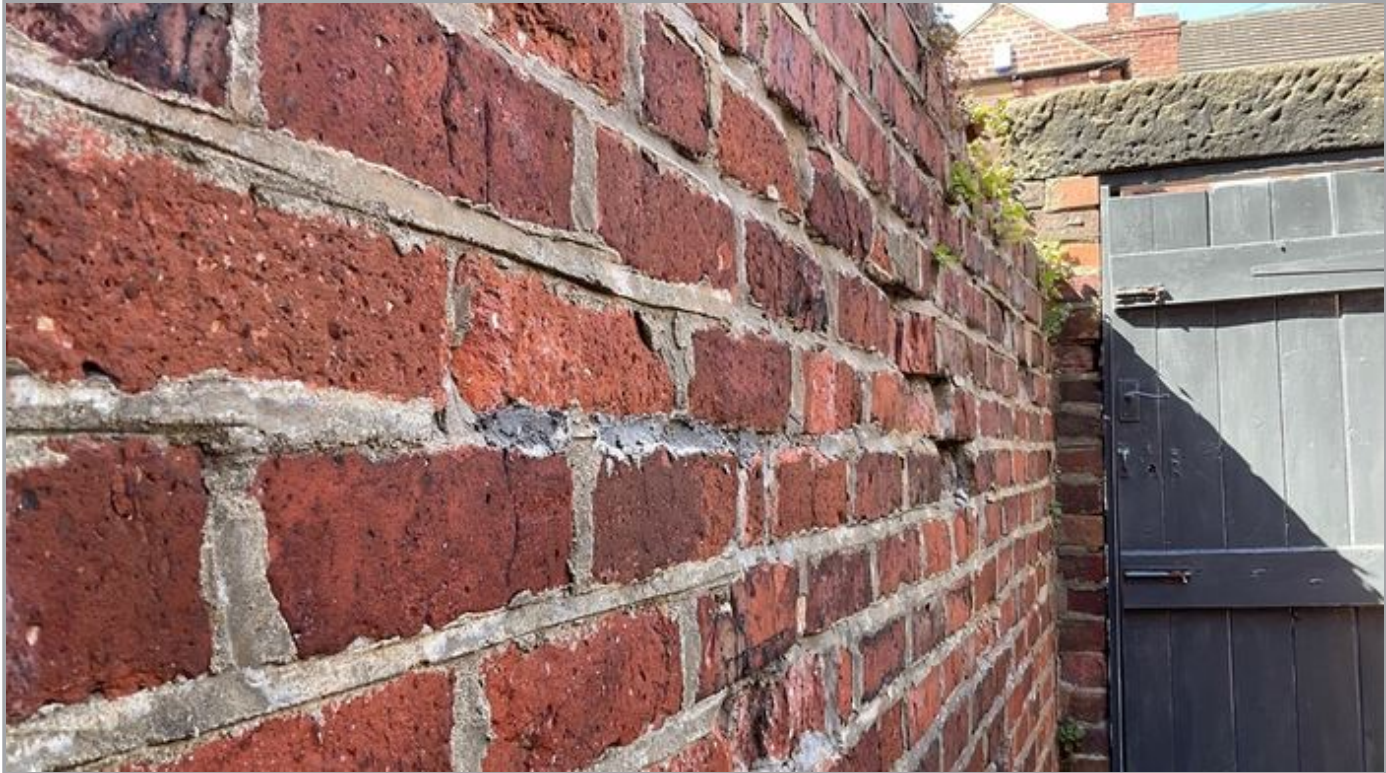
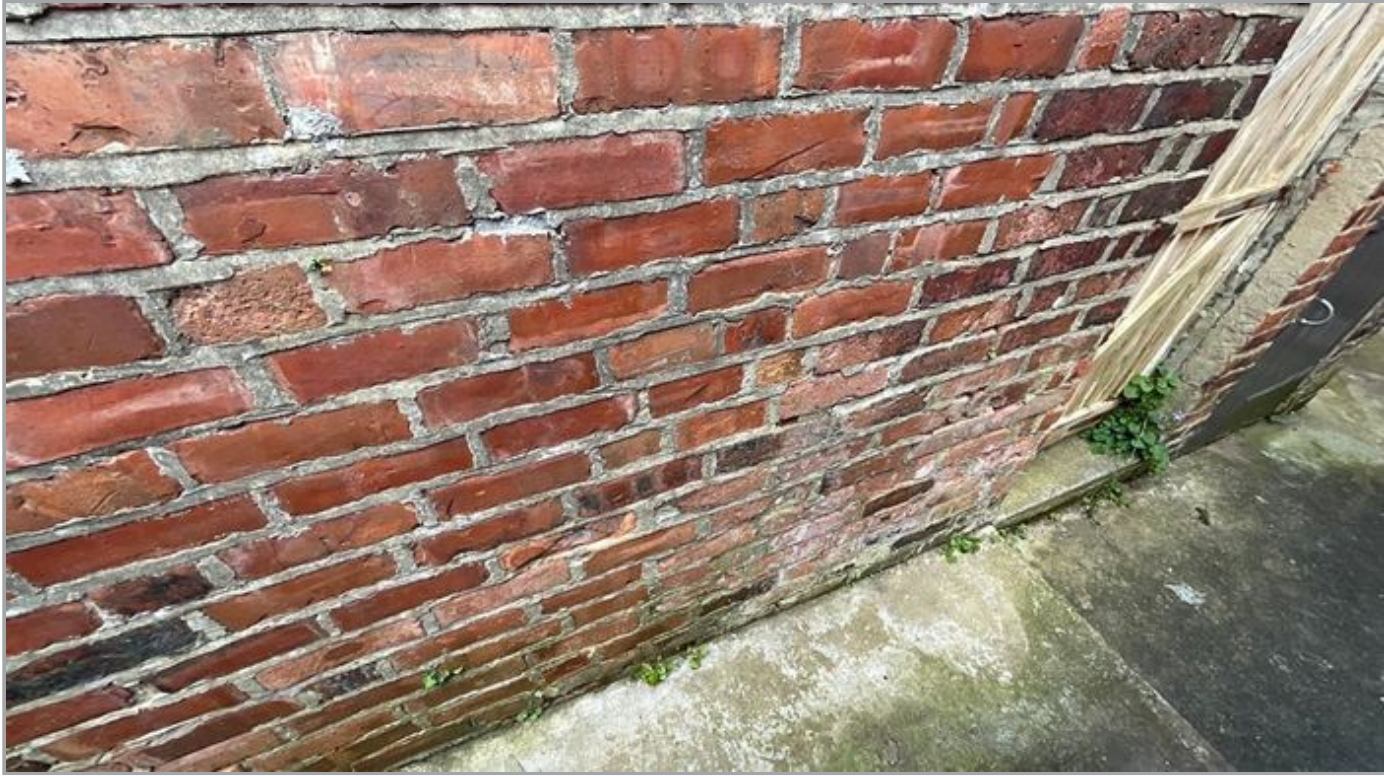
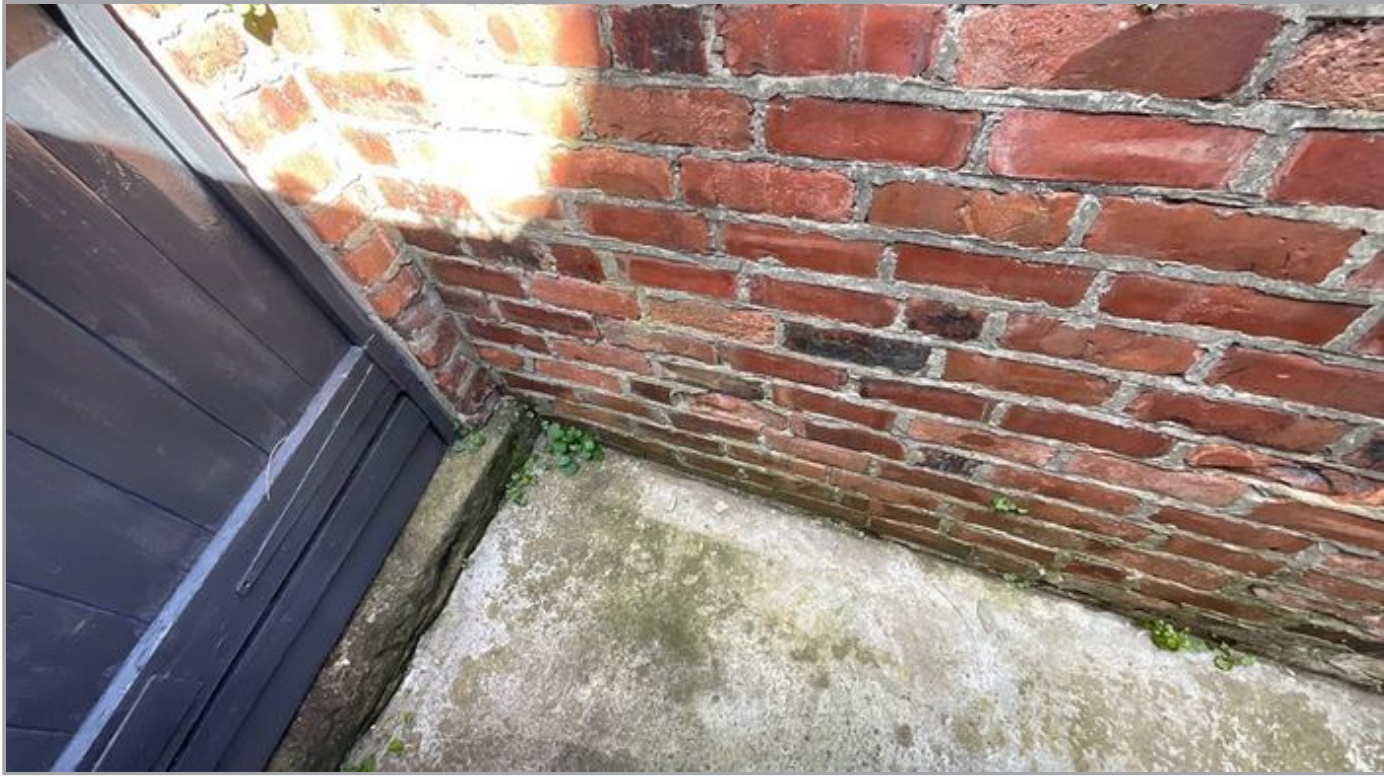
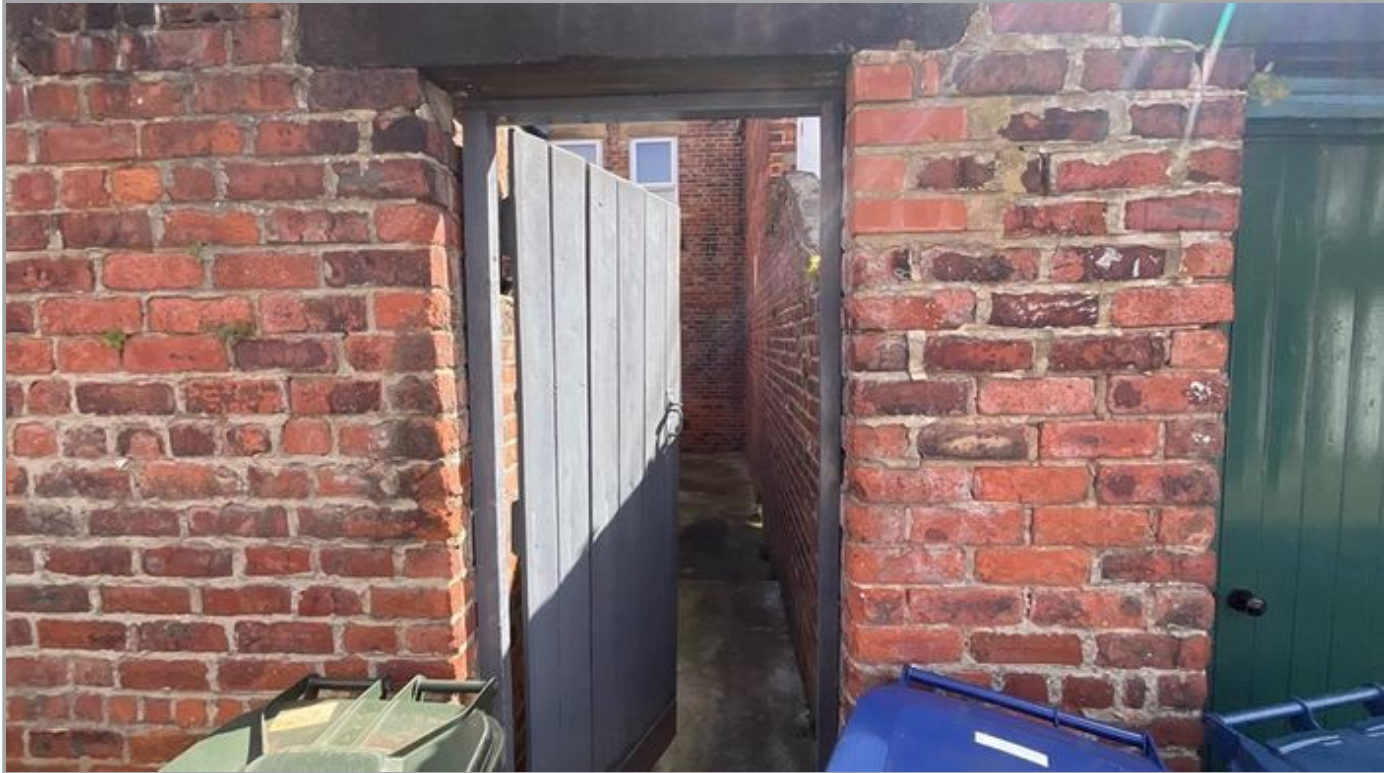
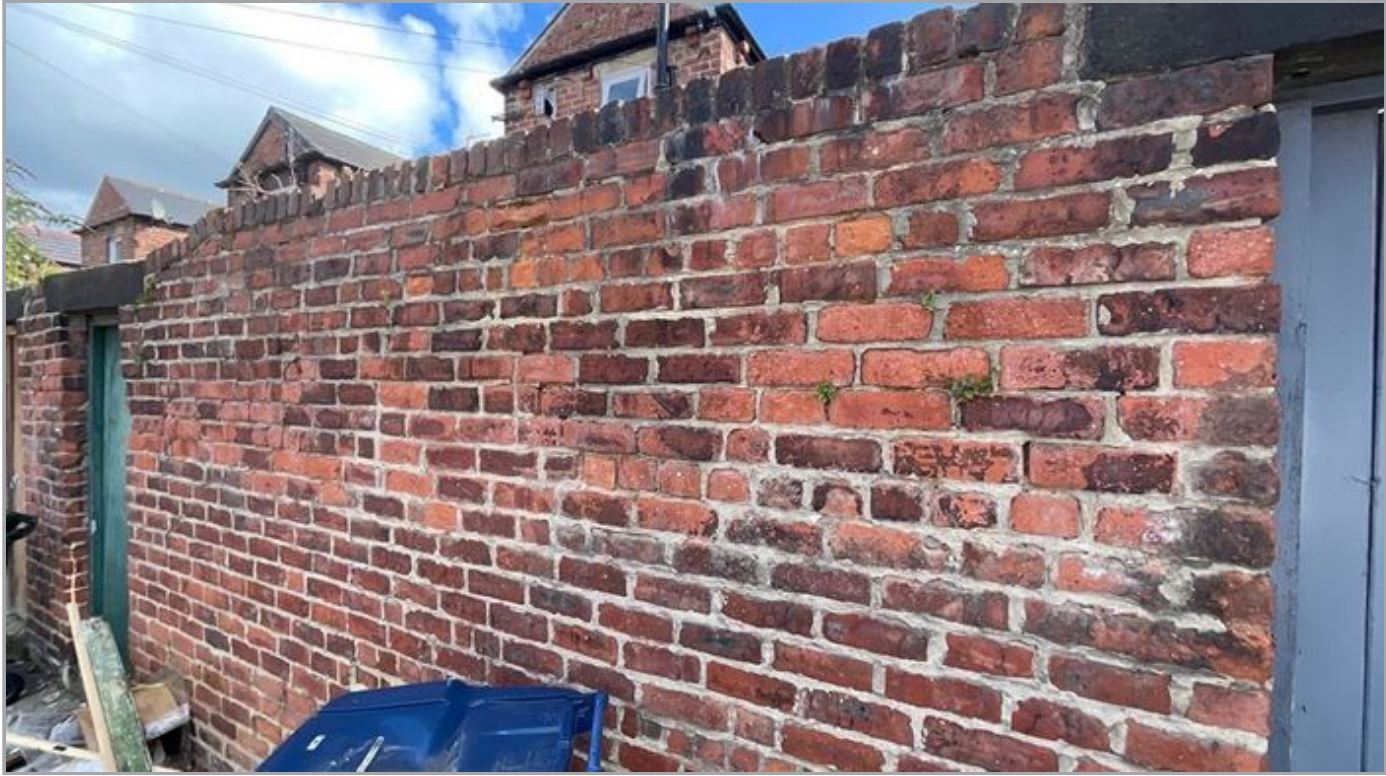
Pointing/Spalling
