LEVEL 2

Your survey report

Inspection date

21 July 2023

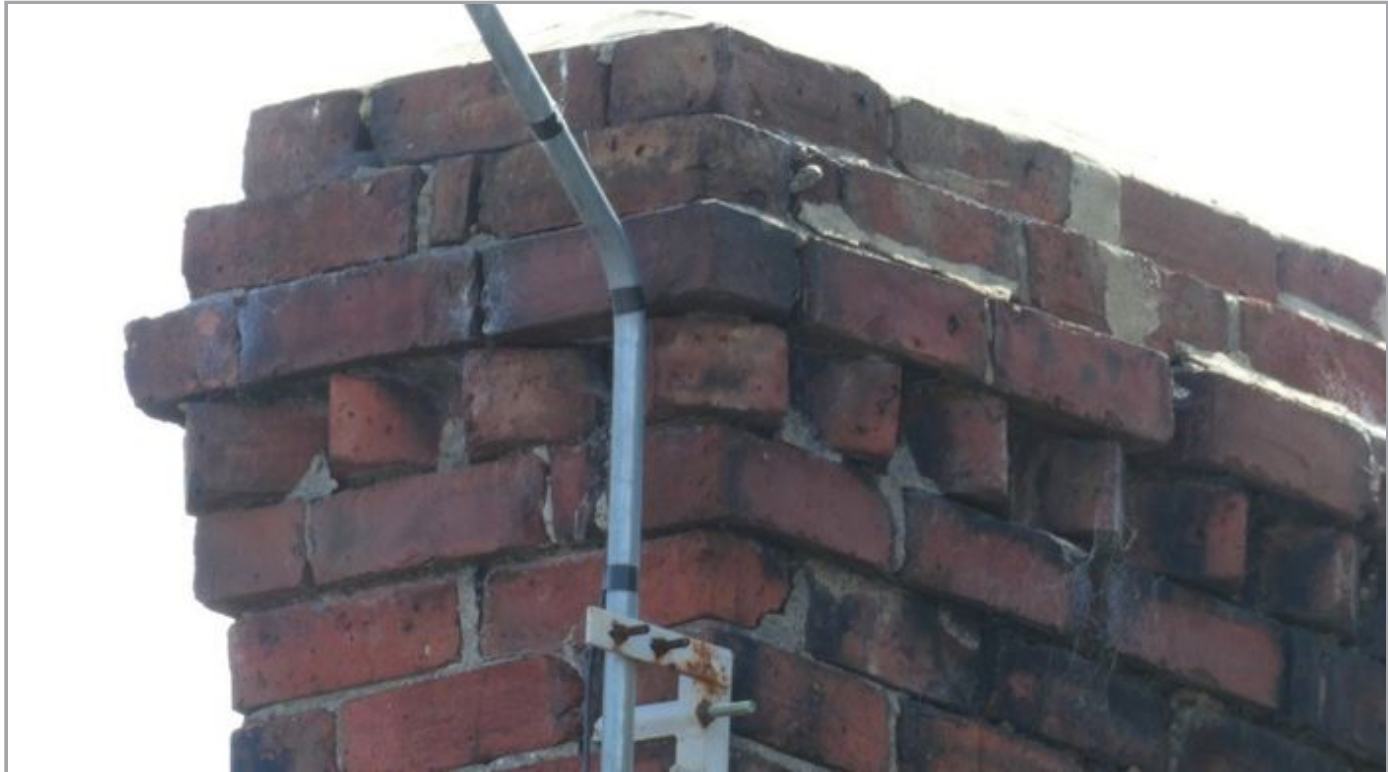
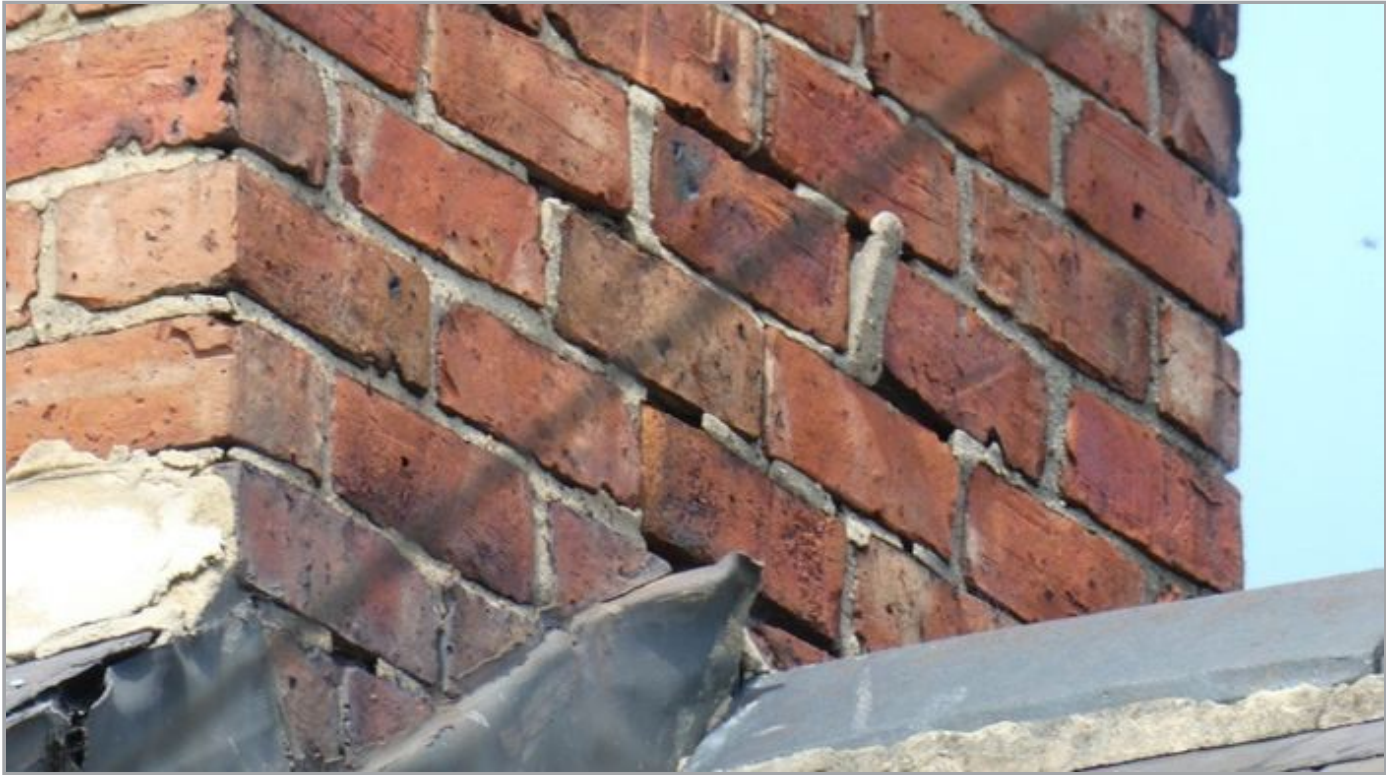
Eroding Pointing

The mortar between the brickwork (called pointing) is eroding as a result of seasonal weathering and requires localised repointing, although it is often more beneficial to repoint the full elevation. Solid brick walls rely upon the quality of the external pointing and brickwork surfaces for their weatherproofing and as there is no cavity gap, they control potential damp problems by evaporating moisture naturally, especially when pointed properly.

As the walls require repointing, you should consider using a lime mortar as it is flexible and highly breathable, compared to the more commonly used cement mortar. Cement mortars tend to retain moisture and in a solid brick wall, that will allow it to migrate into the property. Once the remedial work has been carried out, the walls should be regularly inspected and maintained.

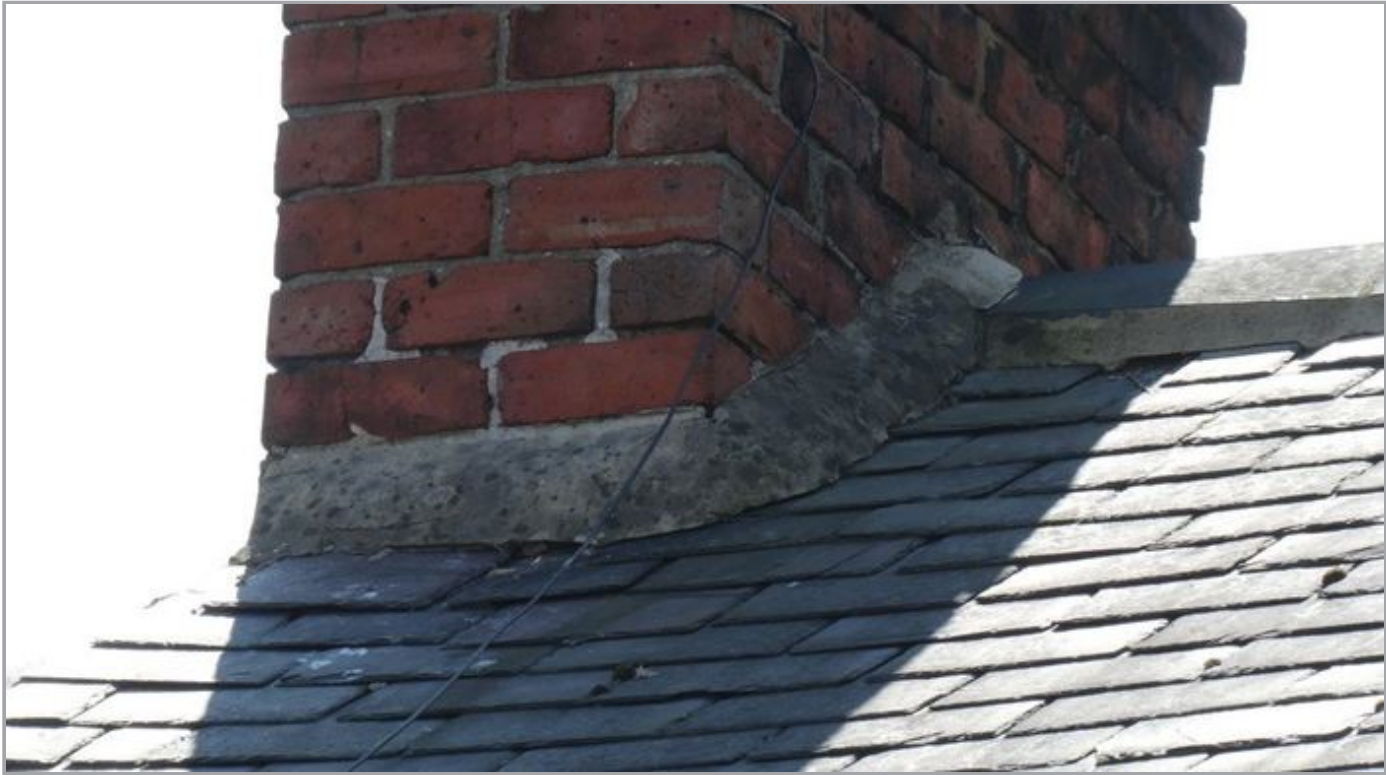
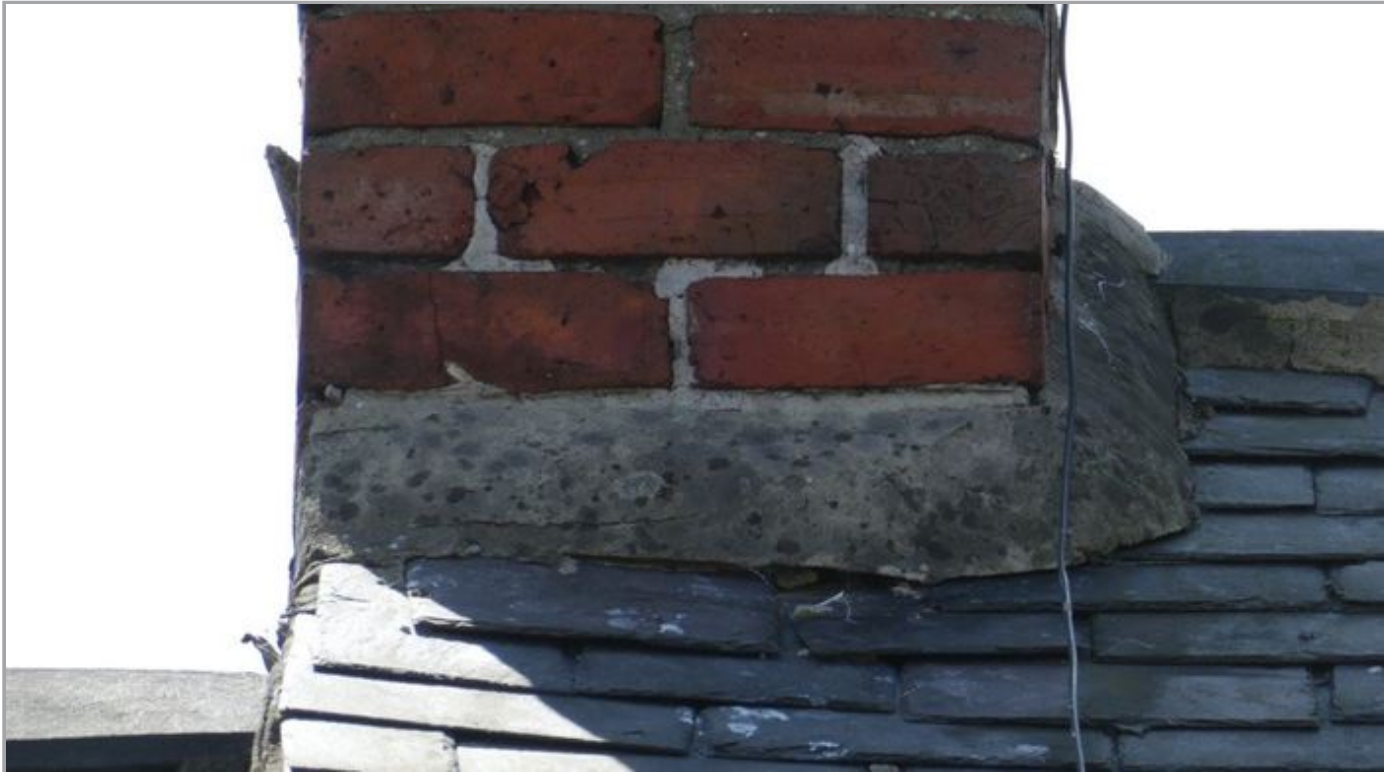
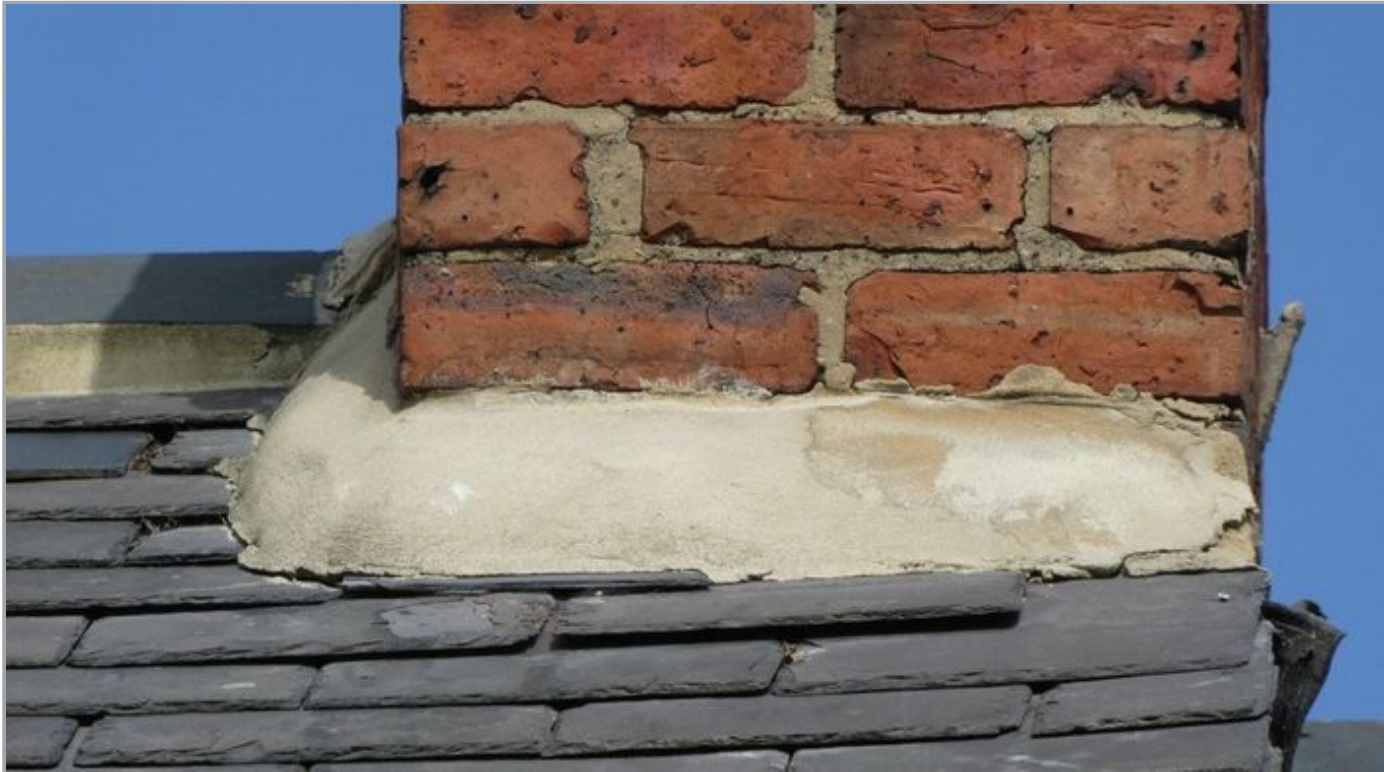
The protective detail (called flashing) to the chimney stack is formed with mortar fillet. This was found to be in a satisfactory condition. However, it needs to be regularly inspected and repointed accordingly, to ensure some form of weatherproofing and help prevent rainwater penetration into the roof space.

Inadequate Flashing

It should be noted that this type of flashing detail is inferior compared with lead and requires much more ongoing maintenance, therefore you should consider upgrading this with a more robust alternative, if it is within your budget to do so.

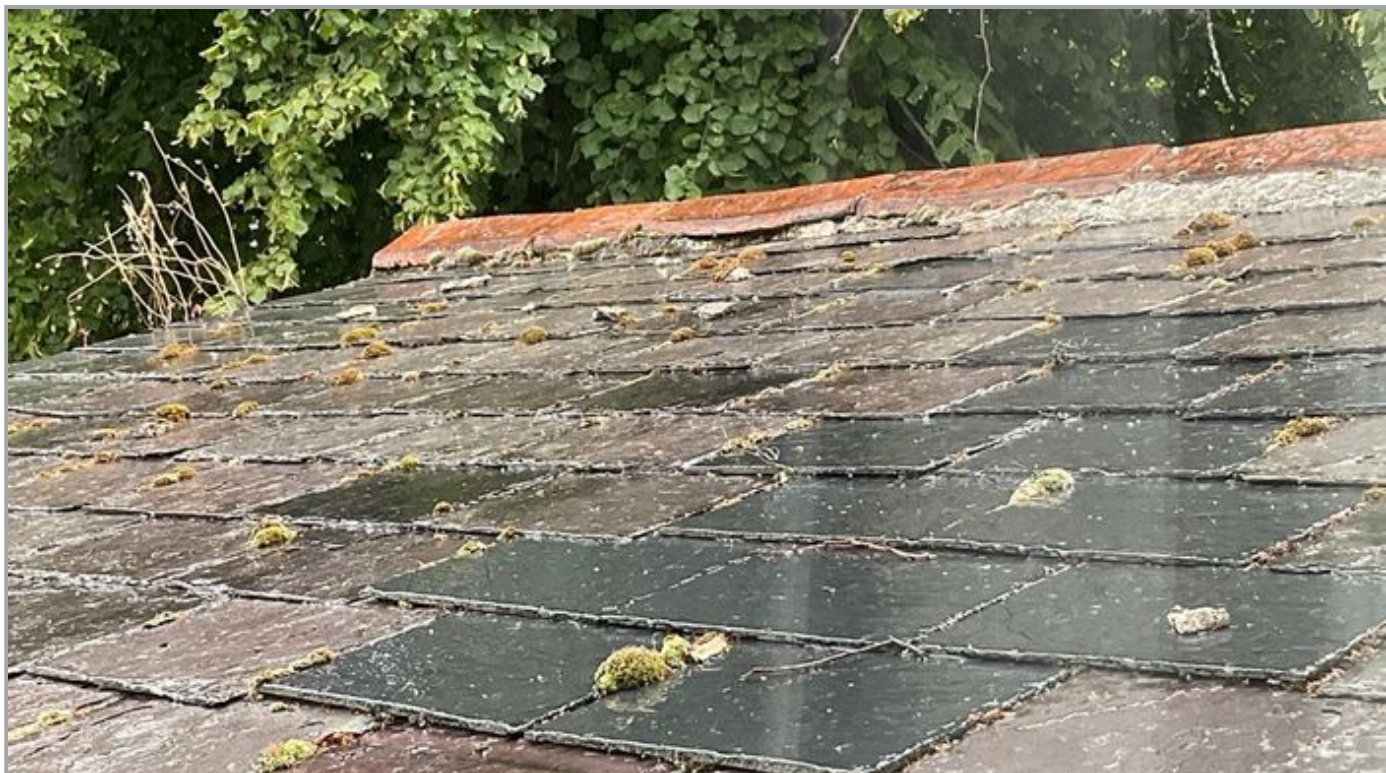
Eroding Ridge

However, it should be noted that whilst repointing is a suitable form of weatherproofing, you should consider installing a modern plastic interlocking system called a dry ridge system, if it is within your budget to do so, as it requires minimal maintenance once installed.

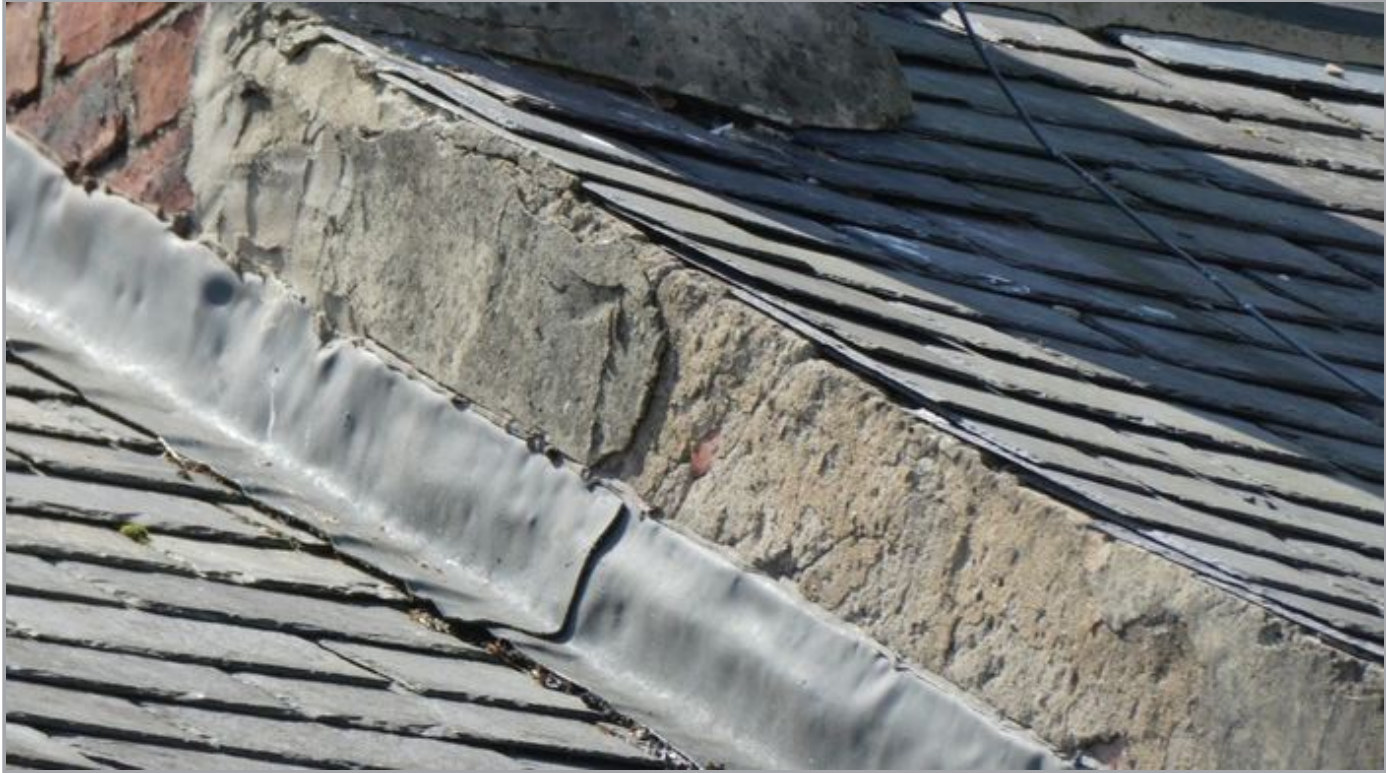
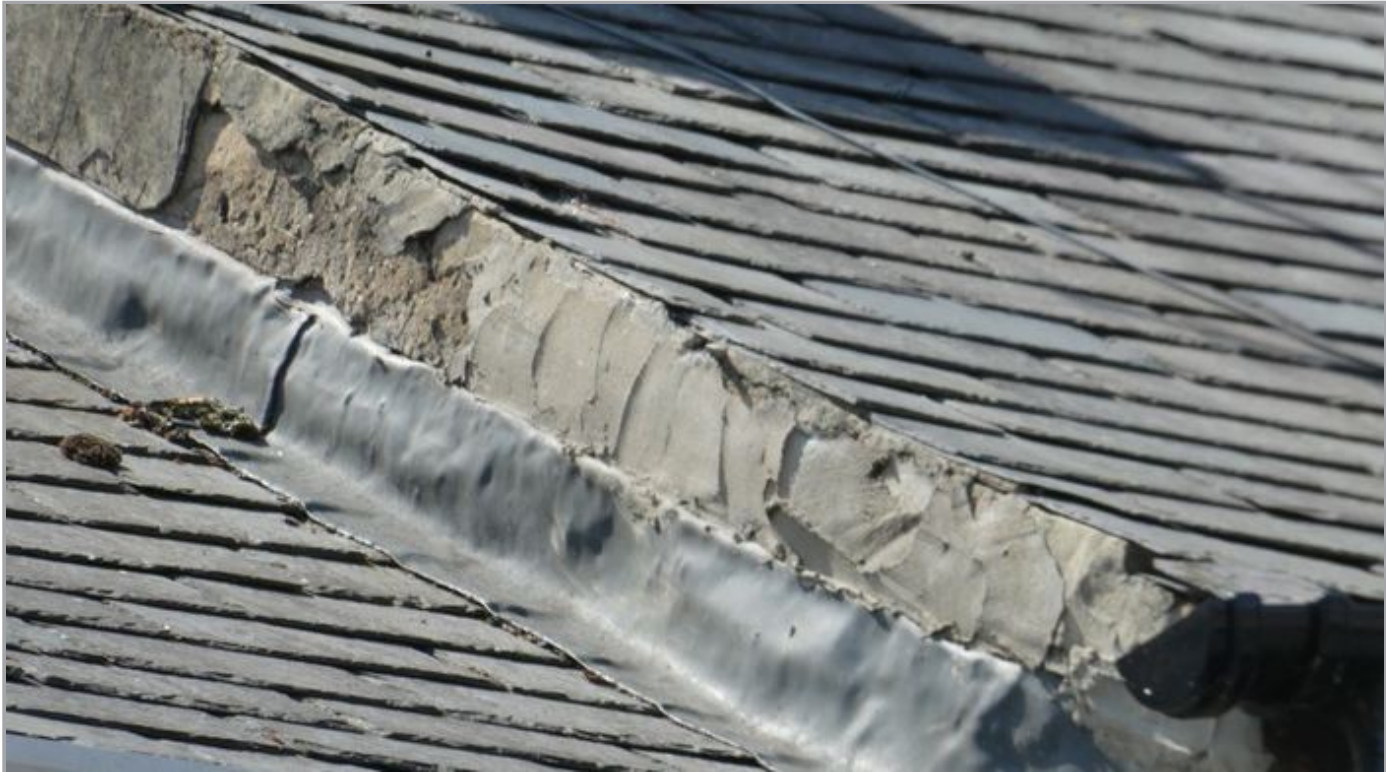
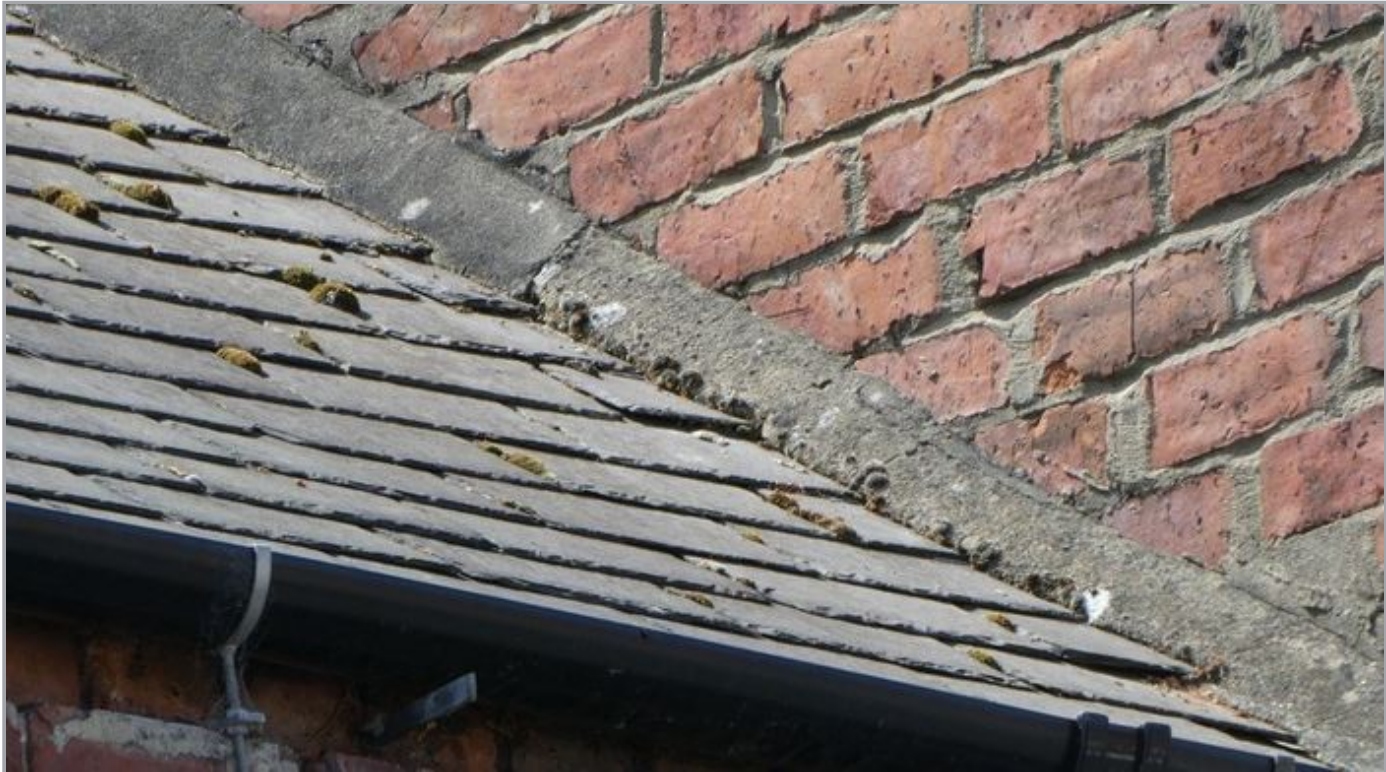
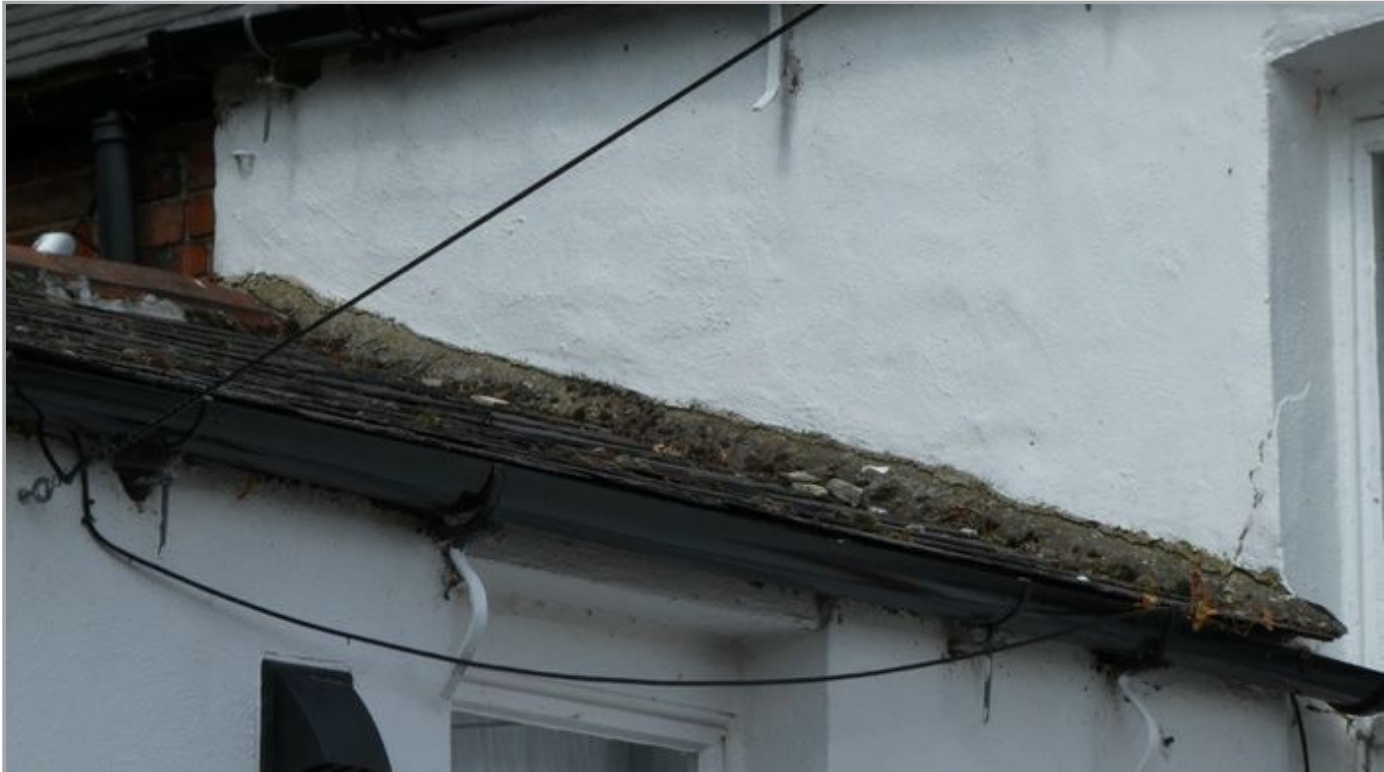
The junctions to the front and rear roofs and neighbouring properties external wall is sealed with mortar fillet flashing and this was found to be cracking/eroding and for a temporary repair, it should be repointed.

Inadequate Flashing

This type of flashing detail is inferior compared with lead and until remedial work is carried out, this area will now be more vulnerable to water ingress and problems associated with damp. You should consider repairing with a stepped lead flashing, as this will offer much better weatherproofing and requires minimal maintenance once installed.

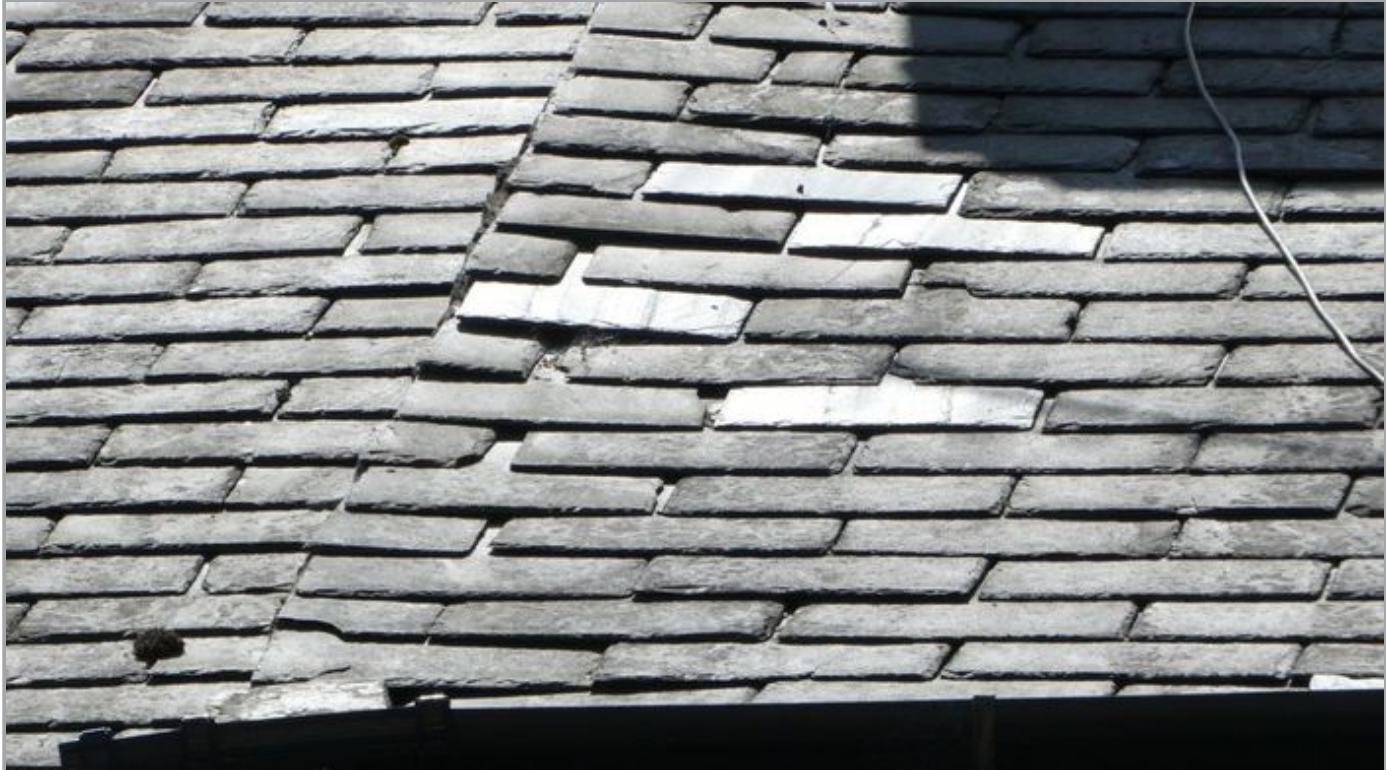
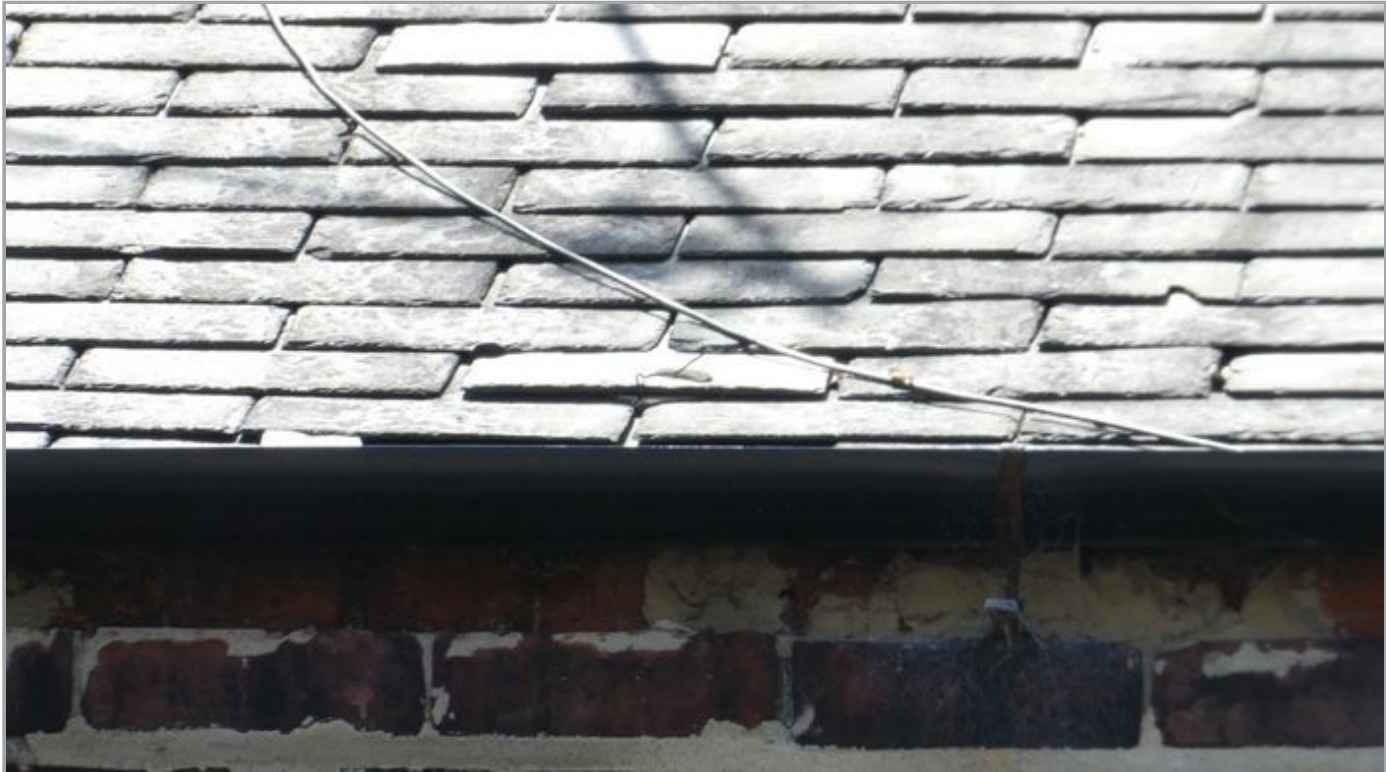
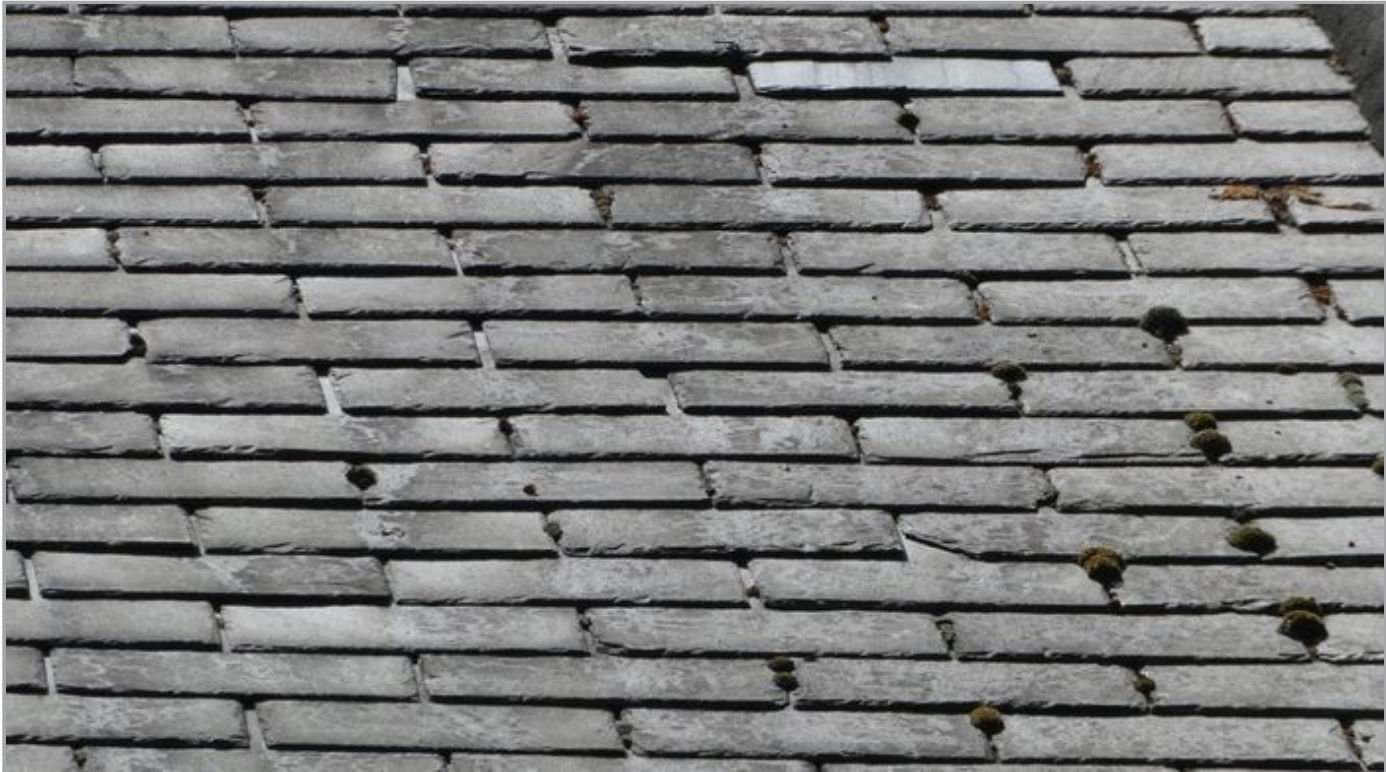
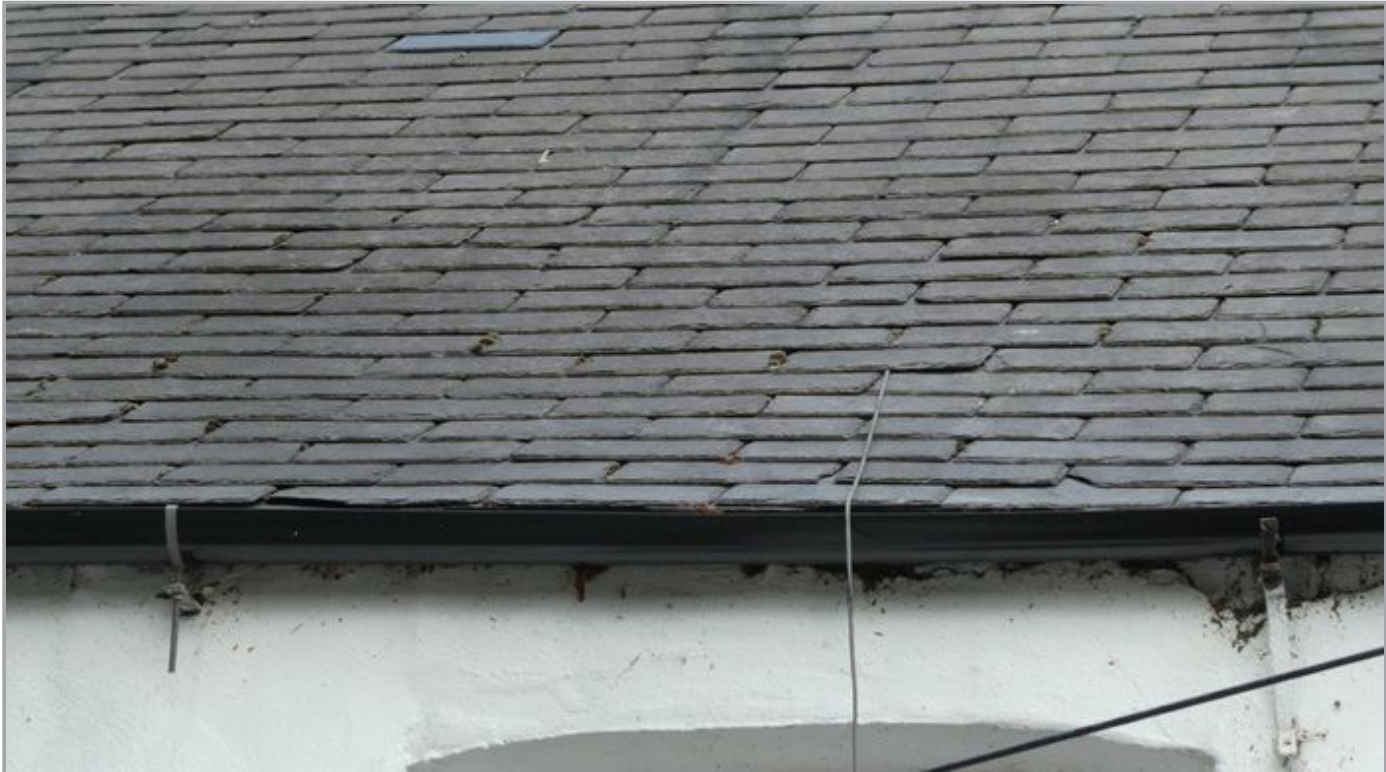
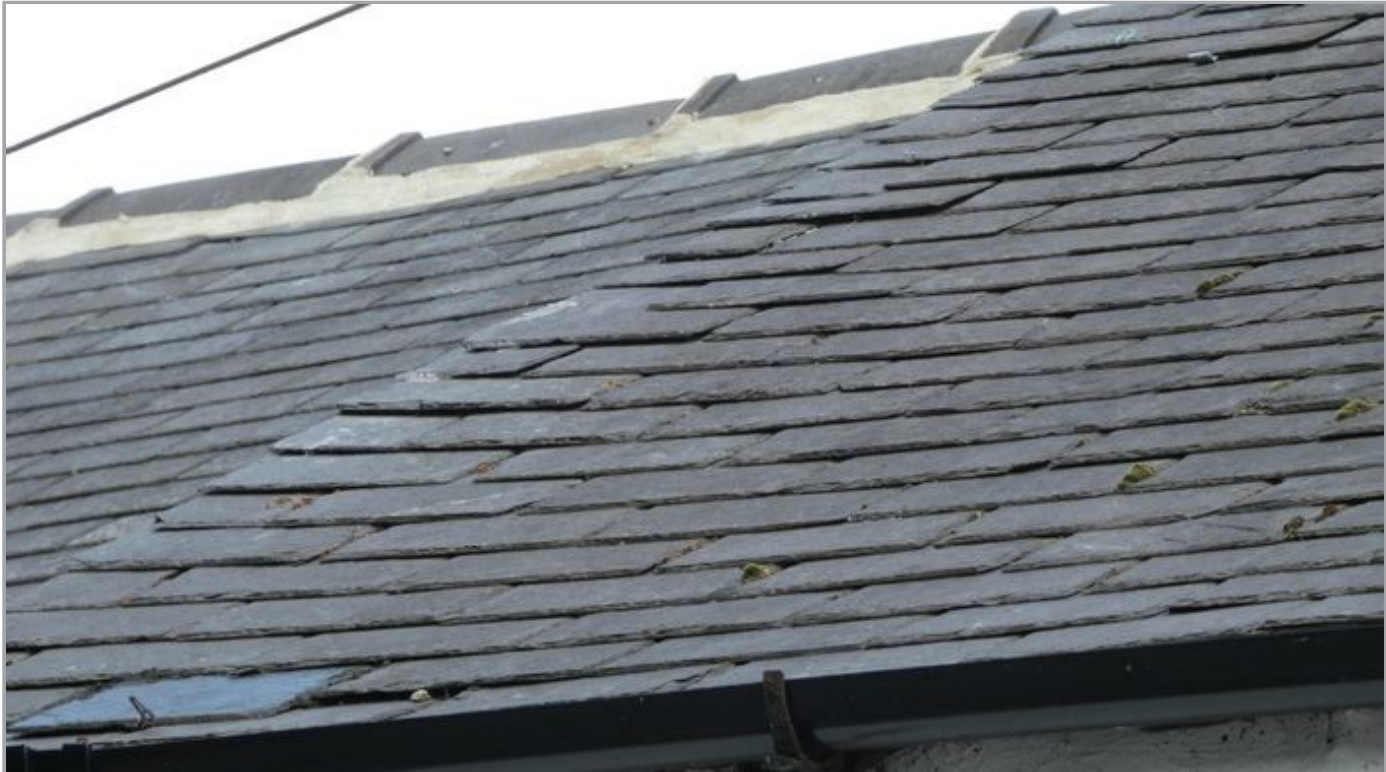
There are numerous lifted, loose, and damaged coverings to the front and rear roof slopes. The affected coverings will require re-setting or replacement to provide adequate weatherproofing and prevent rainwater penetration into the roof space and problems associated with damp and timber infestation. When the remedial work is carried out, the remaining coverings should also be inspected to check their serviceability.

Lifted/Loose/Damaged Coverings

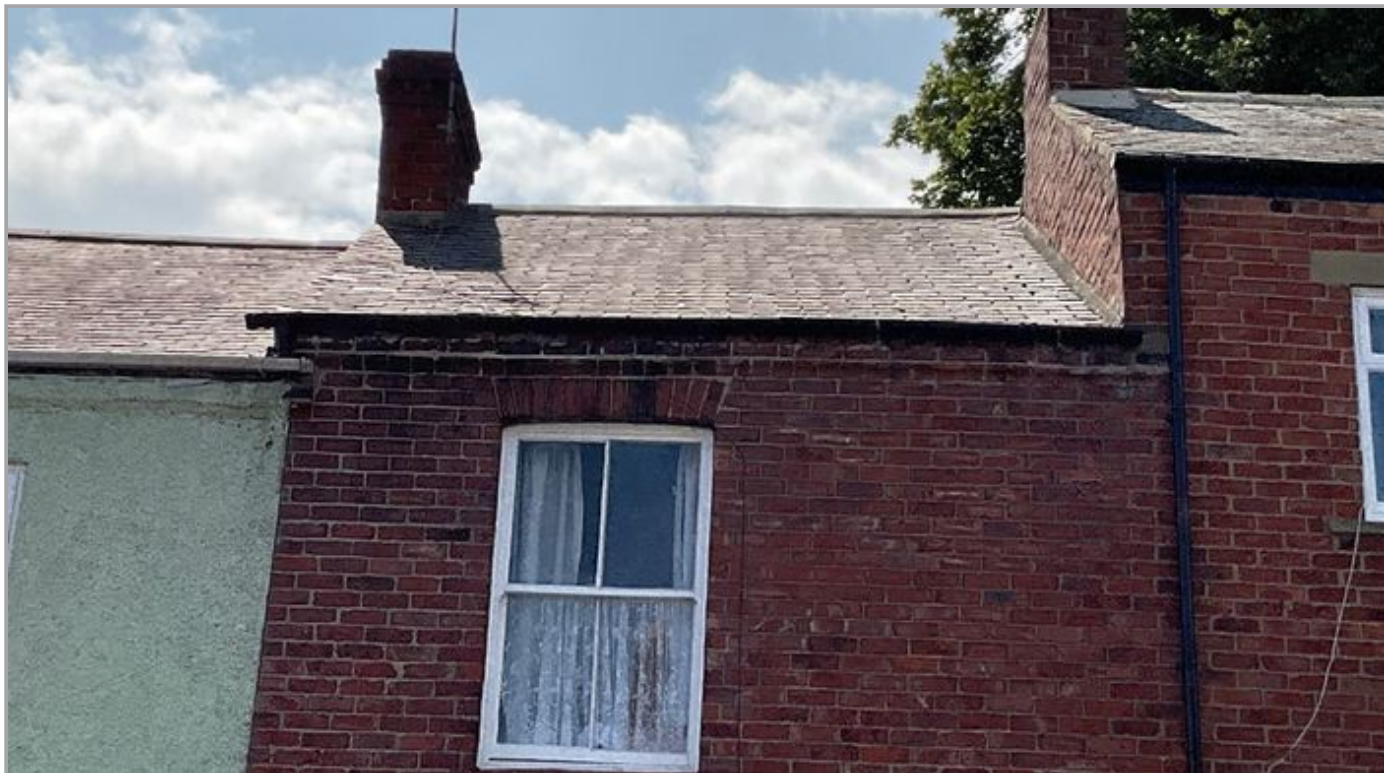
As the downpipes and gutters are shared with the neighbouring property to the front and rear, you should check with your legal adviser about your rights and obligations before carrying out any repairs/maintenance work and we refer you to our comments in Section H.

Shared Fittings

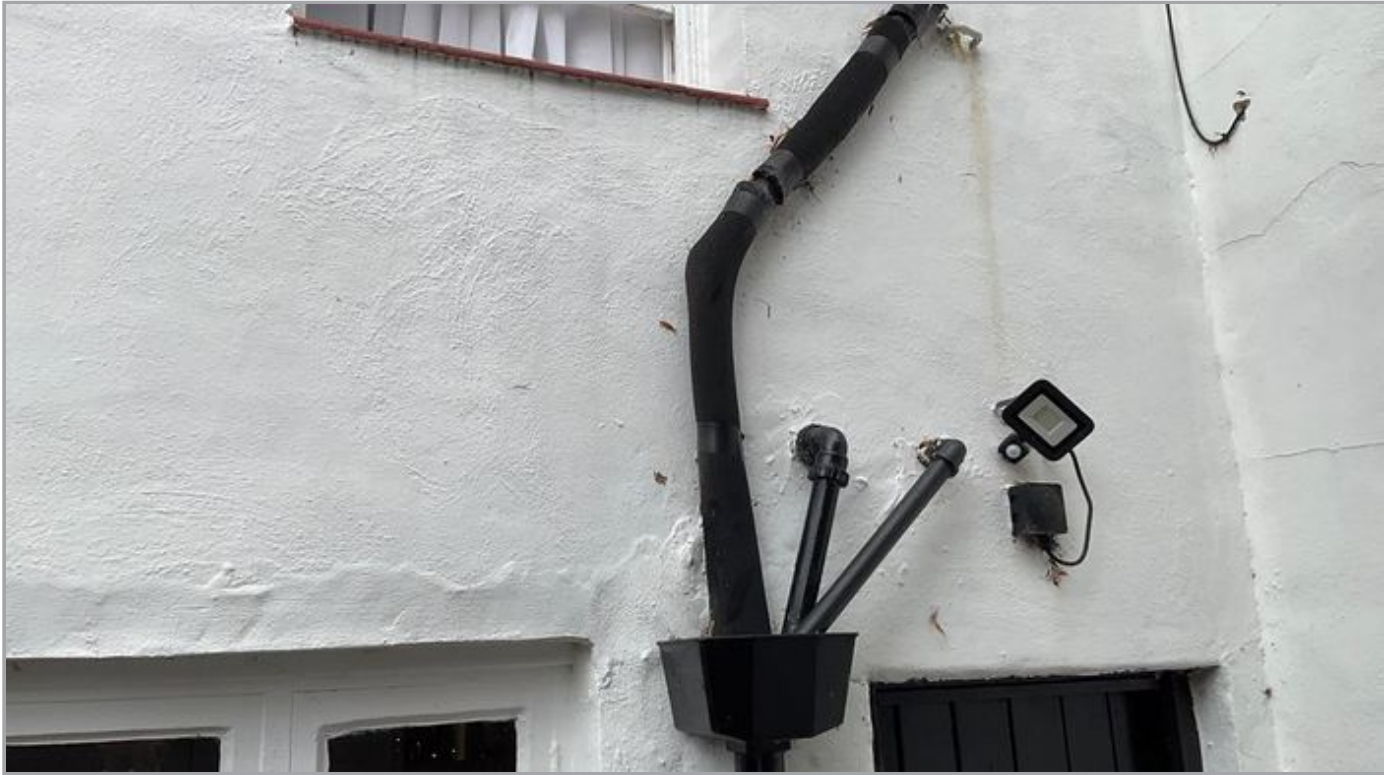
Hopper Head

Hopper heads should be regularly inspected and maintained as blockages from a build-up of debris/vegetation can cause an overflow of rainwater to saturate the external wall and this will increase the risk of penetrating damp. Any current blockages should be cleared, and a protective plastic cover installed.

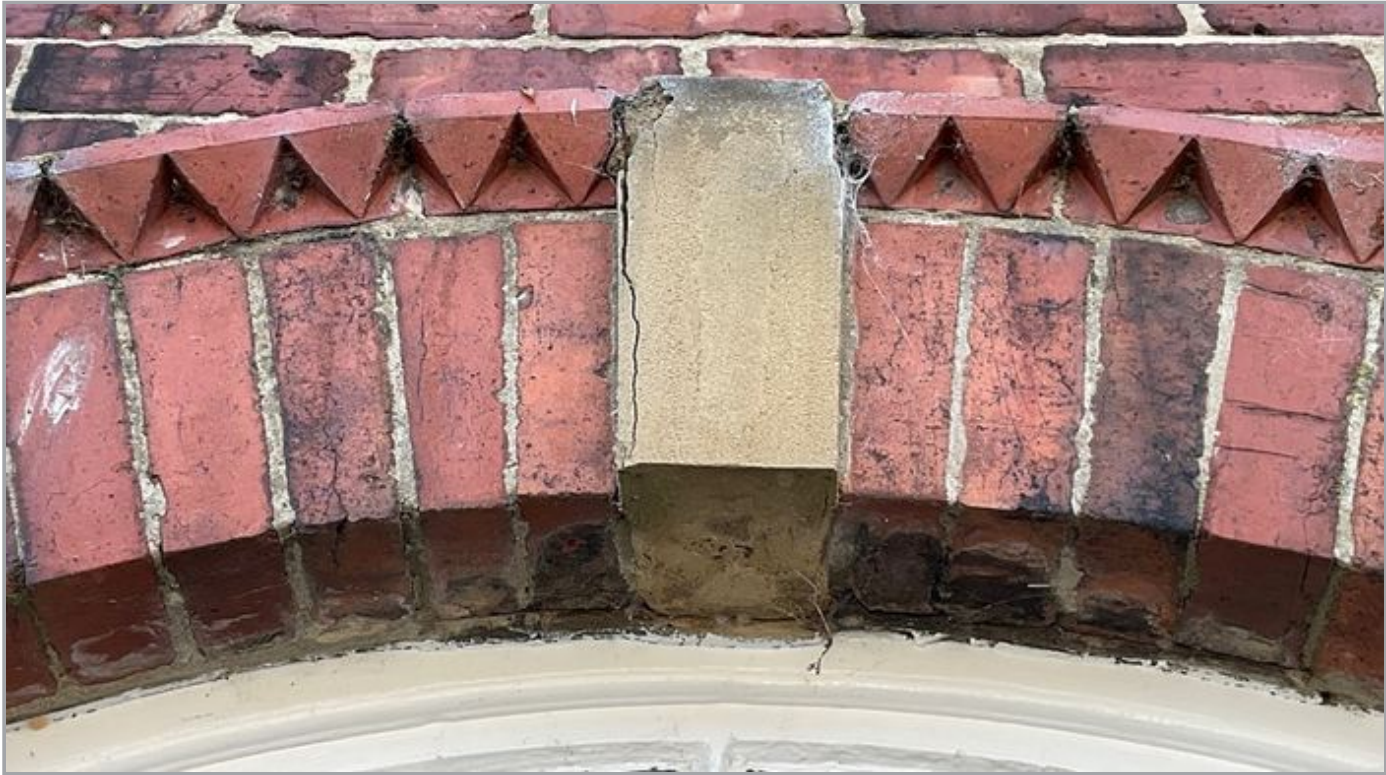
The decorative stone in the middle of the front window arch is called the keystone and this is suffering from deterioration of the outer face, as a result of frost attack (also known as spalling) and this has been exacerbated by the repeated freeze/thaw cycles from seasonal weathering. This eventually causes total disintegration of the stone, therefore it will need to be removed and replaced with a suitably graded equivalent.

Spalling Keystone
