LEVEL 2

Your survey report

Inspection date

21 July 2023

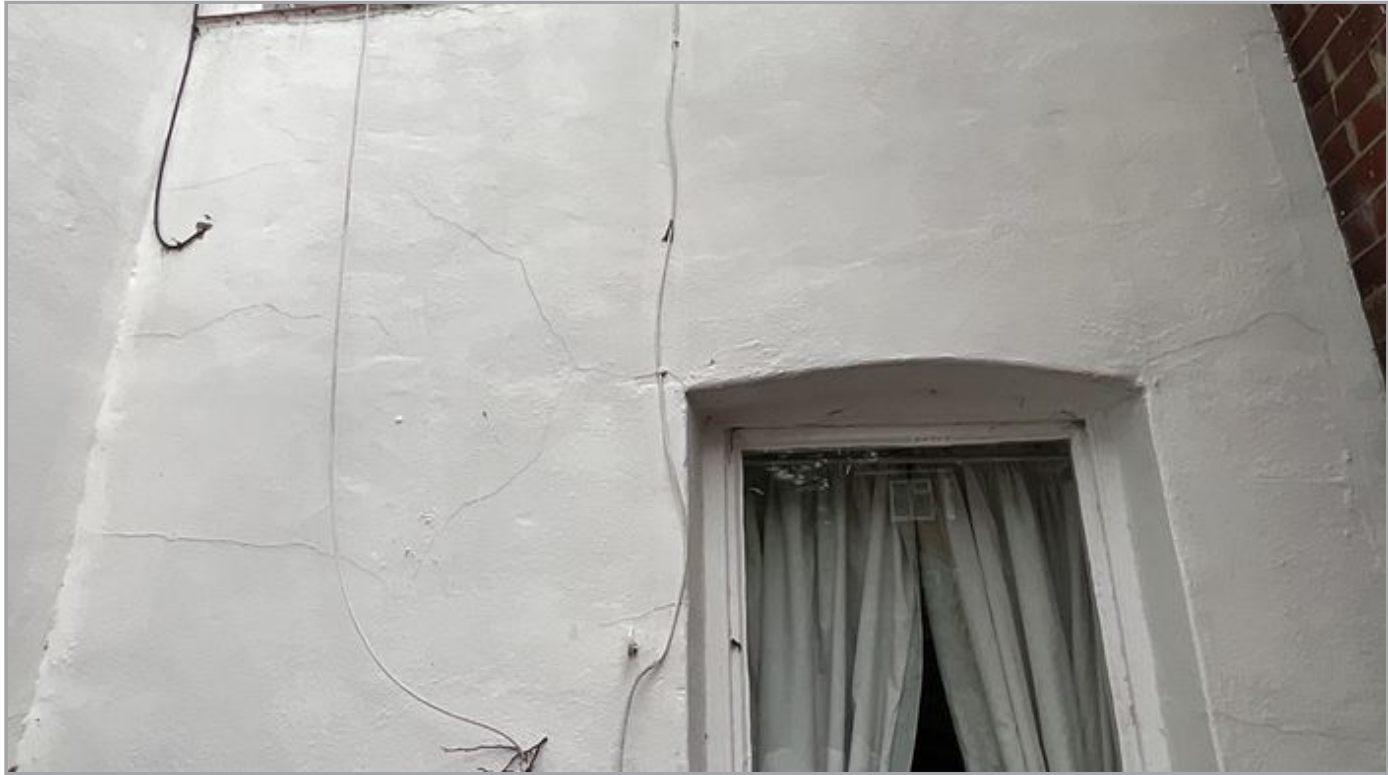
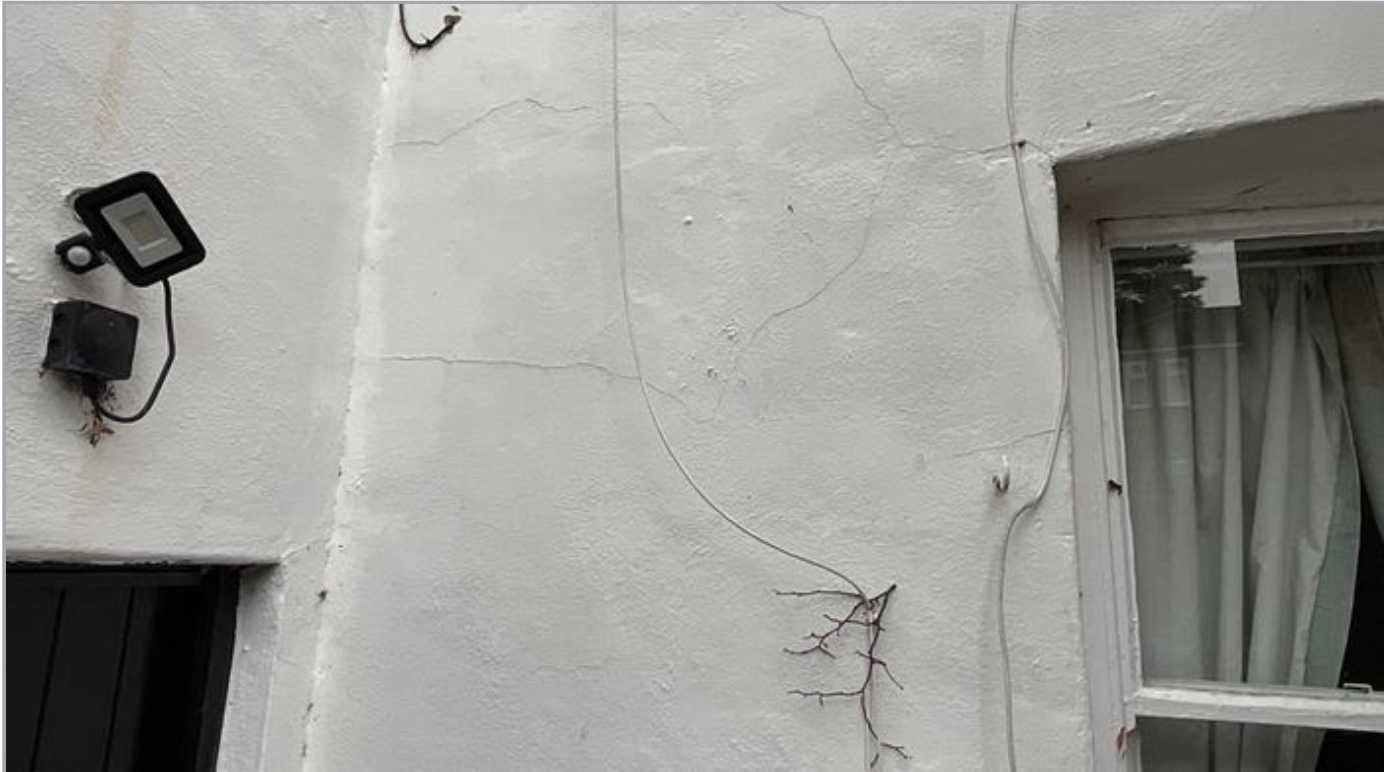
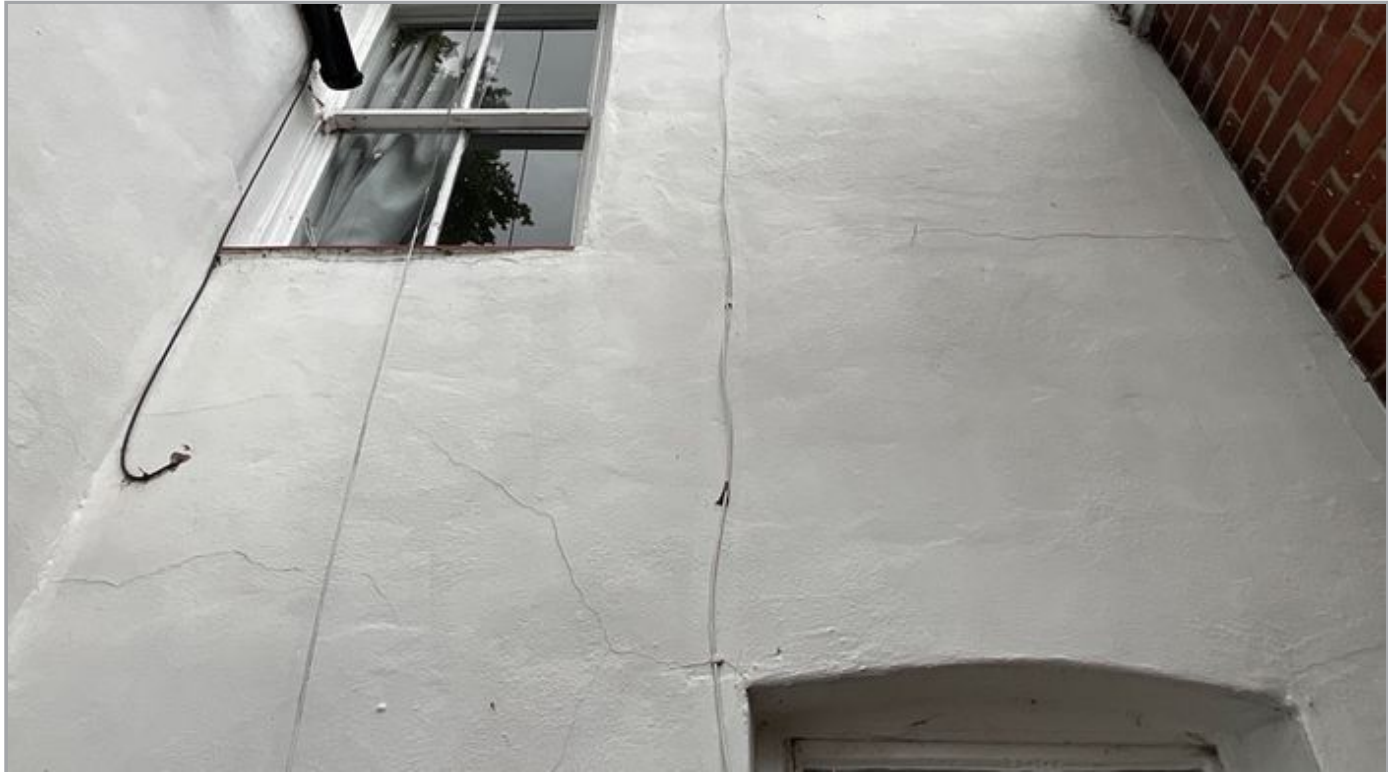
Cracking was noted to the rear rendered walls and this is indicative of shrinkage cracking (also known as crazed or map cracking). This is a common occurrence in cement based rendered properties and is often caused by either an incorrect ratio mix of sand/cement, or poor application with either no scratch coat (base coat), or the mix is too strong, resulting in the top coat and base coat moving at different rates to each other due to the effects of thermal/moisture movement from seasonal weathering. Applying the render in the wrong weathering conditions compromises the strength and can also cause cracking.

Horizontal and more straight type cracking was also noted to the rendered coating to the rear elevation walls. This has been caused by thermal movement, as the render and background brick wall expand and contract through temperature variations from the effects of seasonal weathering. This type of cracking is usually of a similar width and follows the path of least resistance, often between or in the vicinity of window/door openings. It is also common on continuous walls with no expansion joints incorporated within the construction.

Render Cracking

Assuming this is a cement-based render, it should ideally be removed as it is non-breathable, will trap moisture behind it, and also deteriorate the brickwork beneath. Should you want to have the walls rendered, using a lime-based coating will allow for greater expansion when dealing with movement/cracking and it is highly breathable compared with cement-based render, therefore it will help control moisture building up and potentially migrating into the property.

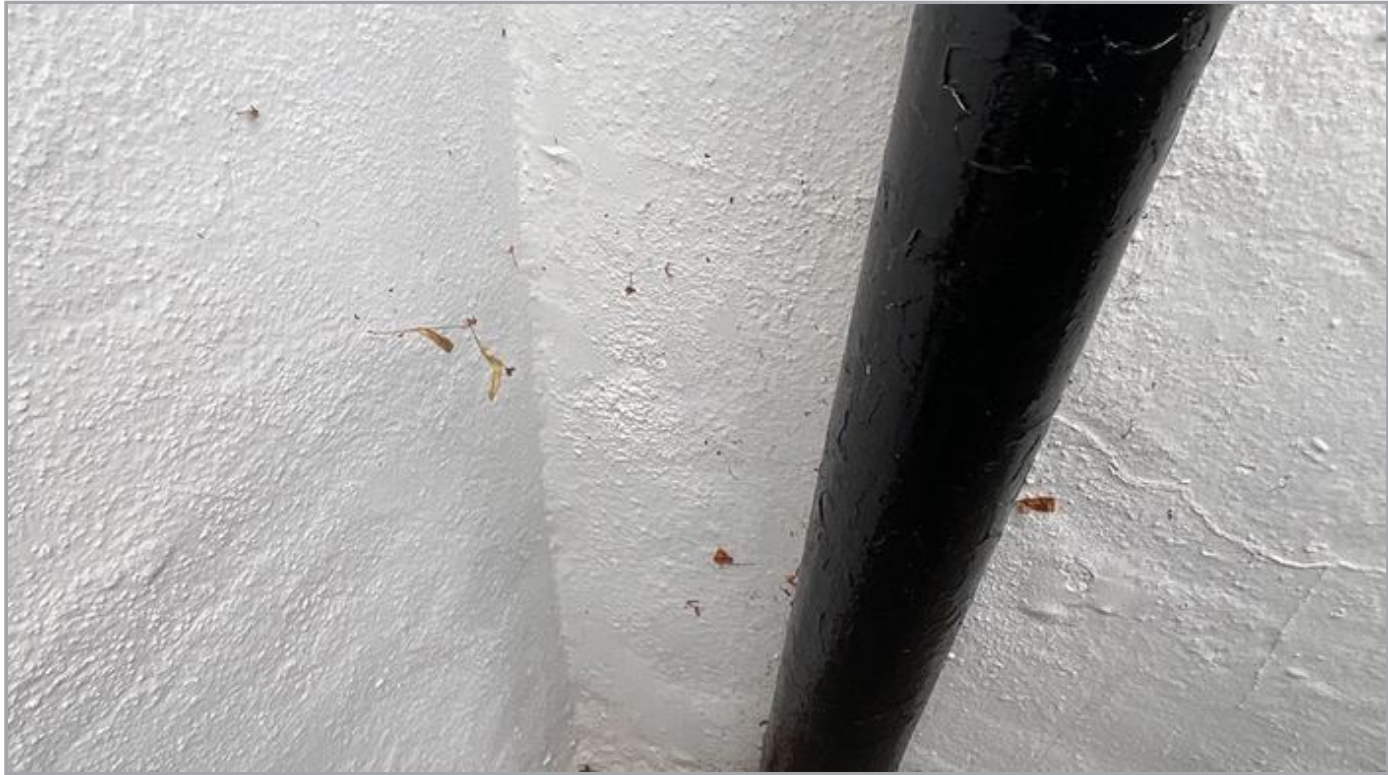
The rear of the property has been painted with what appears to be numerous coats of non-breathable paint. Once the paintwork cracks, moisture entering the openings will become trapped as it can't evaporate naturally, and this will increase the risk of penetrating damp, although this is dependent on the condition of the brickwork and mortar pointing beneath. The paintwork should be removed carefully, and any damaged areas beneath repaired accordingly. 3

There is efflorescence (white powdery salt deposit) growing on the rear elevations. Efflorescence is caused by salts contained within the brickwork, brought to the surface by the natural evaporation of moisture. This is not unduly serious, and the white deposits can be removed by dry brushing. The staining may continue until all the salts have been removed by evaporation.

This has been exacerbated due to the non-breathable paint, which is not allowing the brickwork or mortar pointing to breathe, retaining moisture, and preventing evaporation. The paintwork should be removed carefully, and any damaged areas beneath repaired accordingly.

Efflorescence/Paintwork

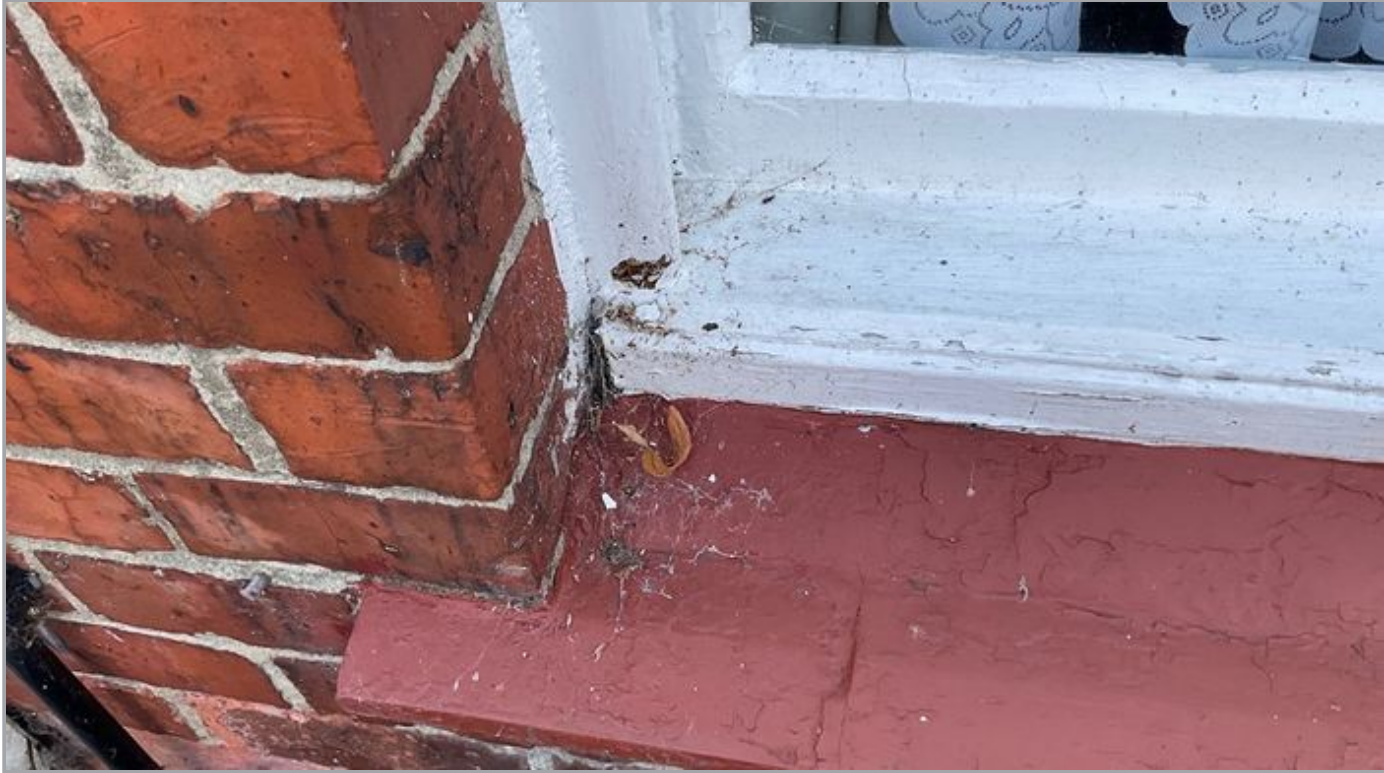
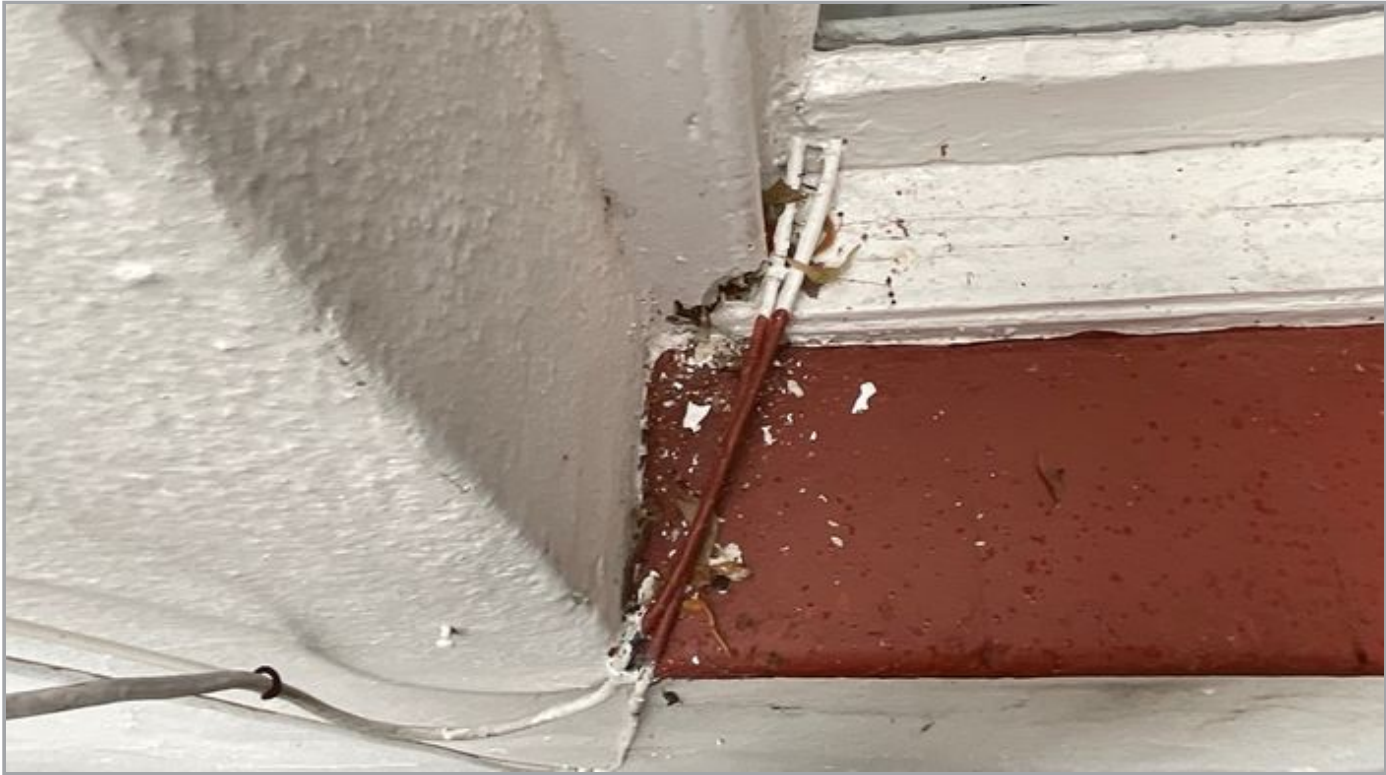
The timber frame windows are weathered/rotten and redecoration/replacement will be required. Timber framed windows that are single glazed, are considered dated by modern standards and it would be more economical to replace them with thermally efficient modern units, ideally with the benefit of in-built trickle ventilation.

Rotten Framework

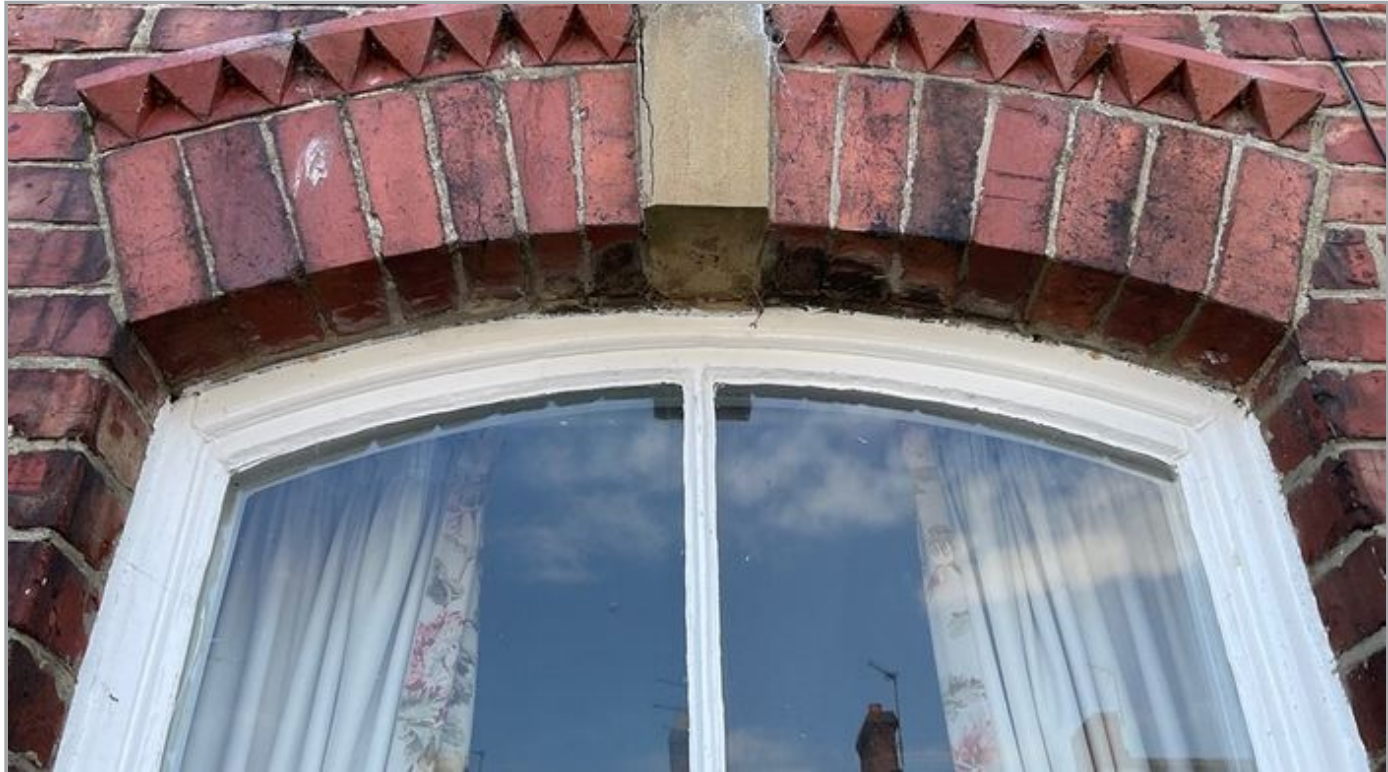
The mastic/mortar to some of the windows is loose/missing, and this should be replaced/repointed. The remaining window junctions should be regularly inspected and maintained. 3

Protective Sealant

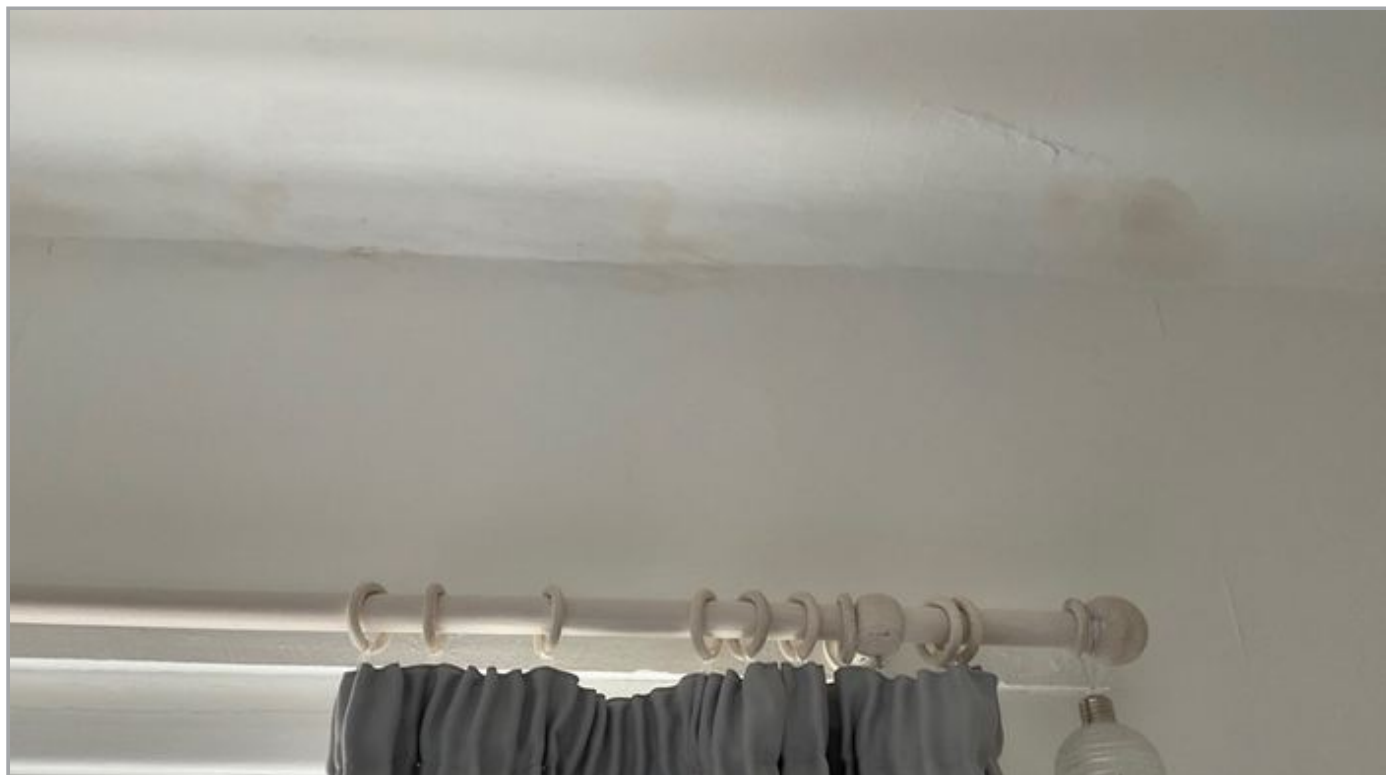
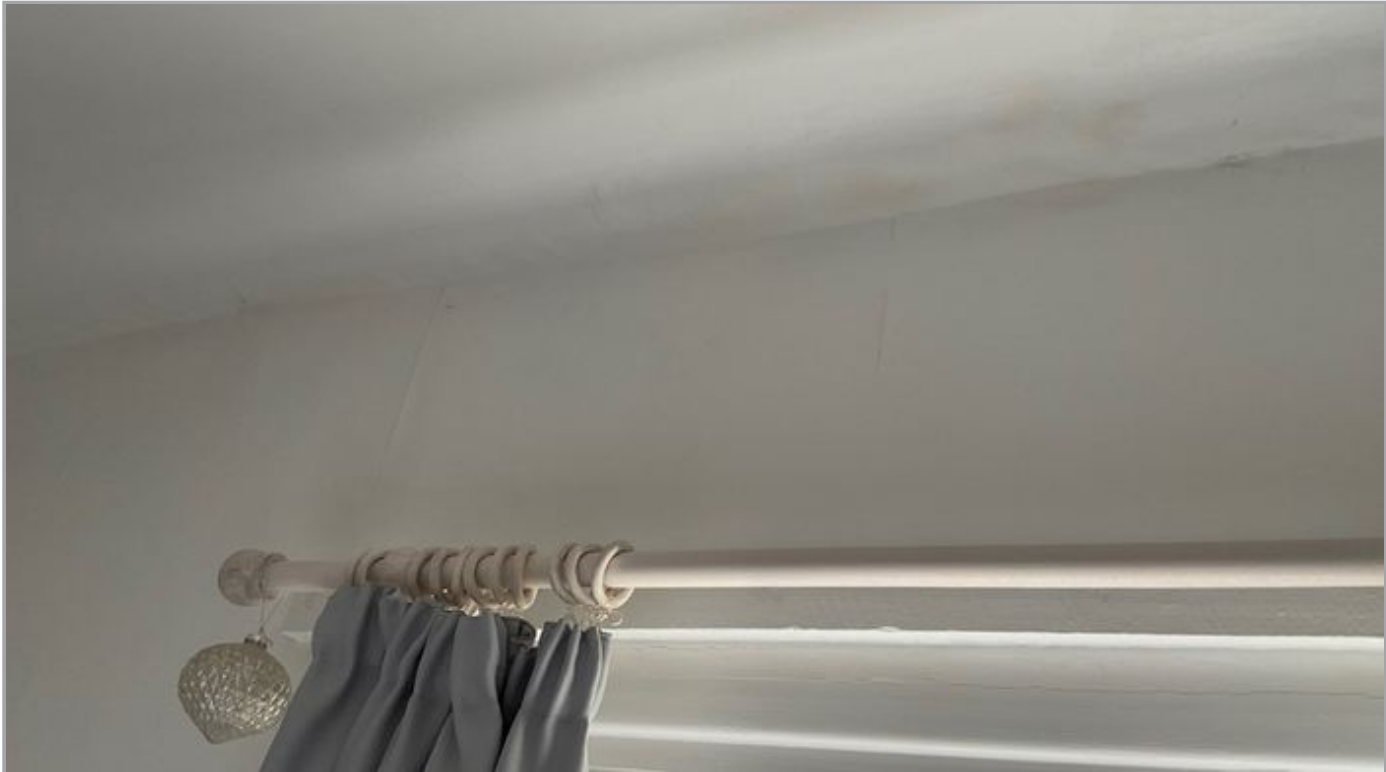
Damp/Staining

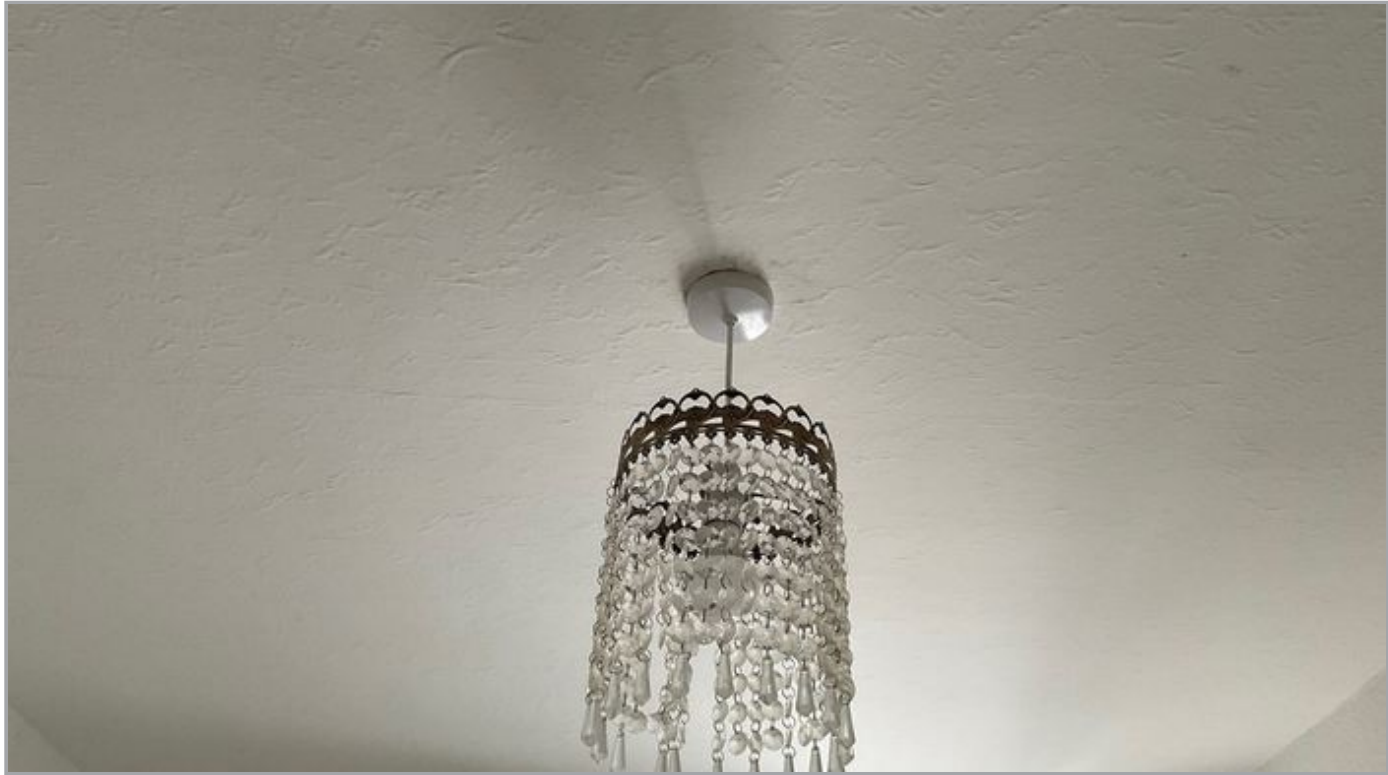
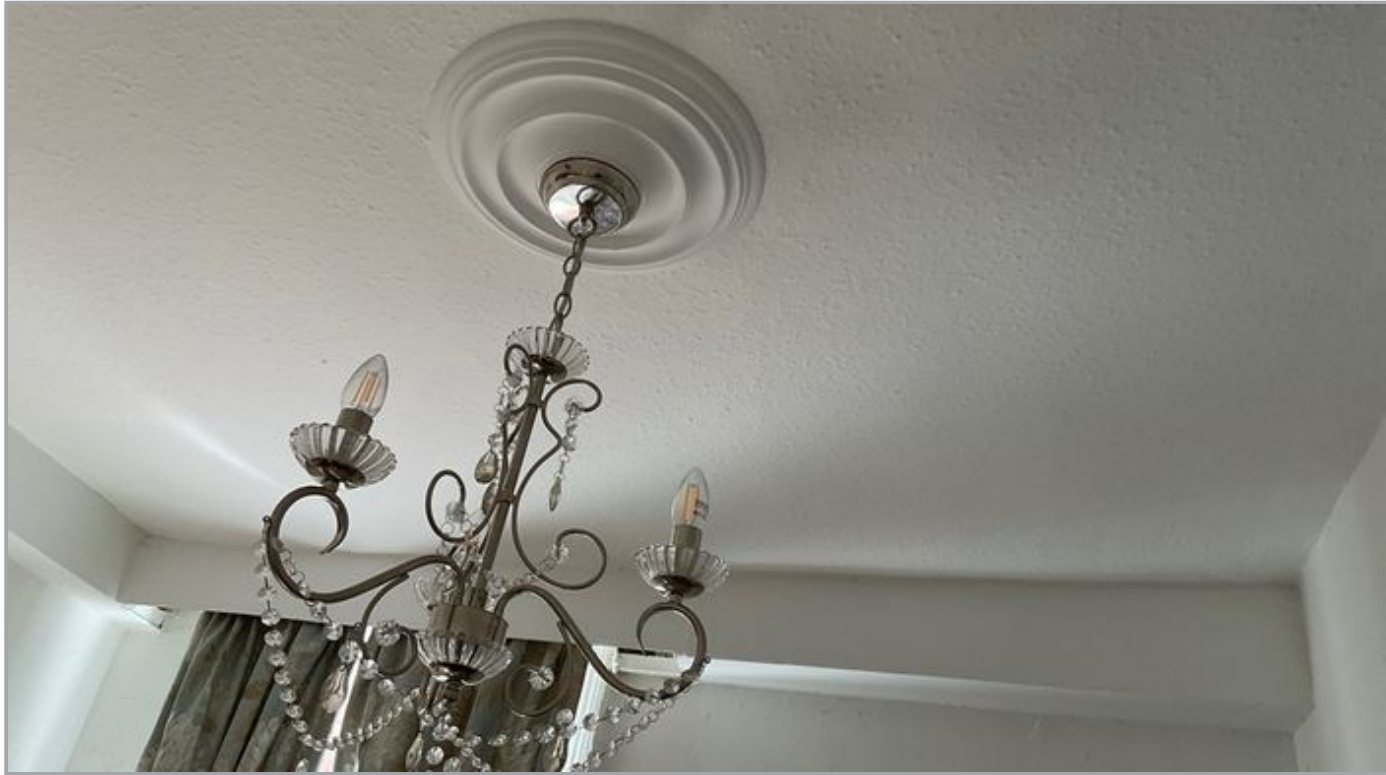
Ceiling Covered - See Limitations To Inspection

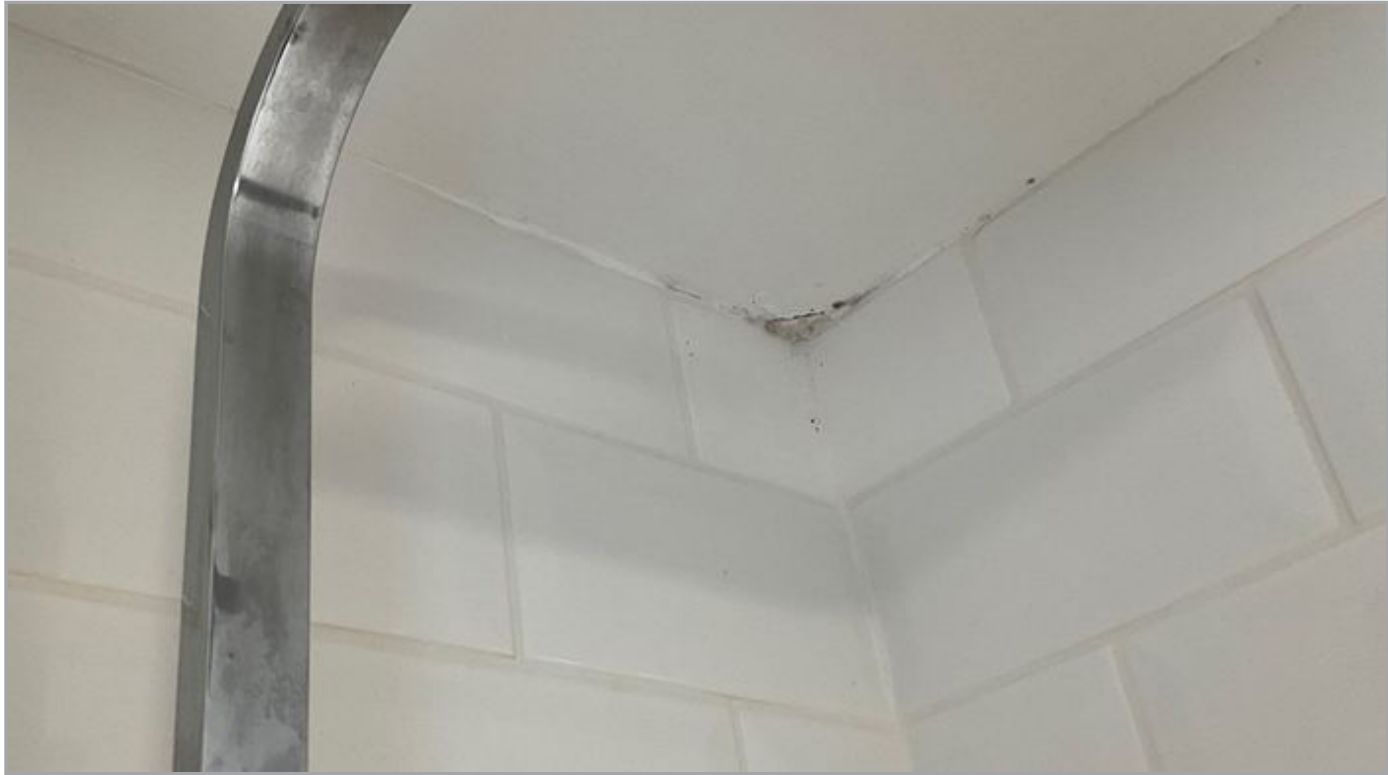
To the bathroom, visible mould was noted, and this can pose a serious health risk to people with breathing difficulties, such as with asthma. When moisture laden air comes into contact with an area that is poorly ventilated and often parts of the property that are thermally inefficient, the moisture begins to condense into droplets of water on the surface and encourages the formation of mould. Corners of rooms or junction areas are particularly susceptible, as these are considered cold spots because they are generally harder to ventilate/insulate.

In our opinion, the mould we noted during the inspection has been caused by the inadequate ventilation within the bathroom, therefore rectifying these will help prevent it and we refer you to Section D5 and E8. However, as the causes of condensation and mould are often multi-factorial, controlling it will require ongoing monitoring and we refer you to our comments in Section E9 for more detailed information on this.

Condensation/Mould

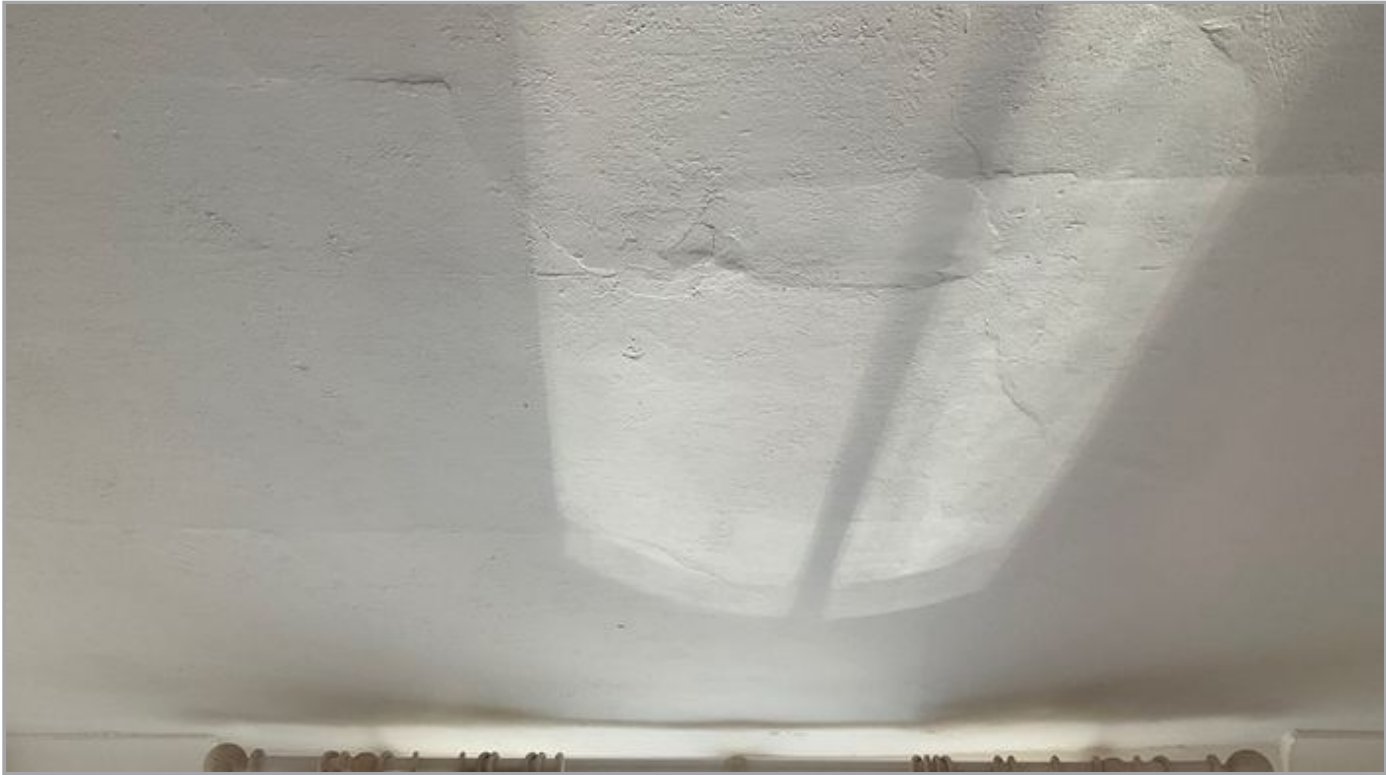
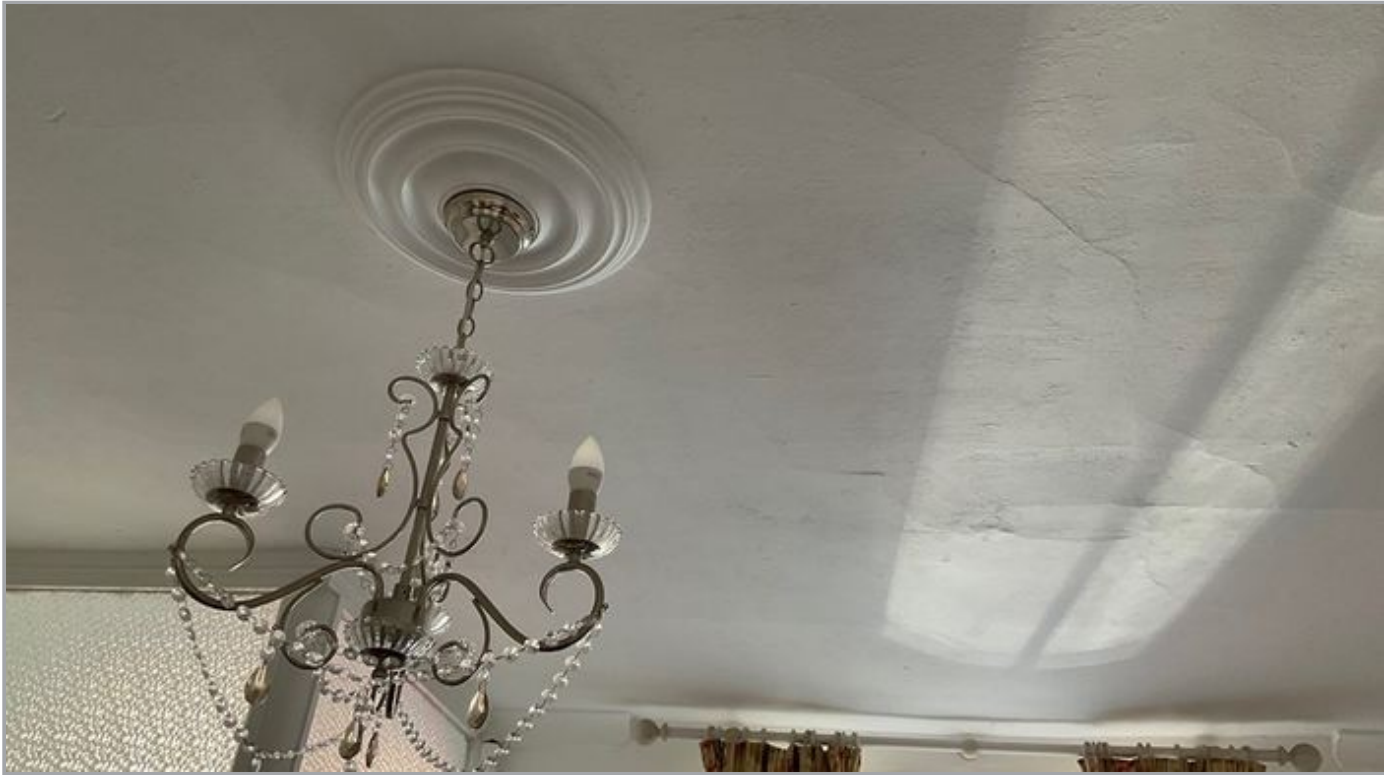
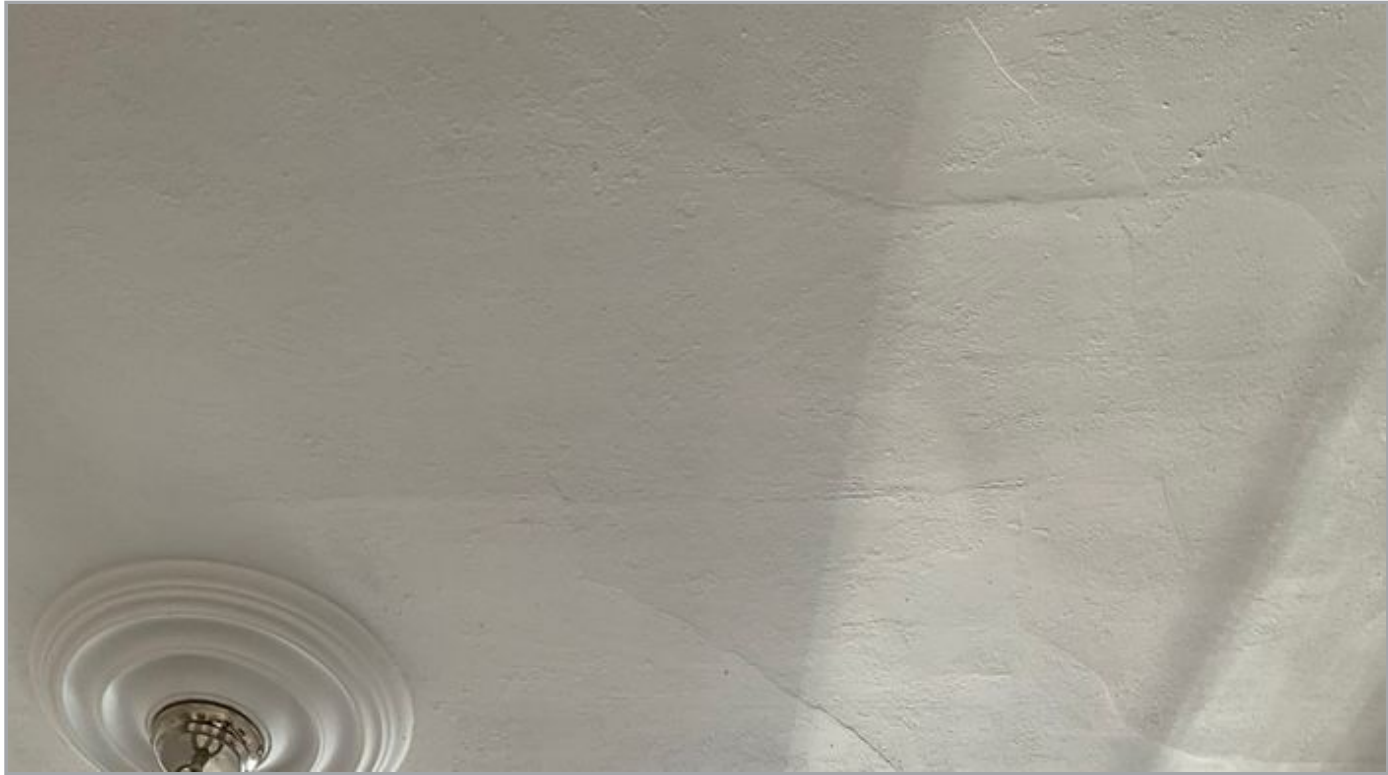
Plaster/Lath
