LEVEL 2

Your survey report

Inspection date

21 July 2023

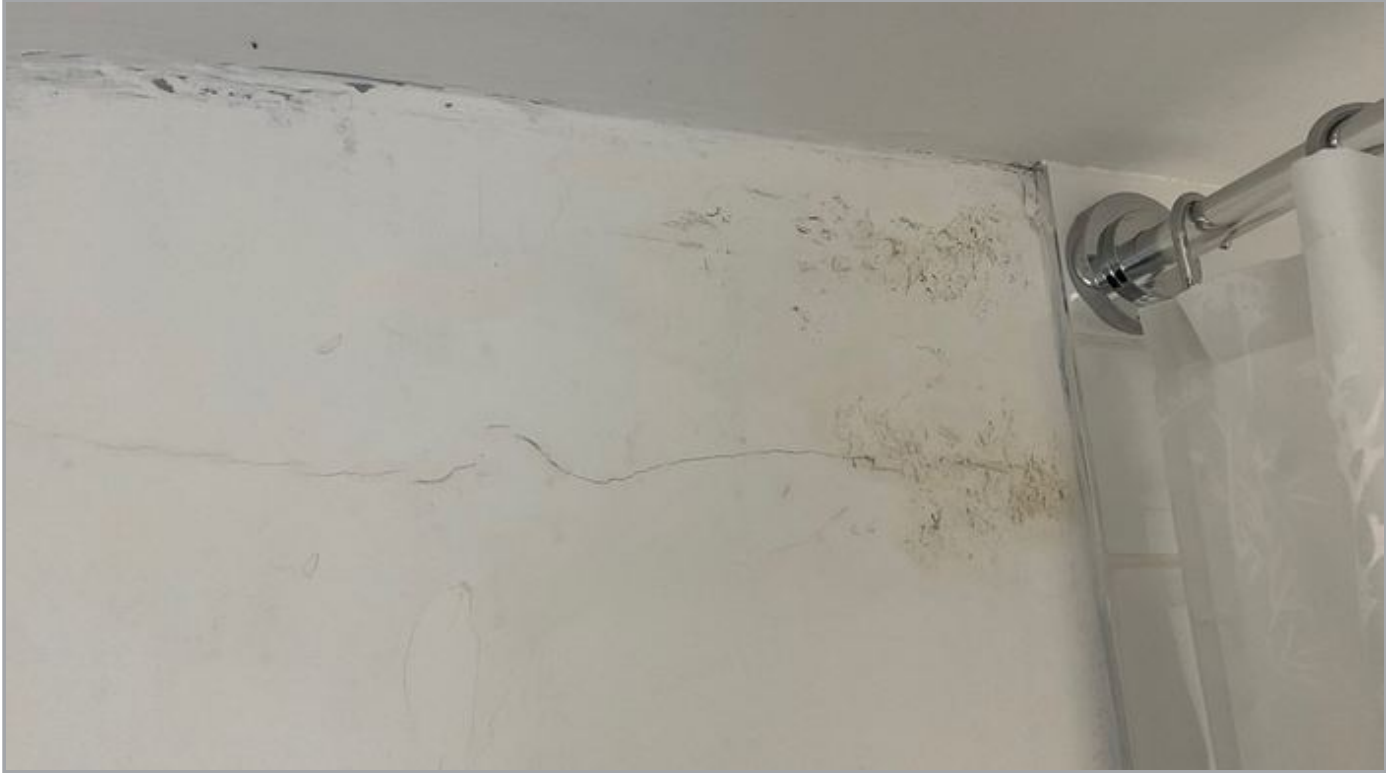
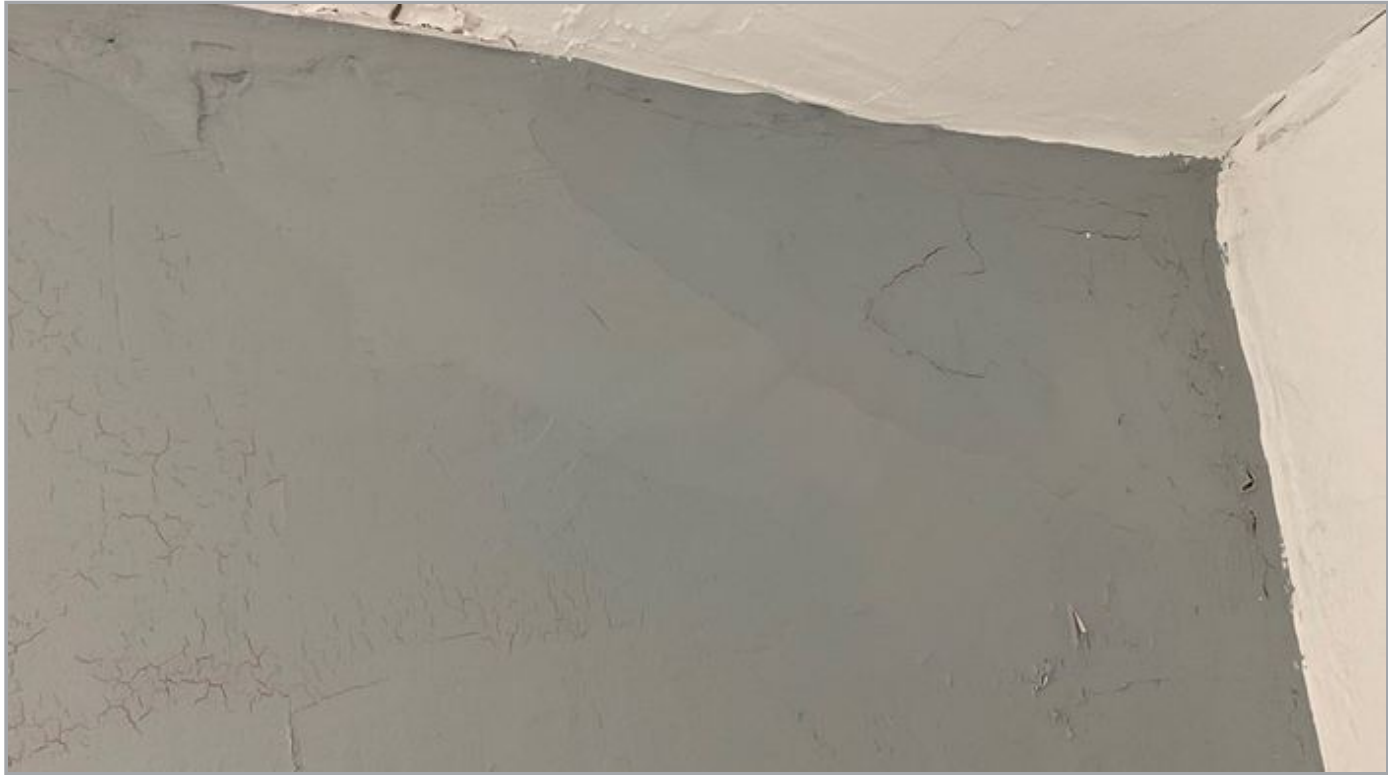
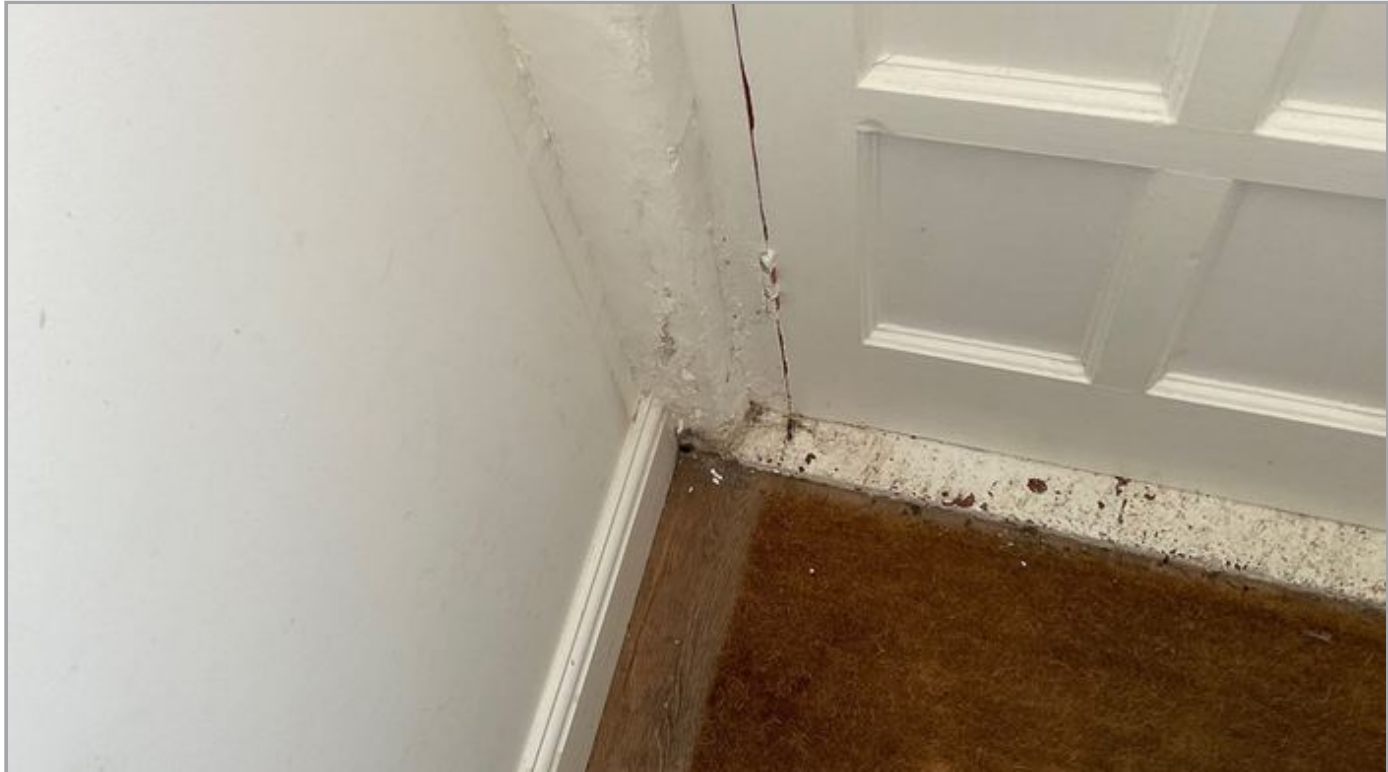
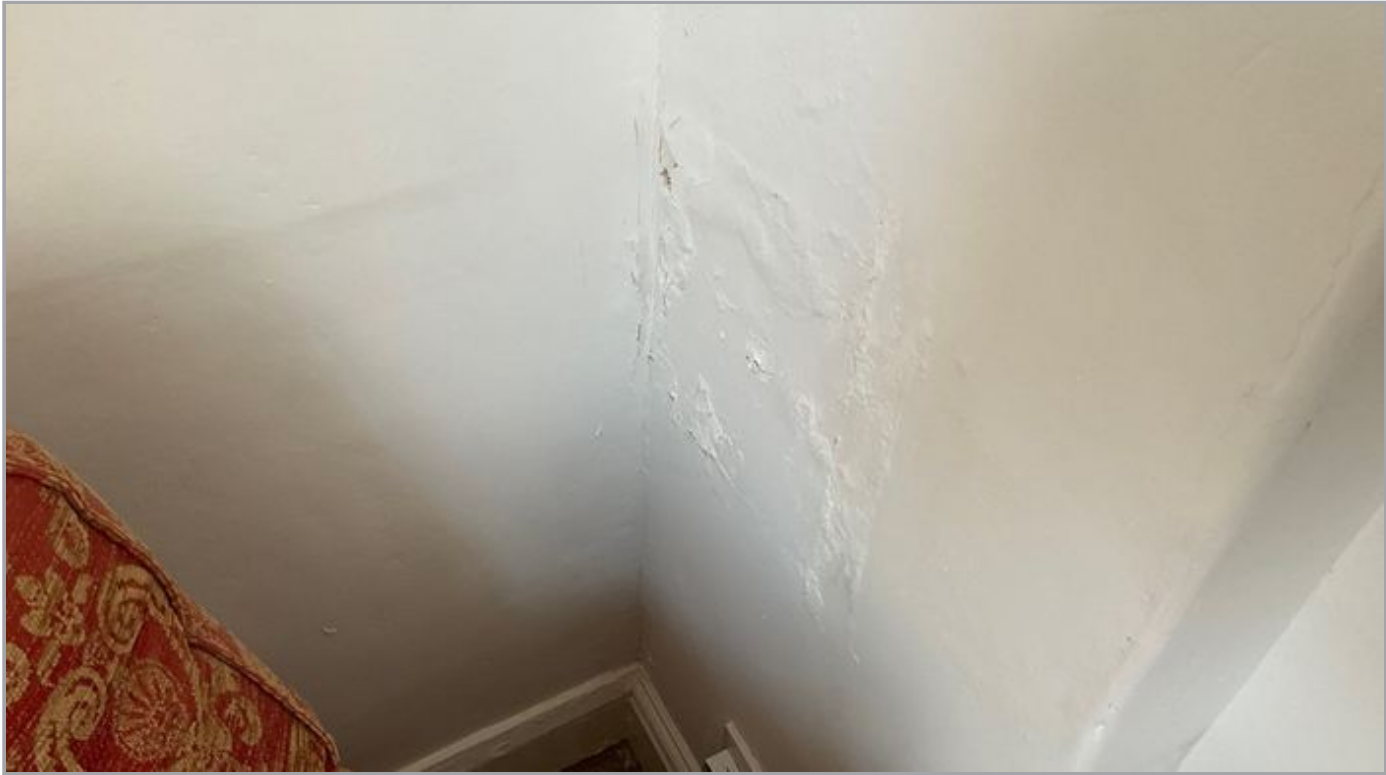
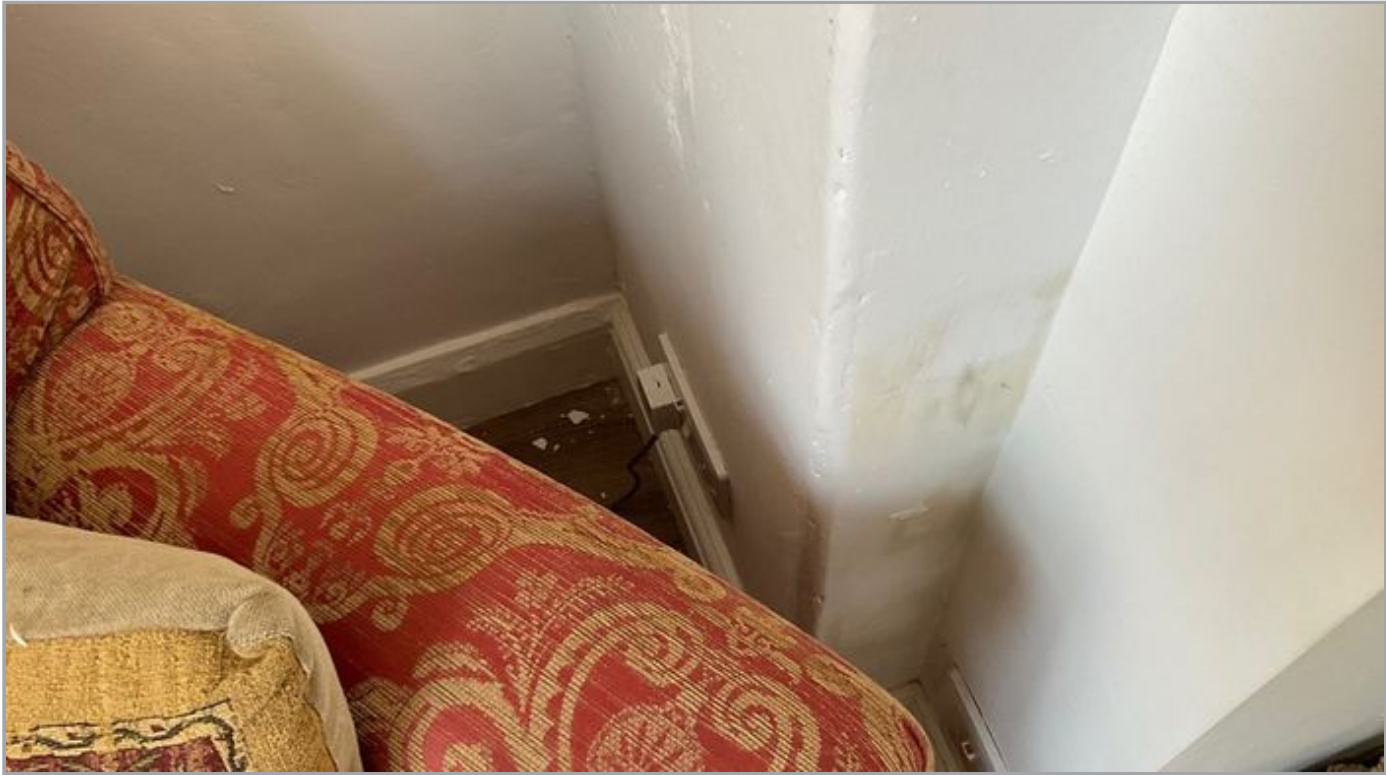
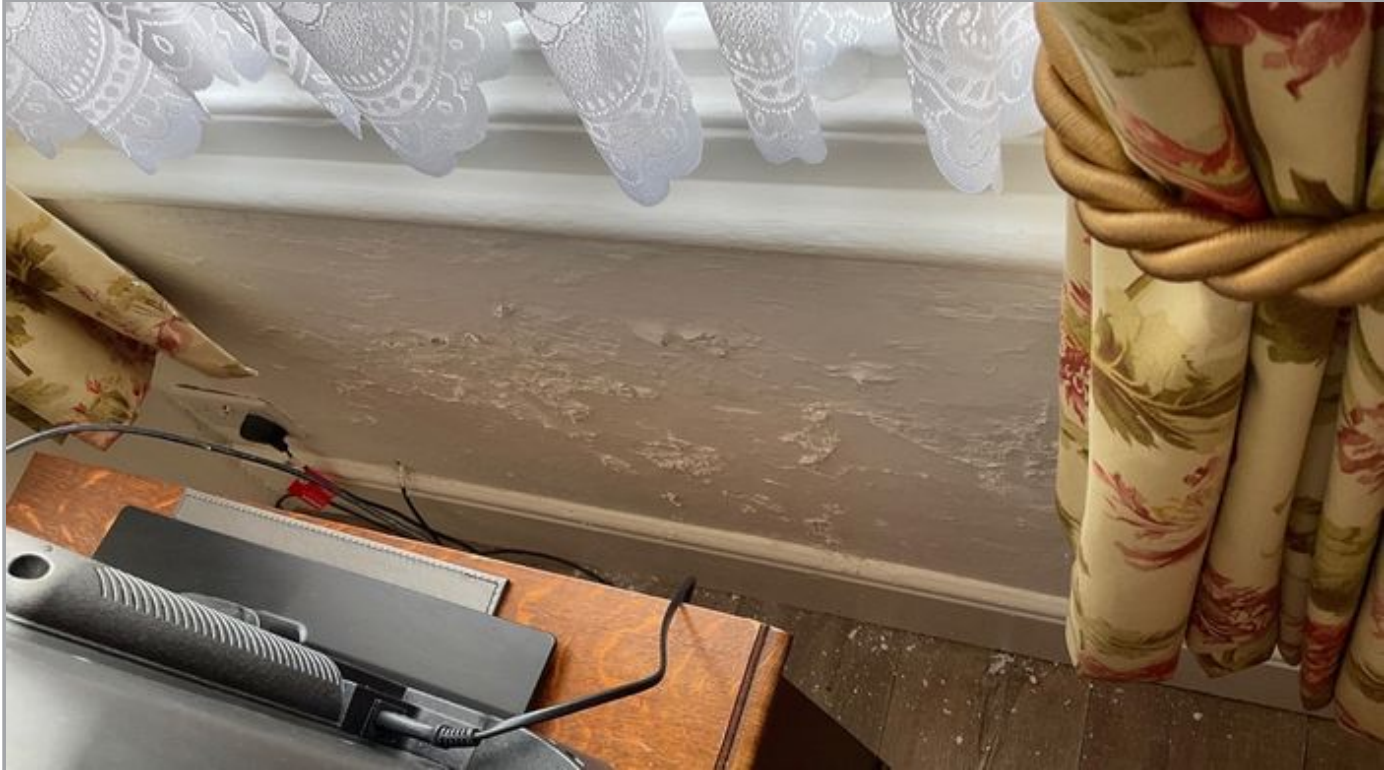
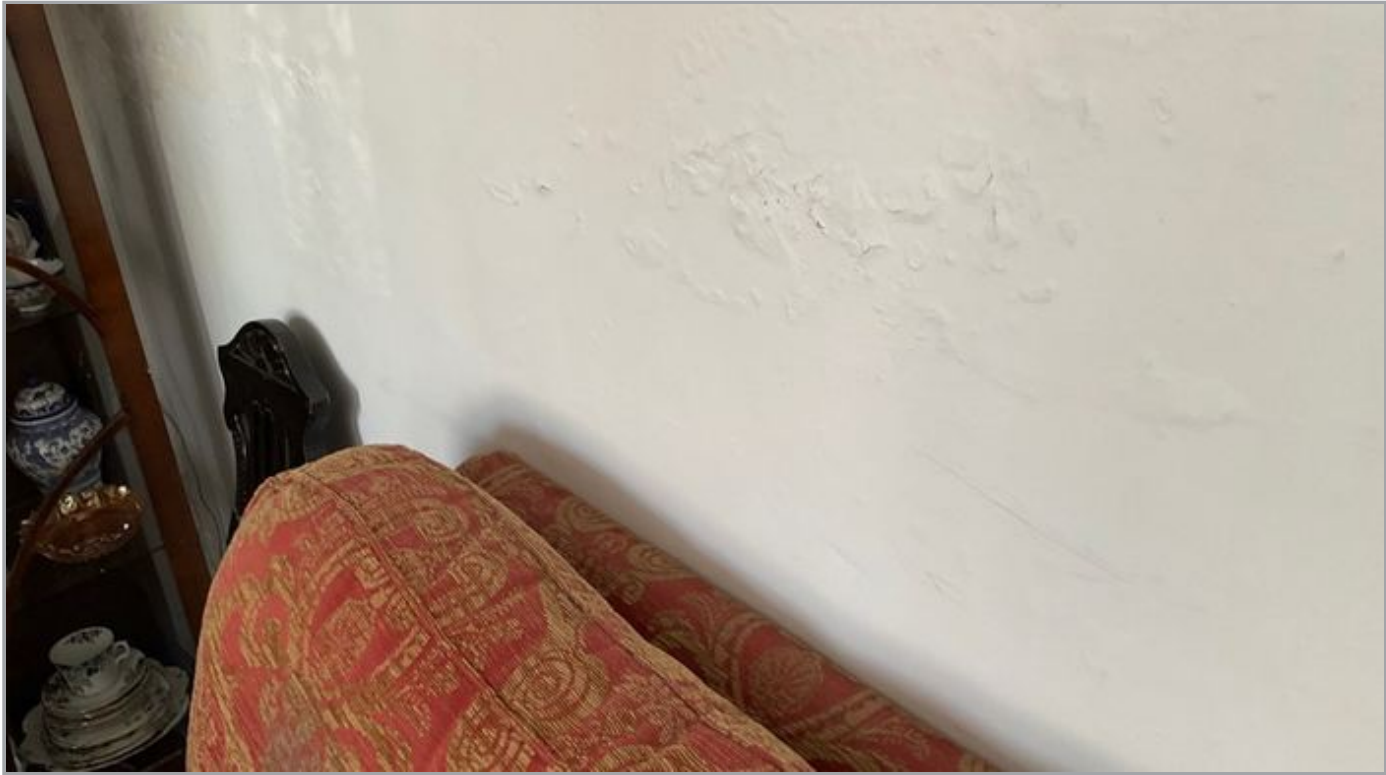
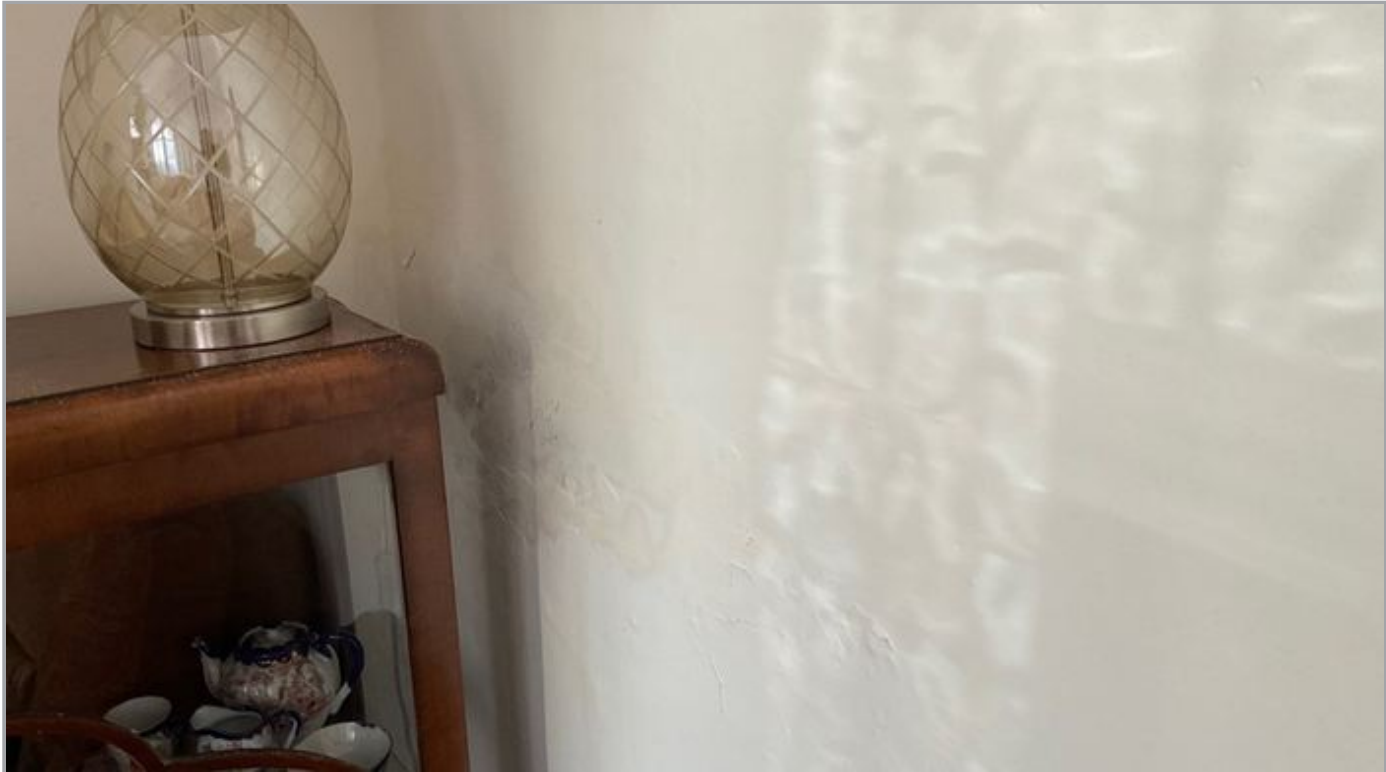
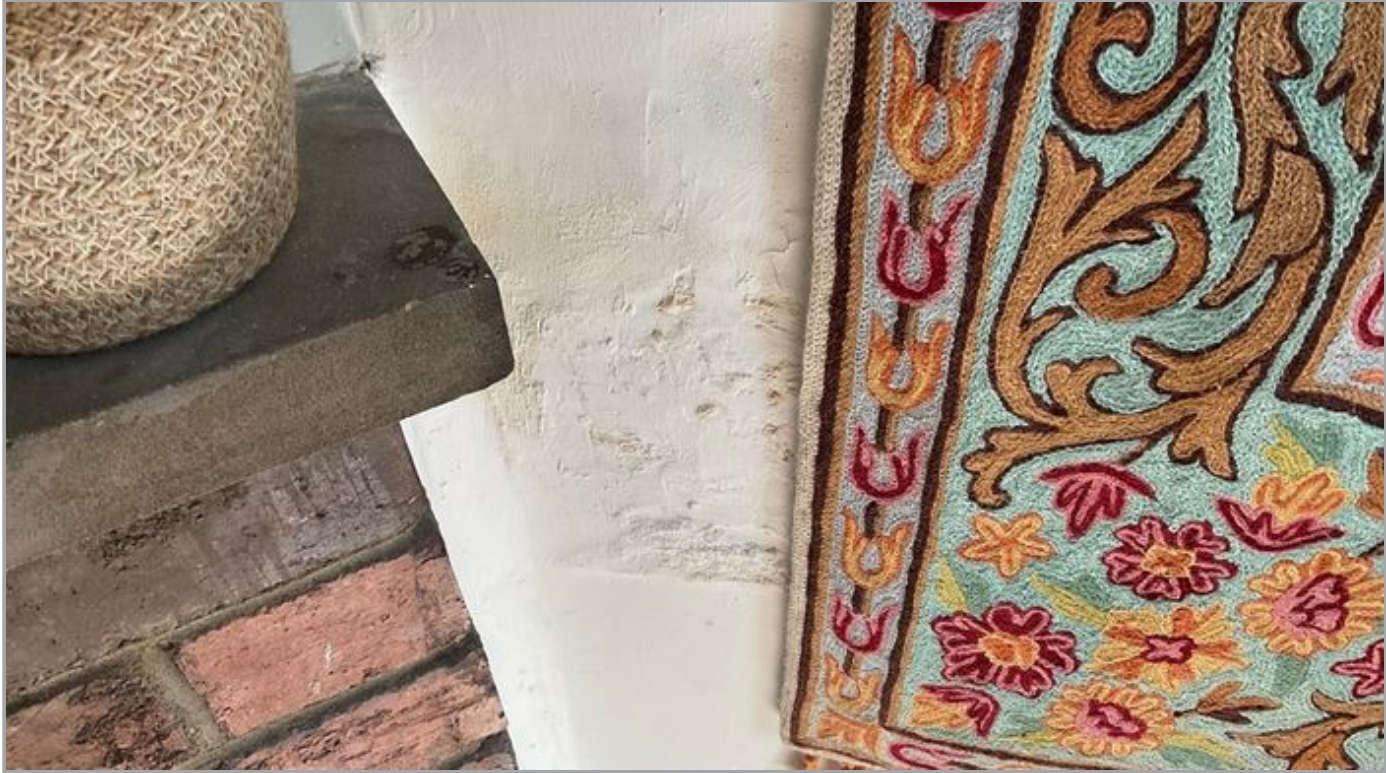
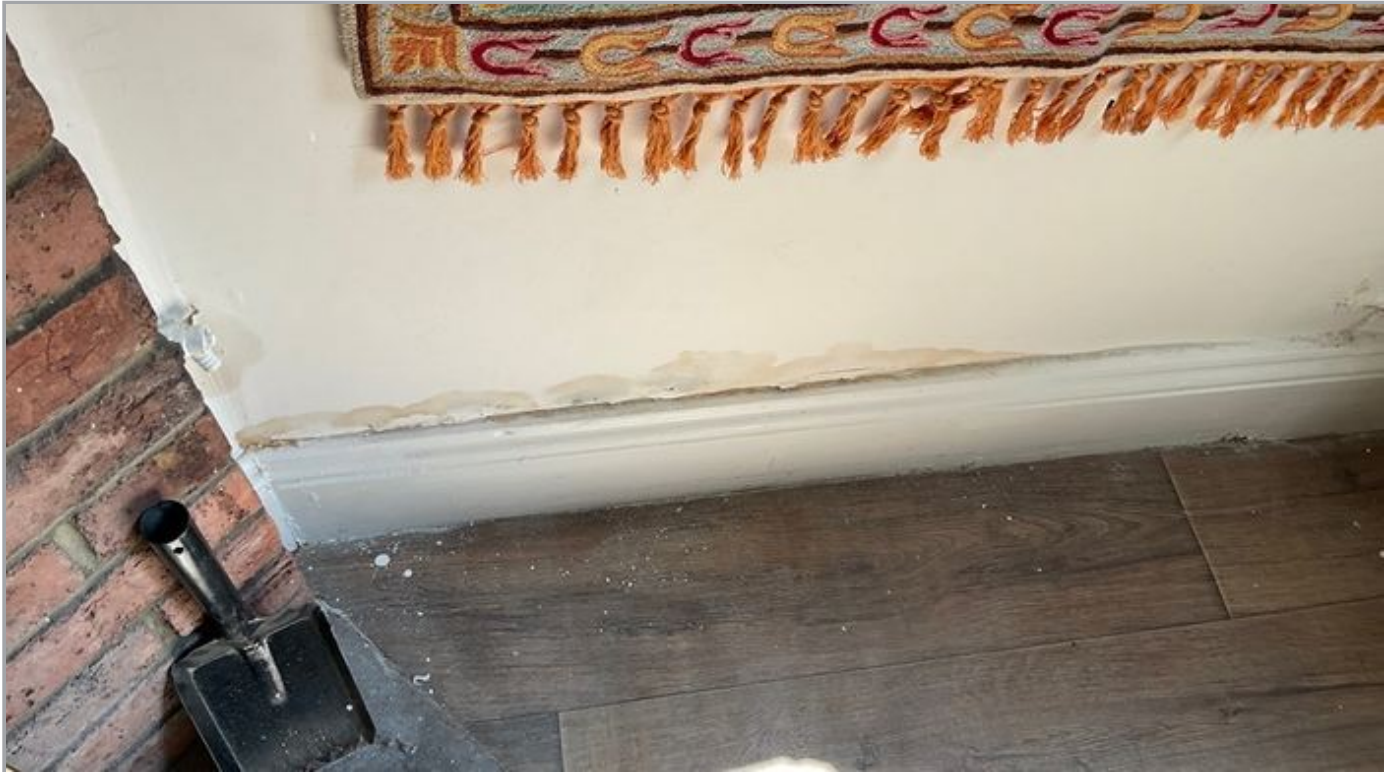
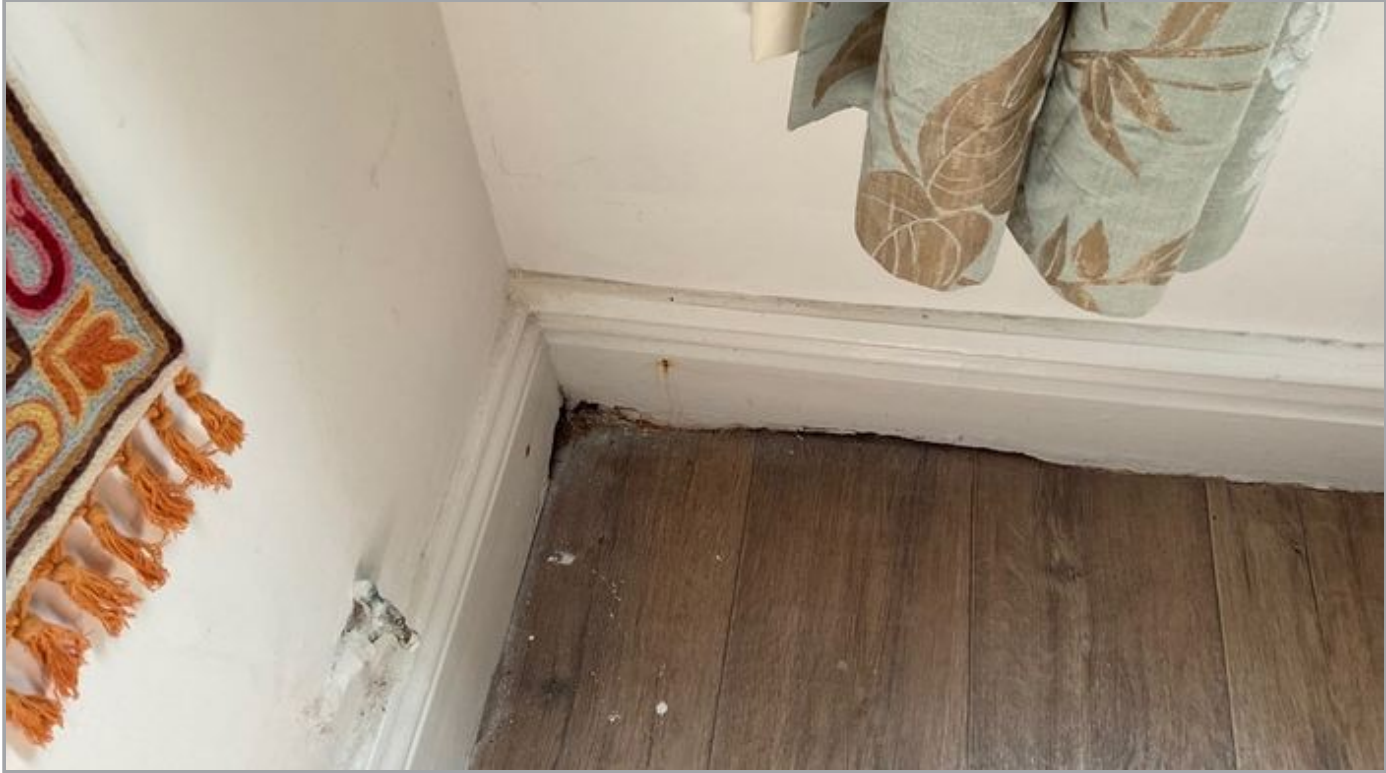
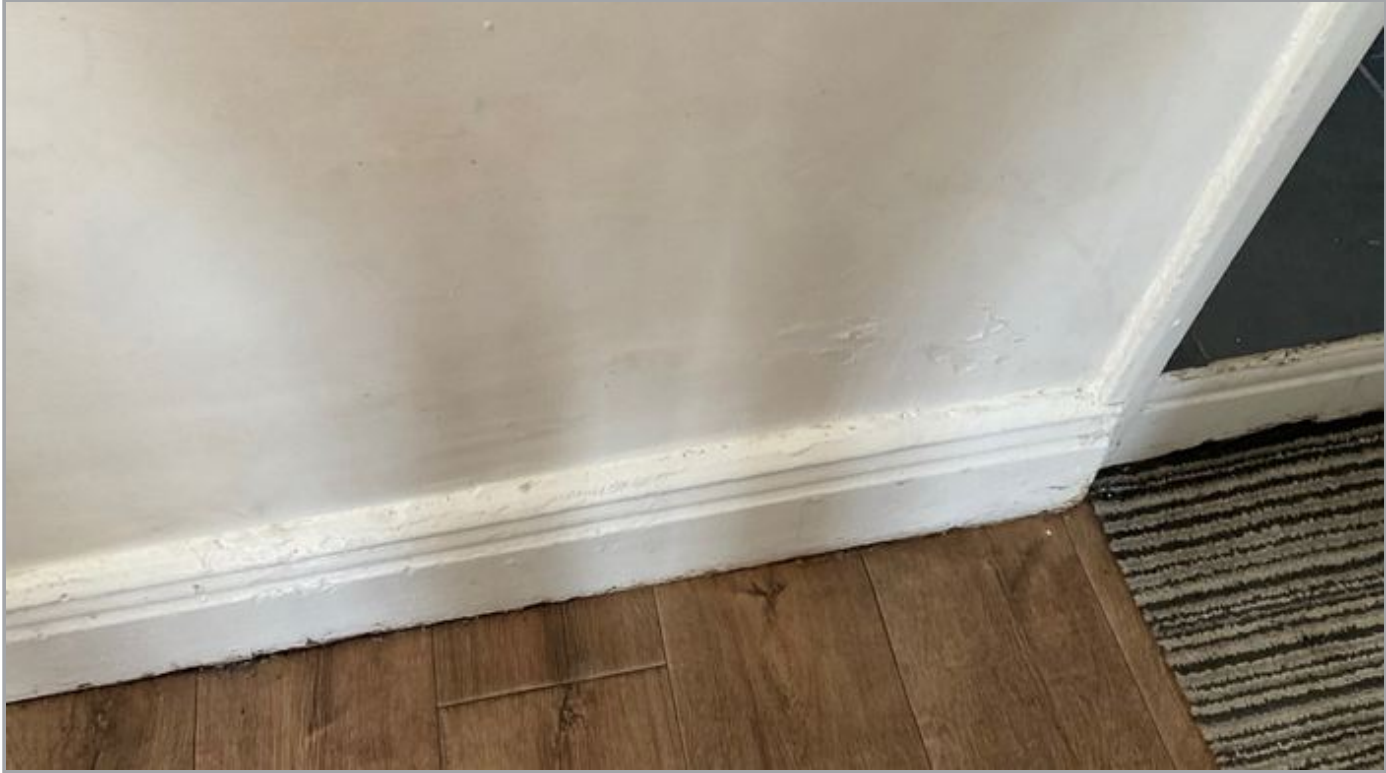
Damp Patches/Salt Staining Bathroom

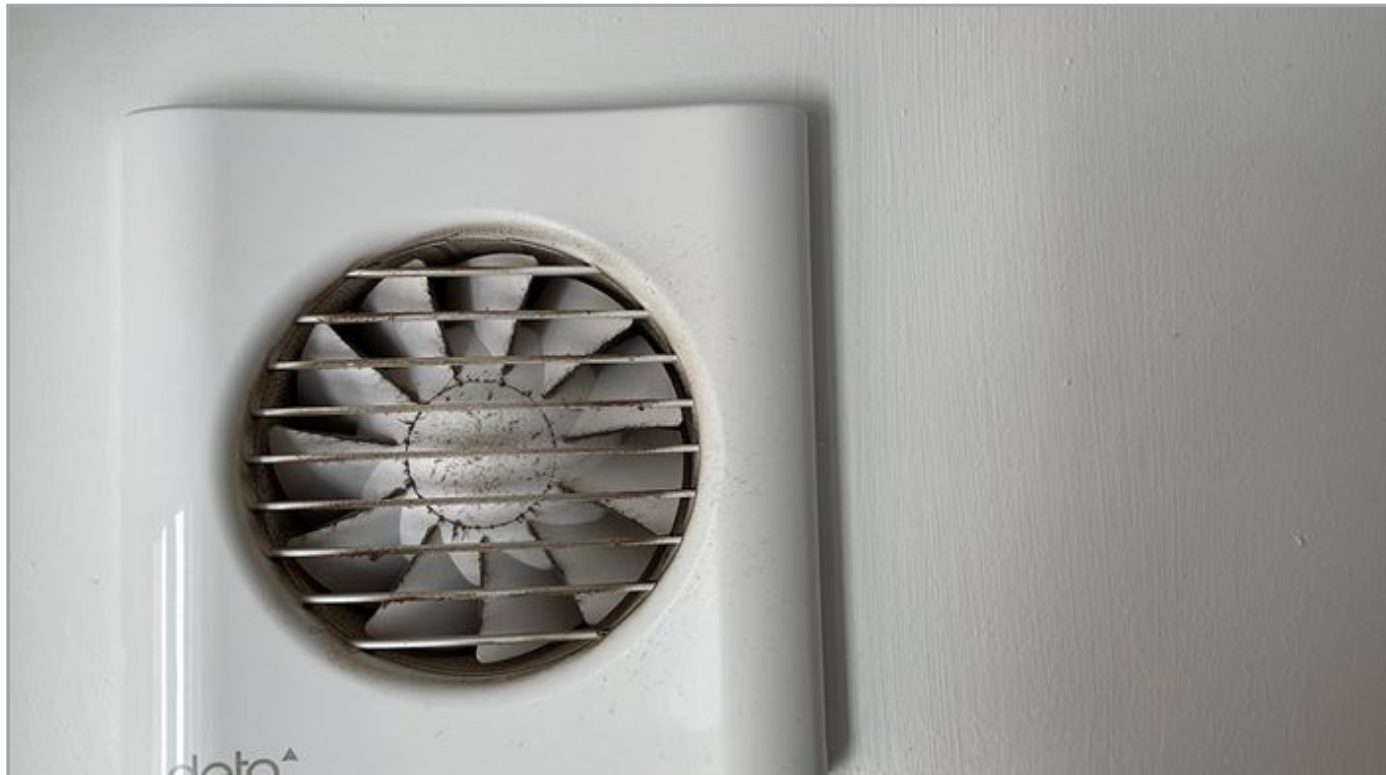
Dust

To continue working effectively at removing excess water vapour in the air and help prevent condensation and mould forming on surfaces, existing mechanical extractor fans should be serviced and cleaned regularly.

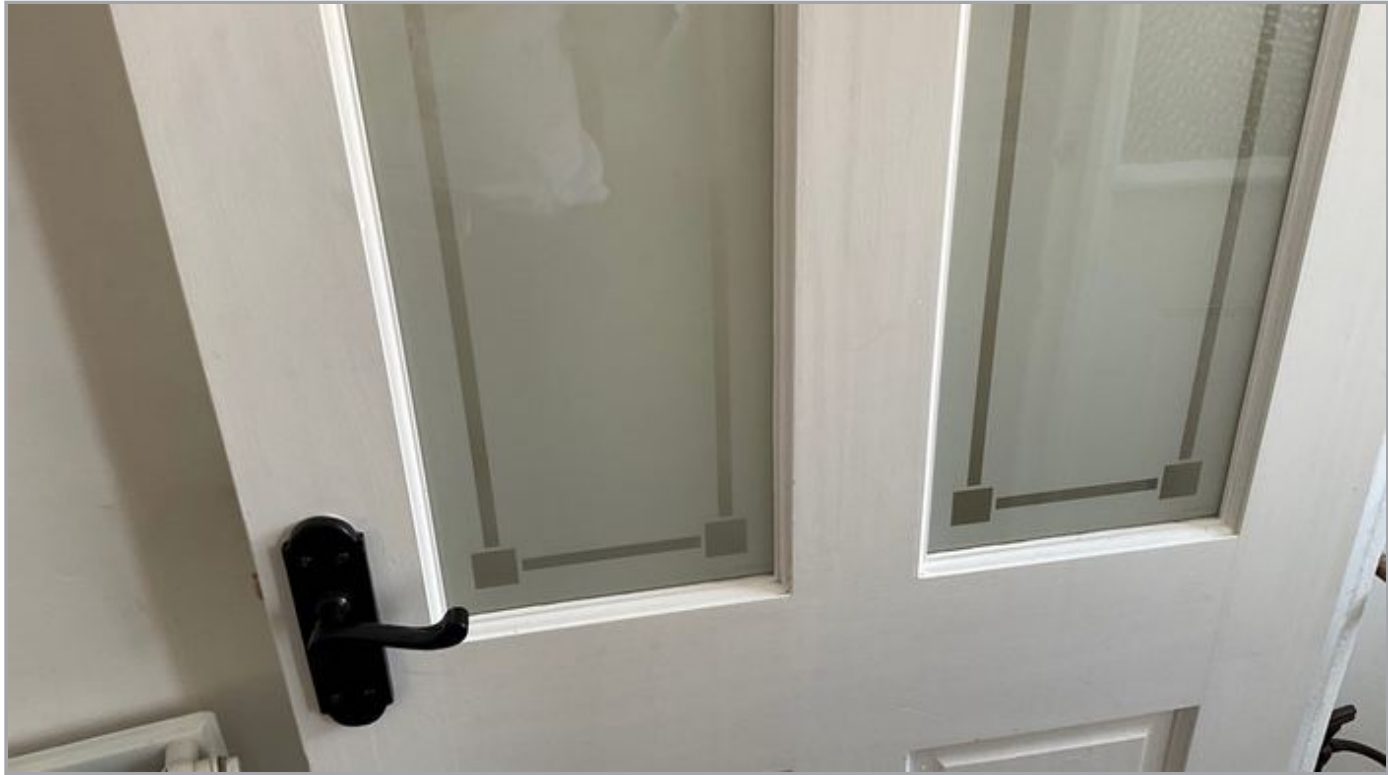
The glazing in the front door does not have a British Standard safety rating and this presents a health and safety risk to occupants. The door is also considered dated by modern standards, therefore it should be replaced with a modern equivalent. This is a risk to persons, and we refer you to our comments in Section I.

Safety Glass

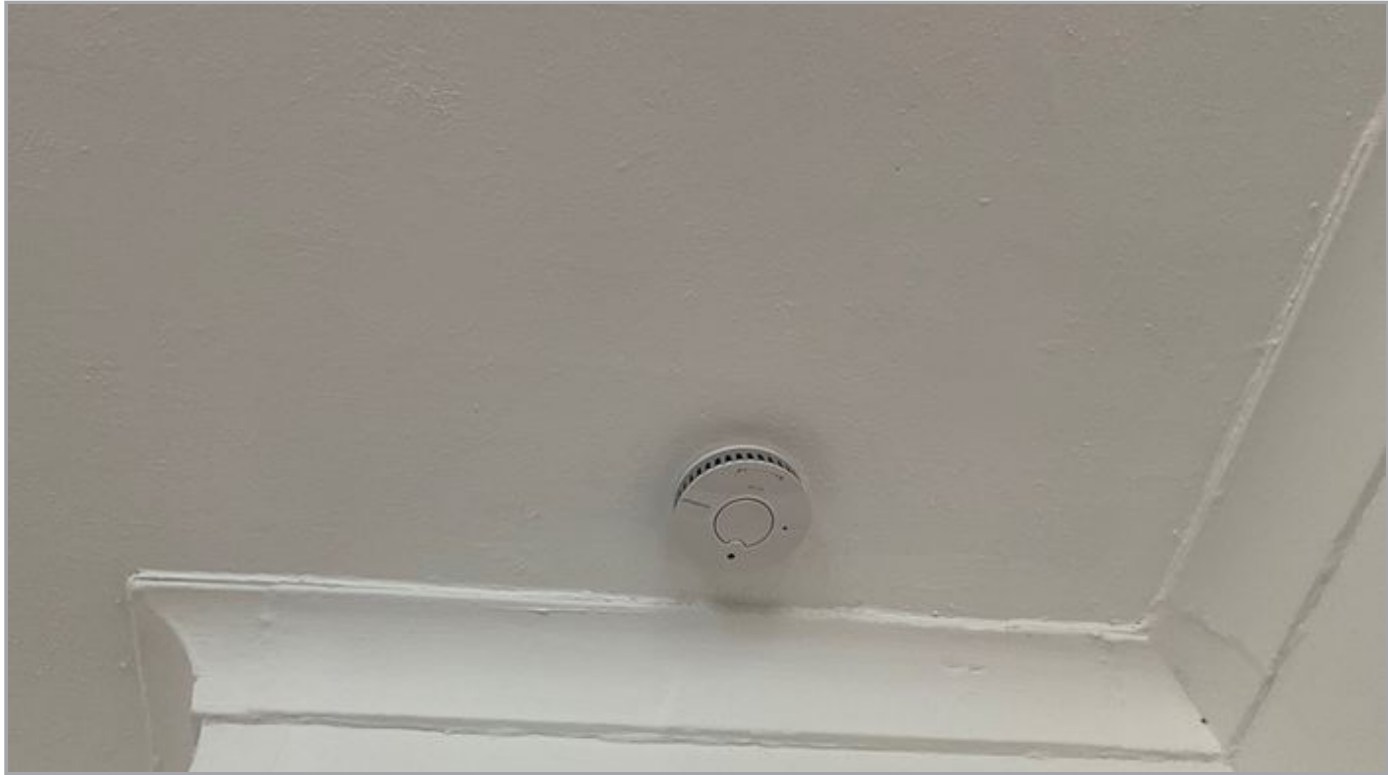
Mains Alarms

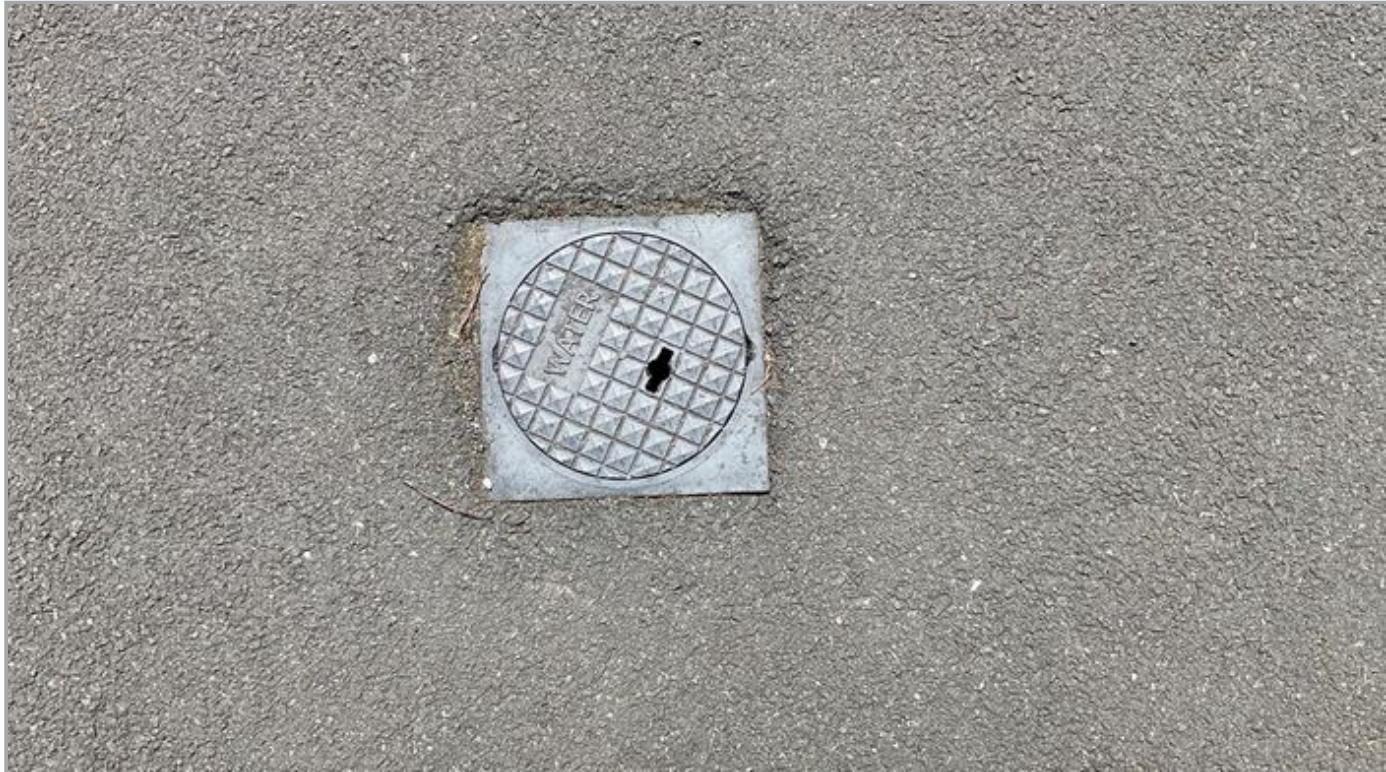
As the internal stopcock could not be found, the vendor should advise you on its location before occupation. This is important in an emergency when supplies need to be cut off to prevent flooding and damage.

Stopcock

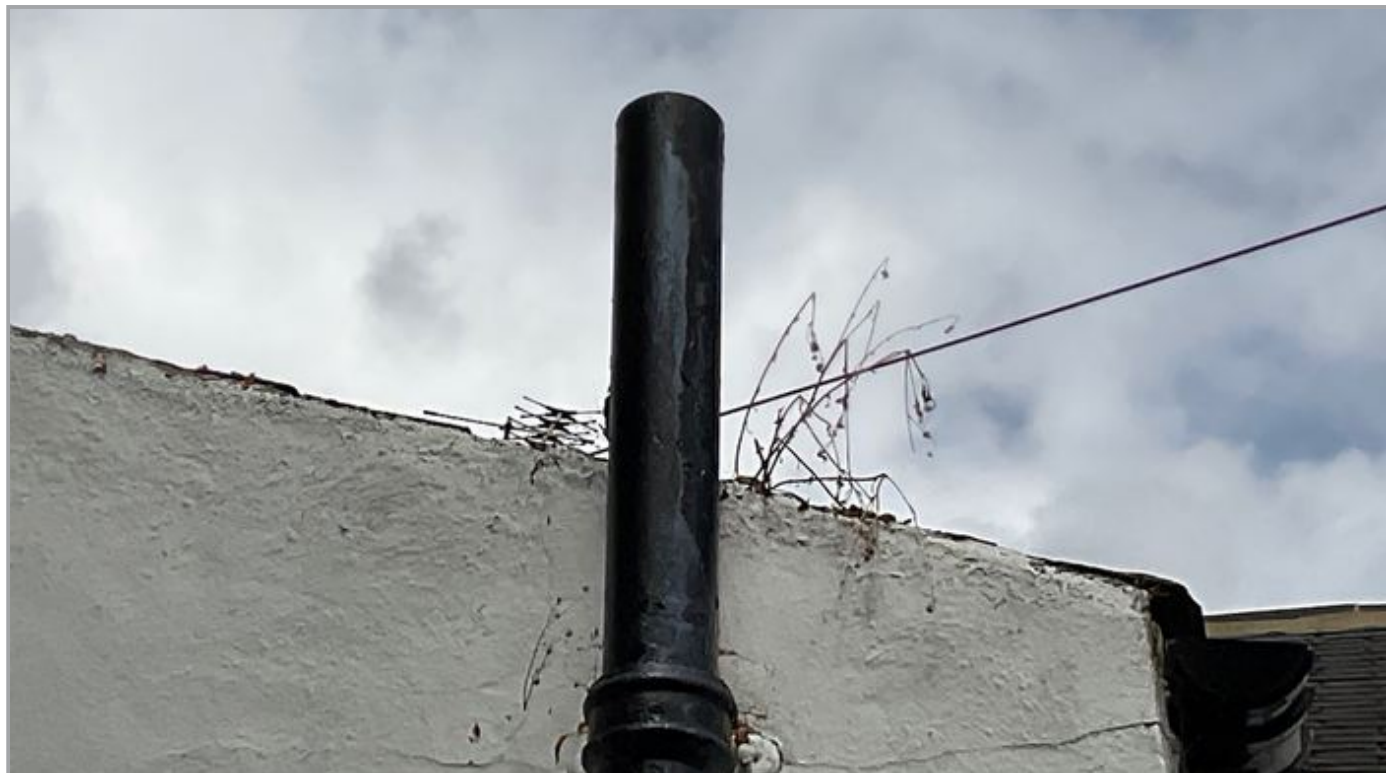
The soil vent pipe (main vertical drainage pipe) to the rear elevation is of cast-iron construction and although it was found to be in a satisfactory condition, it is open, unprotected and without any cage fitting. This is important to prevent nesting birds and debris entering the pipe and causing blockages, which will lead to foul odours entering the property, therefore a cage fitting should be fitted soon to help prevent this.

Open

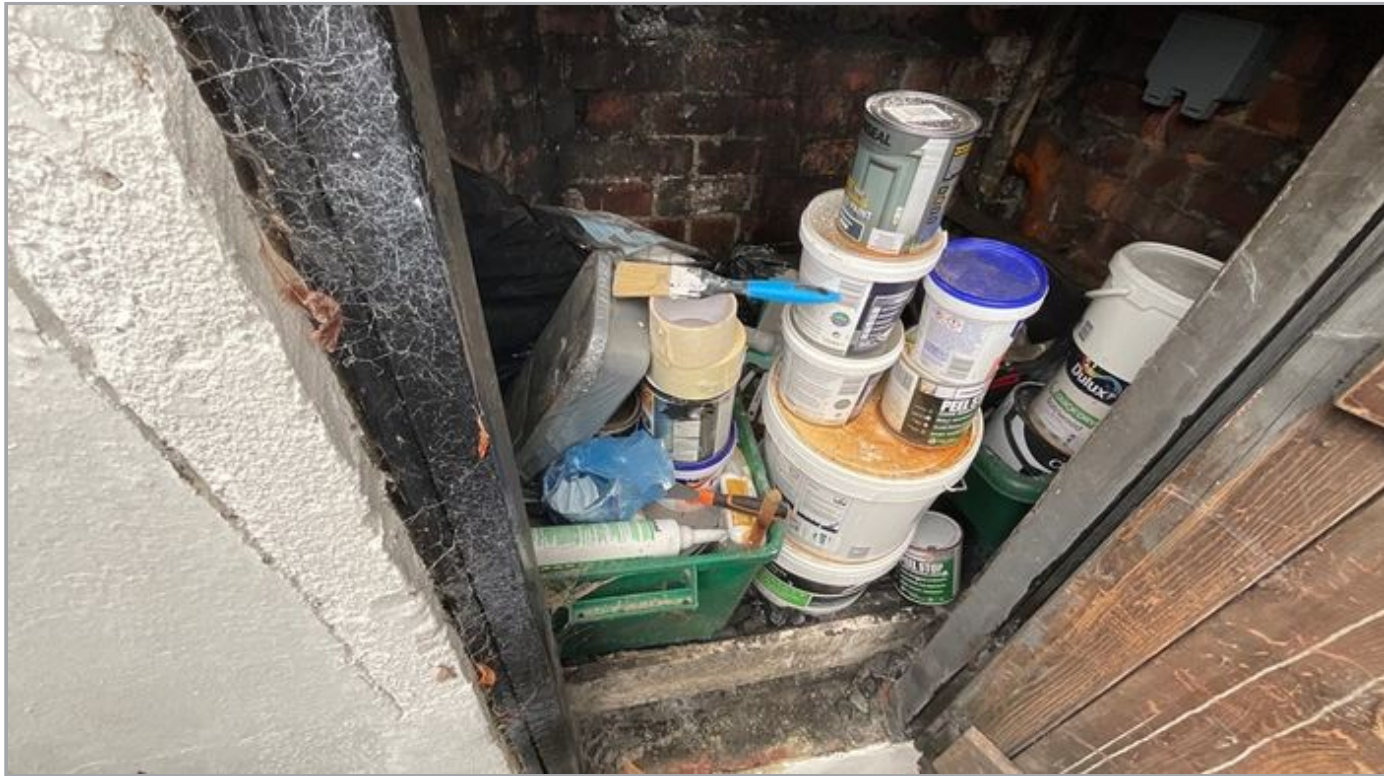
The outbuilding could not be fully inspected because of stored items and therefore we cannot report in detail on such hidden areas and where Condition Ratings have been allocated these may well have been based on a limited inspection.

Restricted Inspection

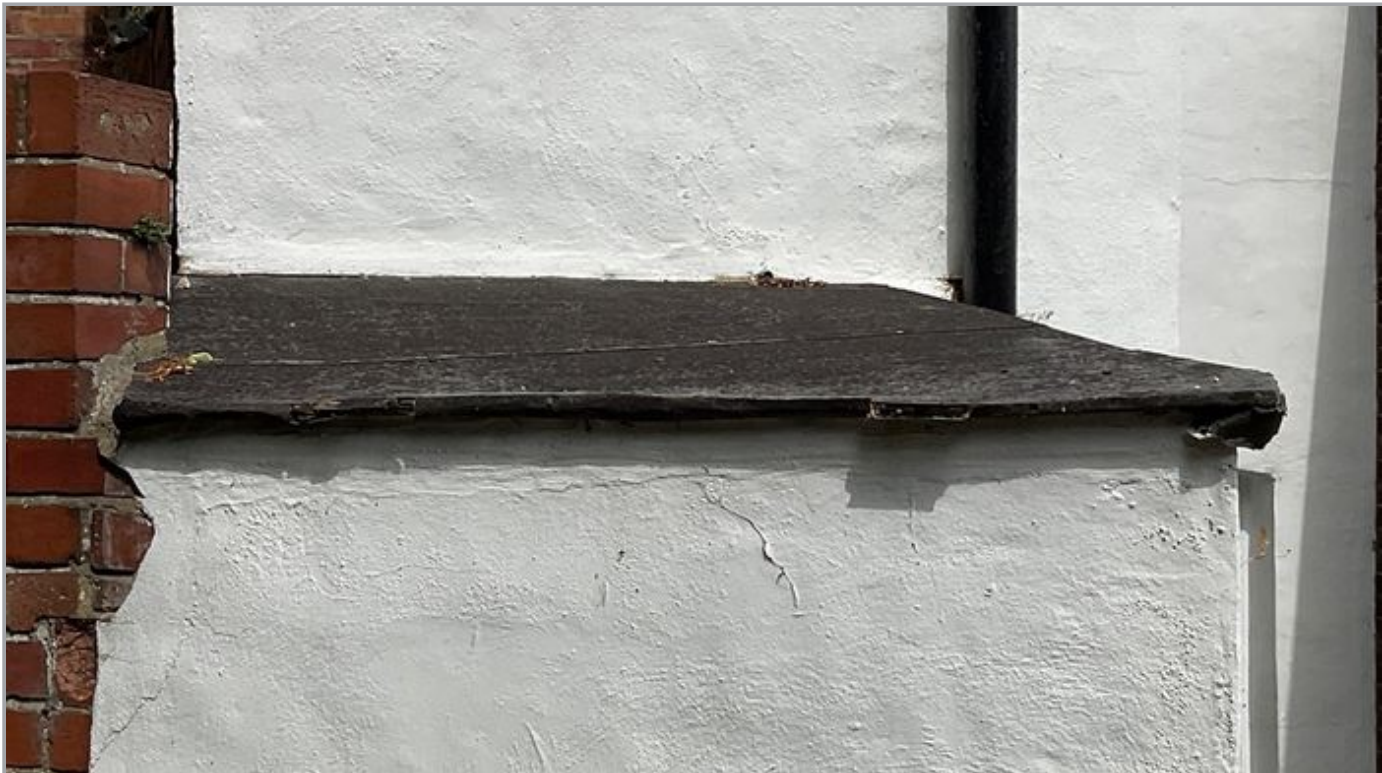
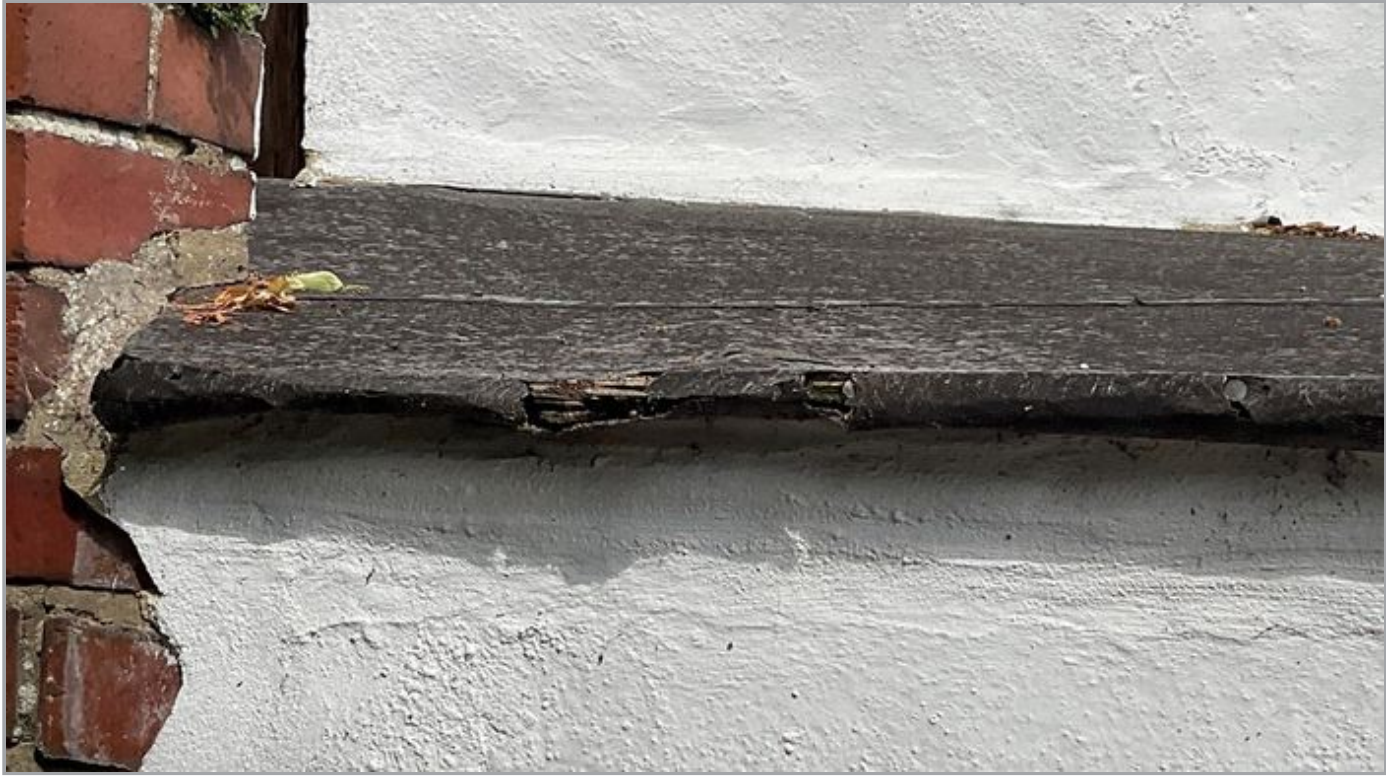
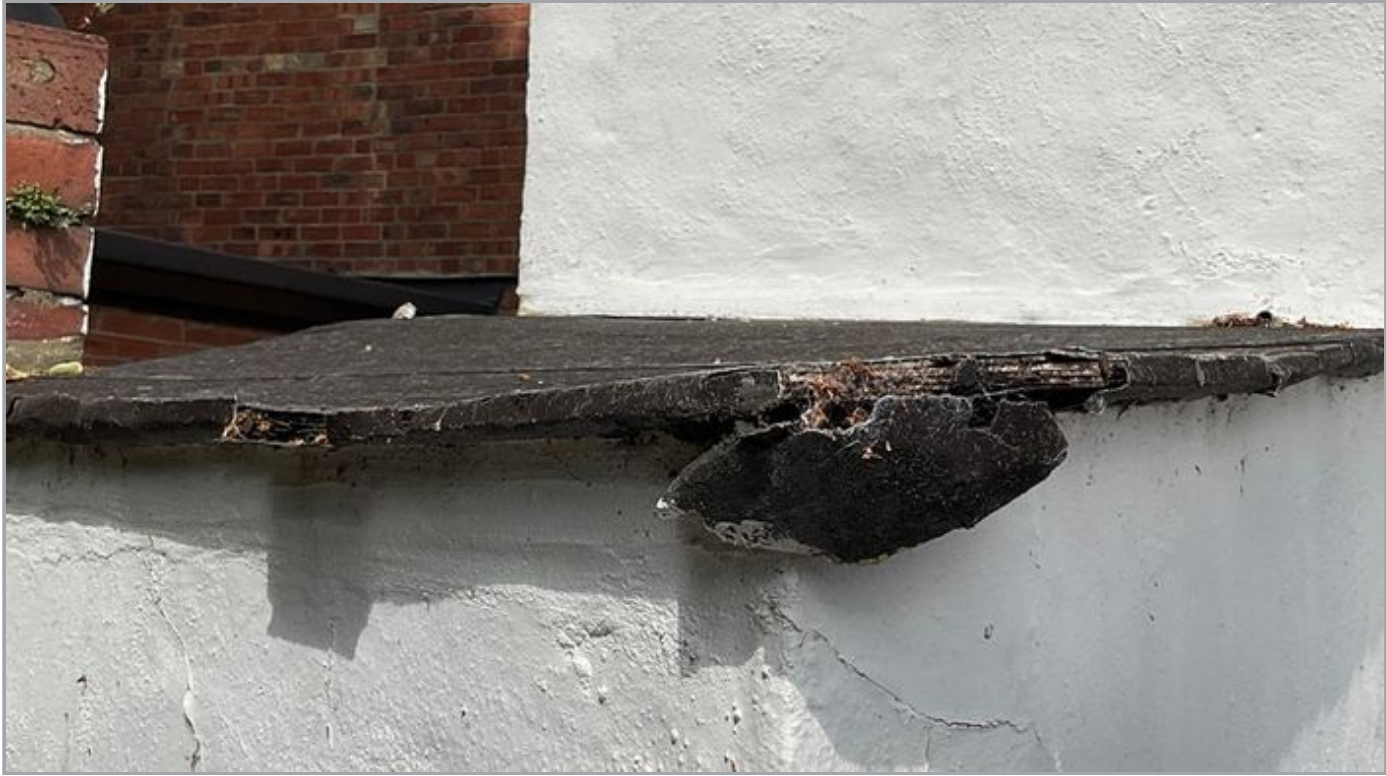
The metal reinforcement within the concrete slab roof has corroded and this expands the metal and displaces/cracking the surrounding concrete and brickwork. As repairing this is likely to be costly and disruptive, you may want to leave it as it is as it's not part of the habitable building and it's used for storage purposes only.

Overhaul Roof
