LEVEL 2

Your survey report

Inspection date

21 July 2023

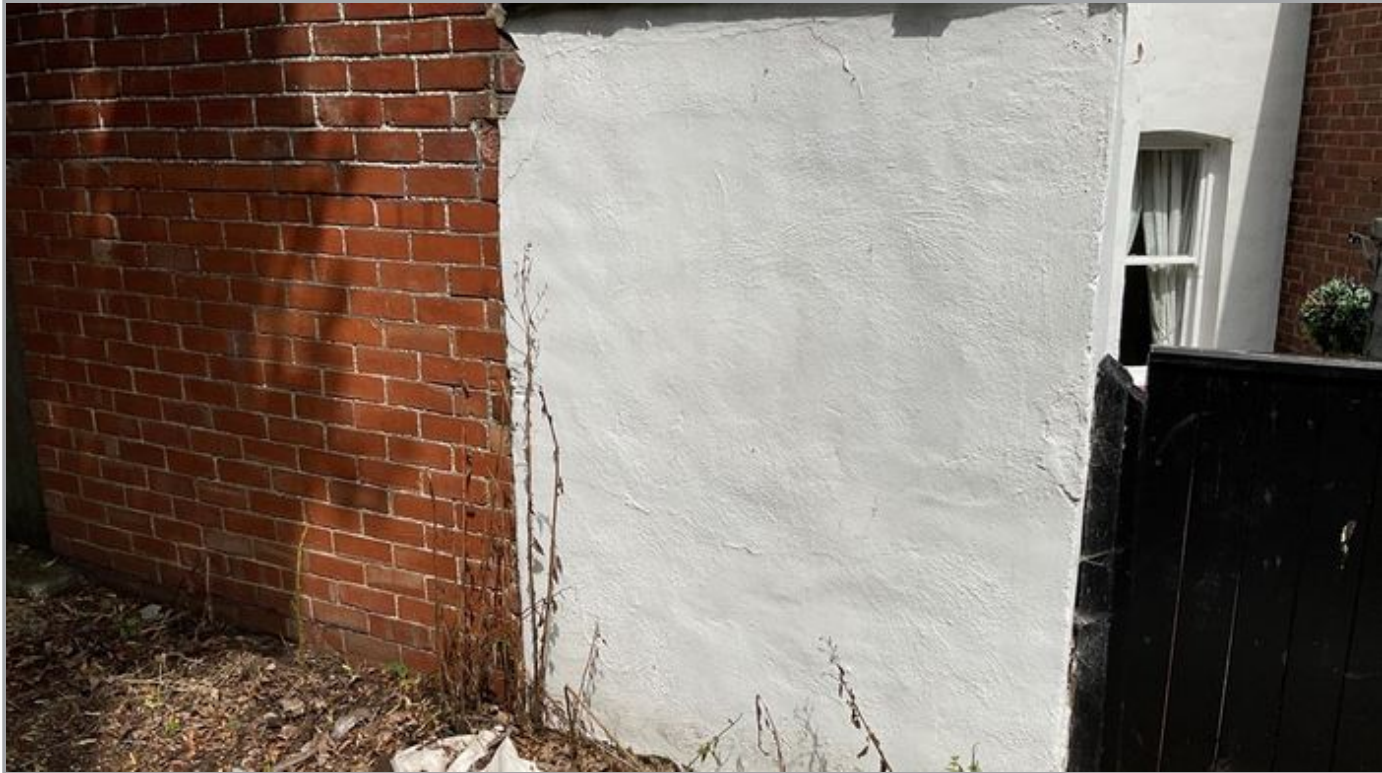
Inadequate Render

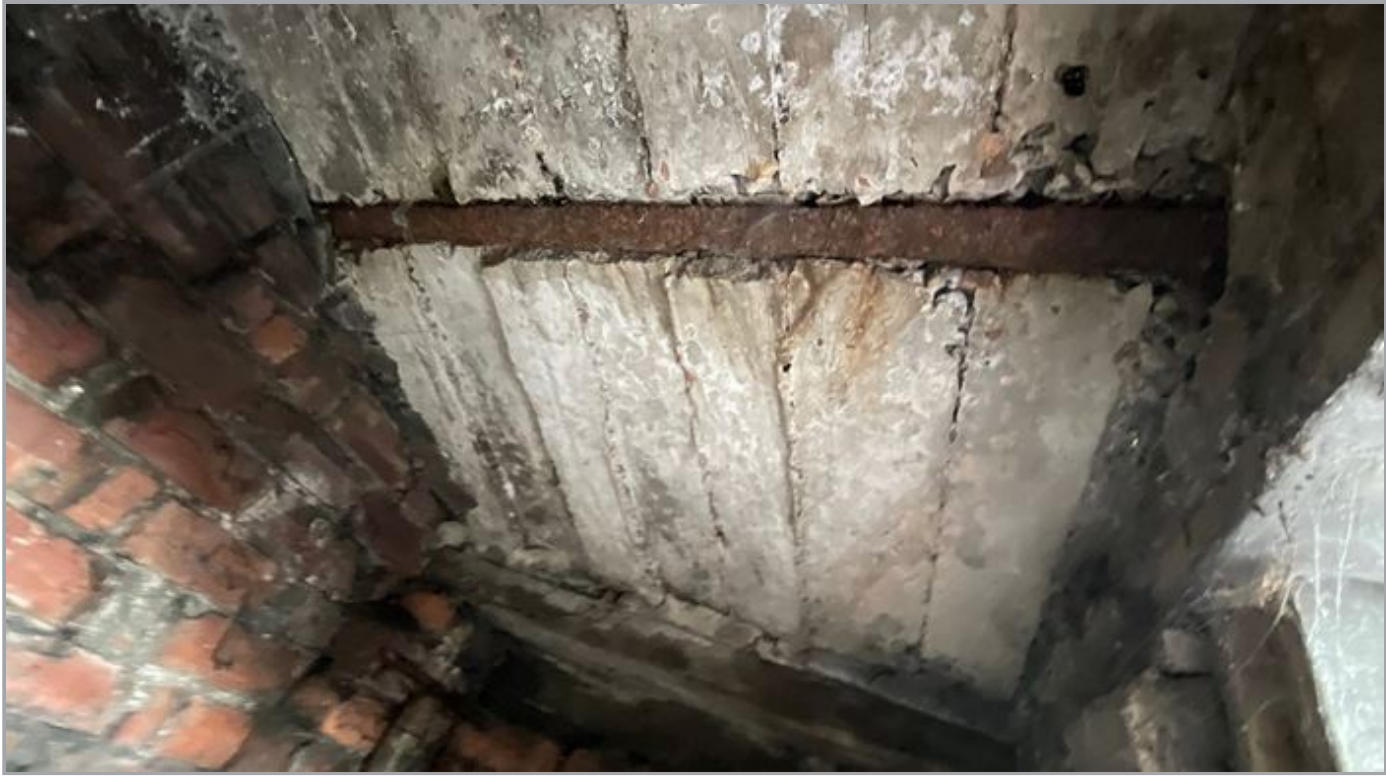
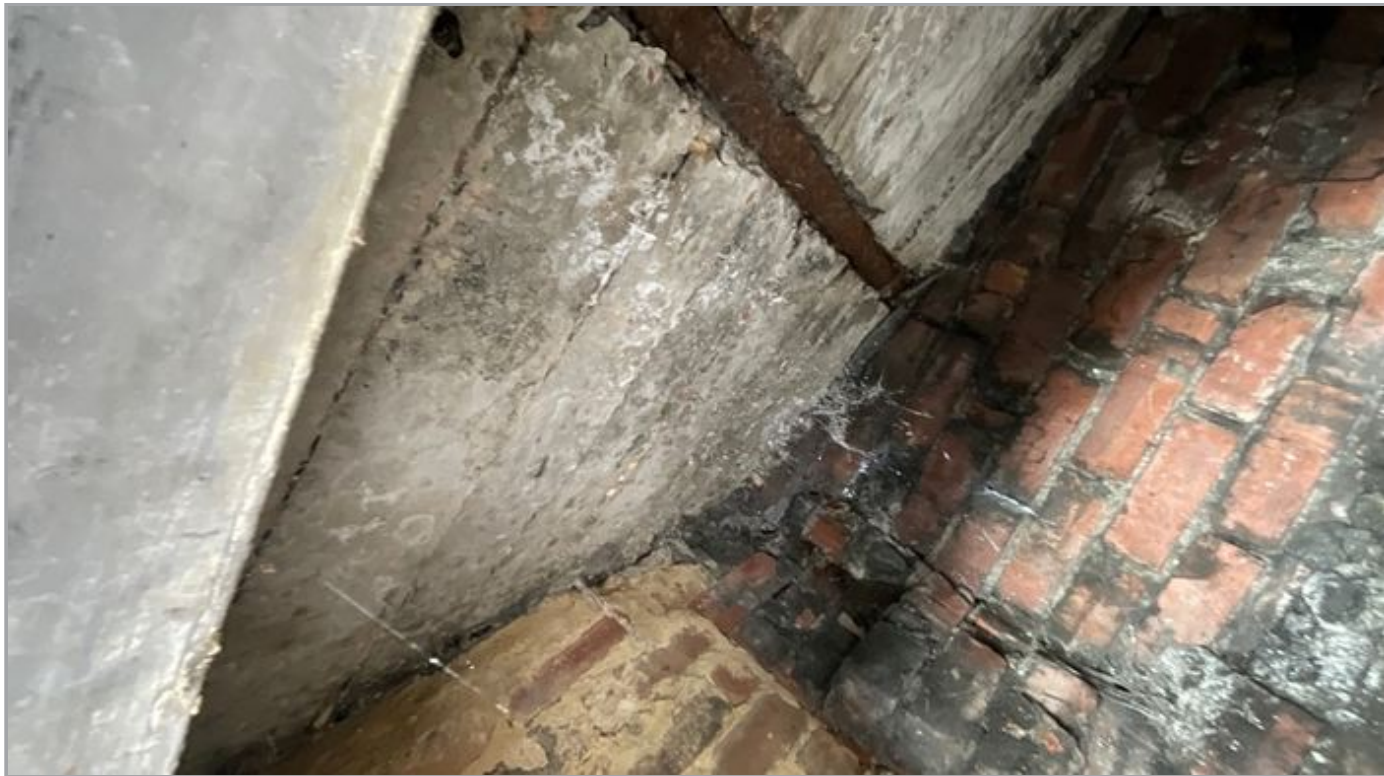
Corroding
