LEVEL 2

Your survey report

30 August 2023

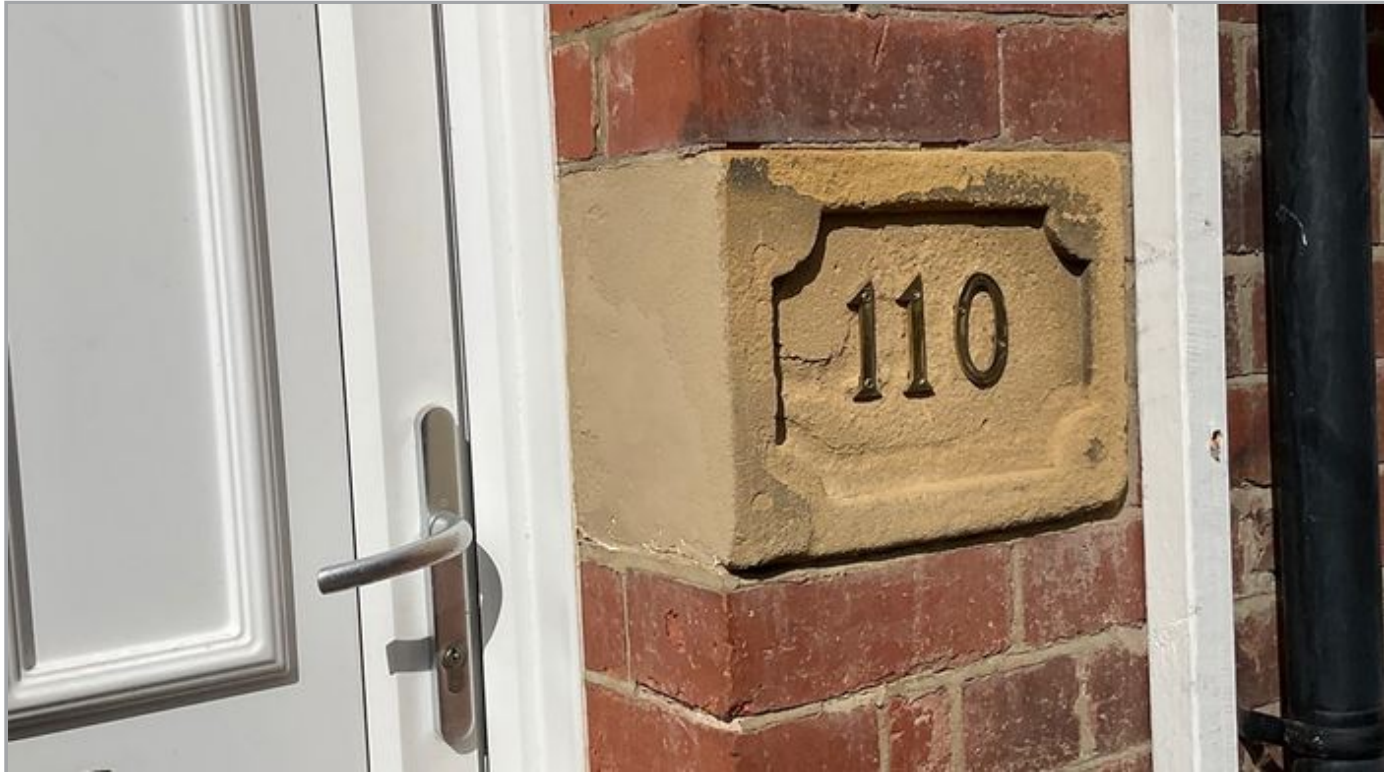
Solid Construction Eroding Pointing

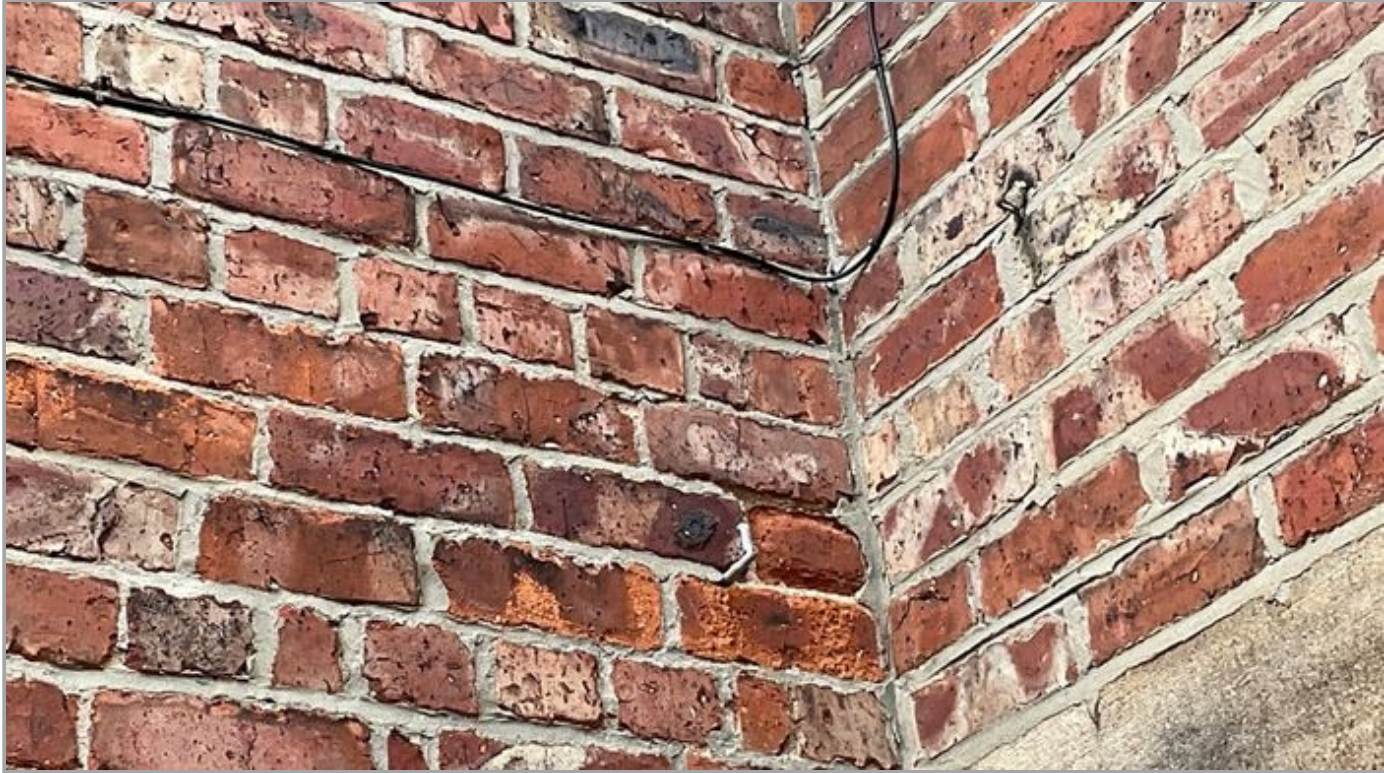
Solid Construction Eroding Pointing

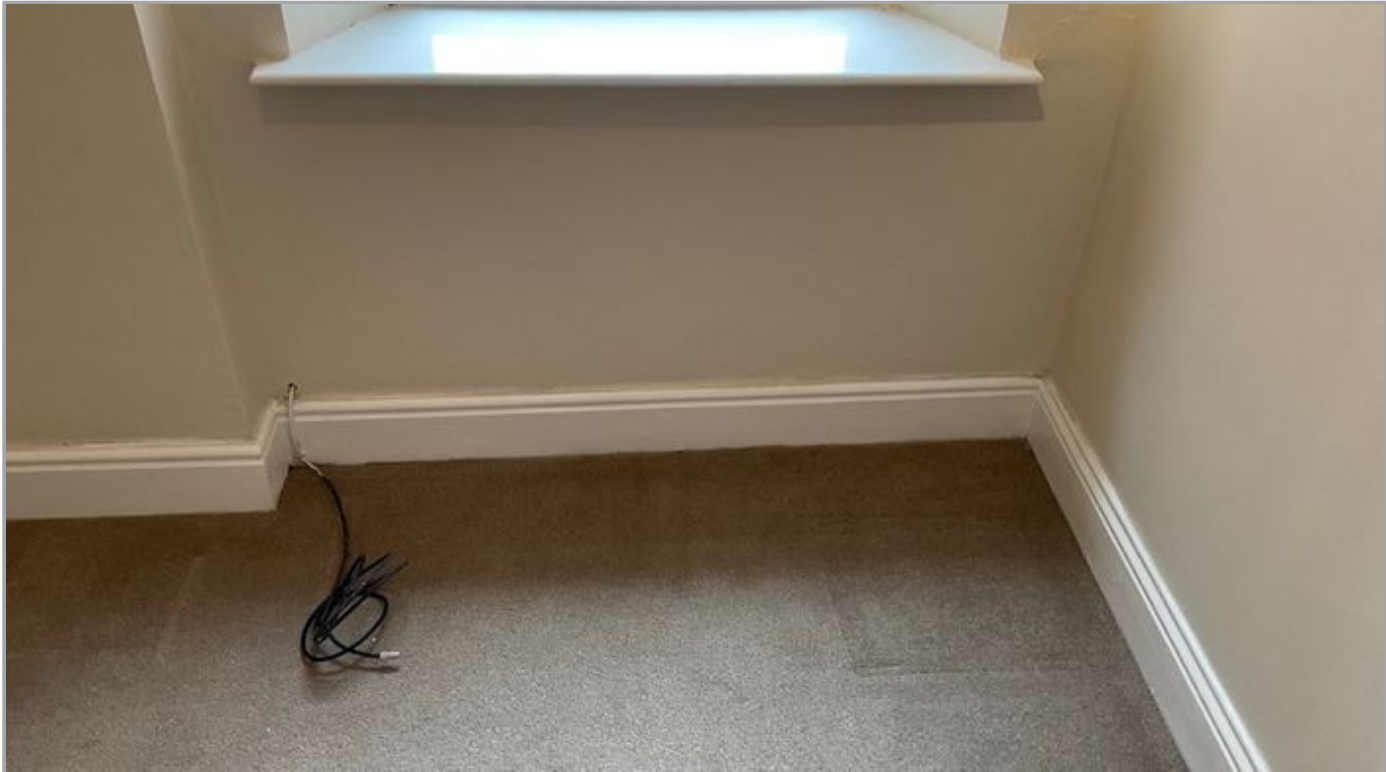
Springy Flooring Rear Bedroom
