LEVEL 2

Your survey report

Inspection date

21 July 2023

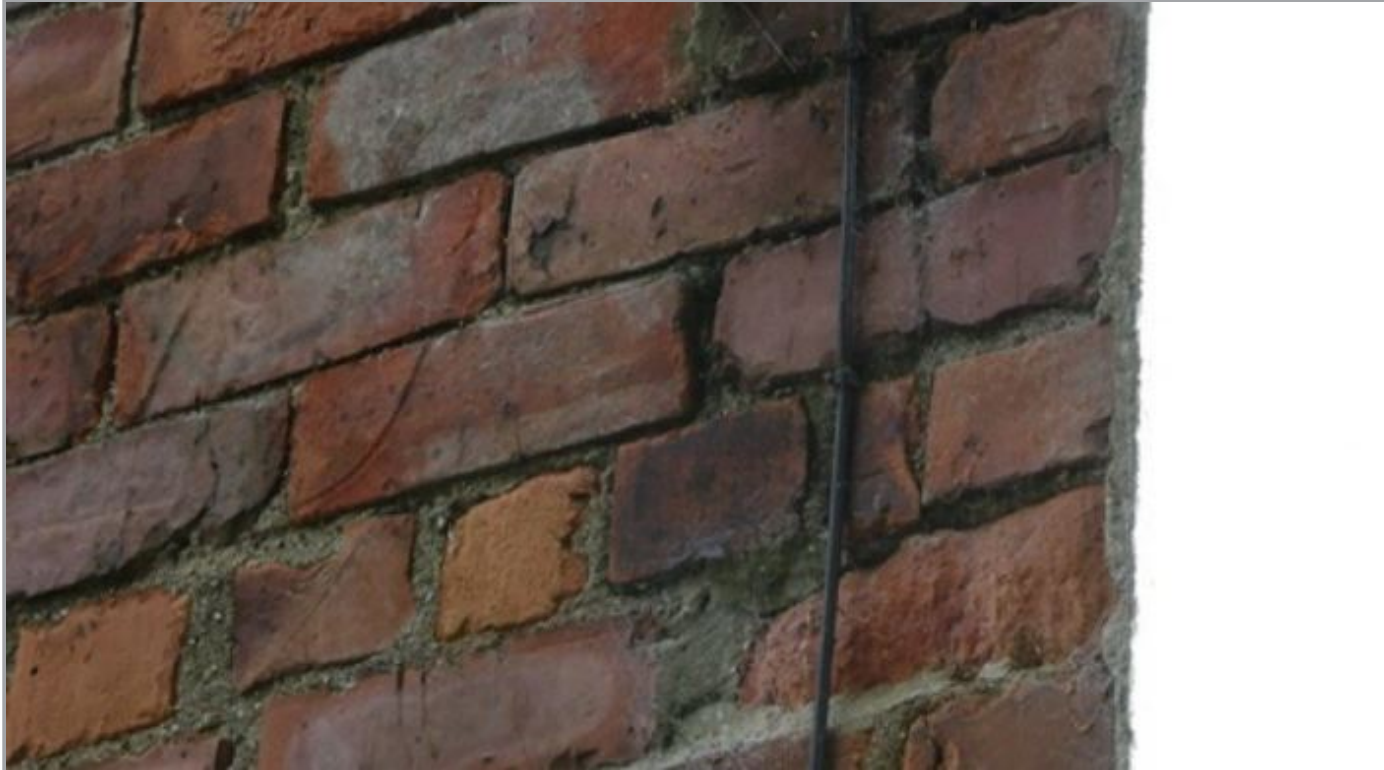
Solid Construction Eroding Pointing

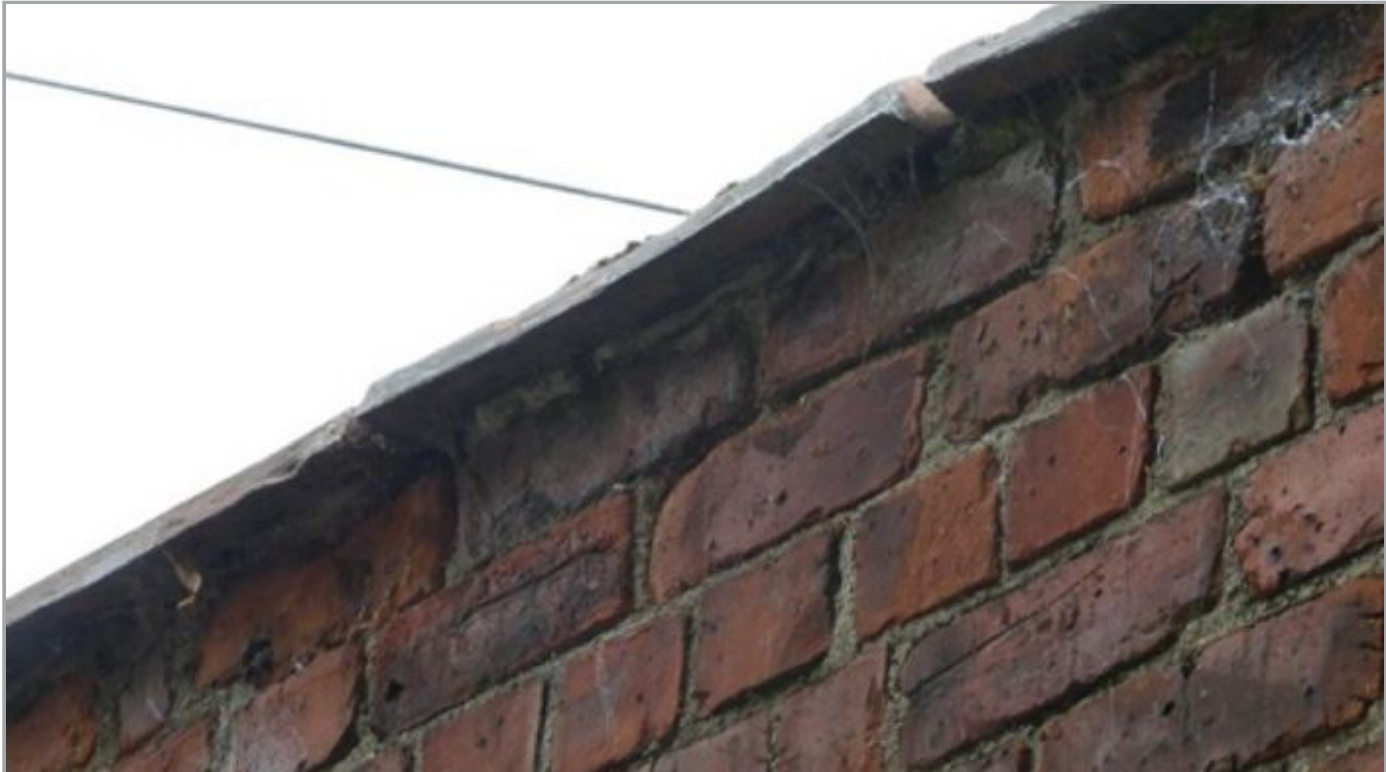
Solid Construction Eroding Pointing

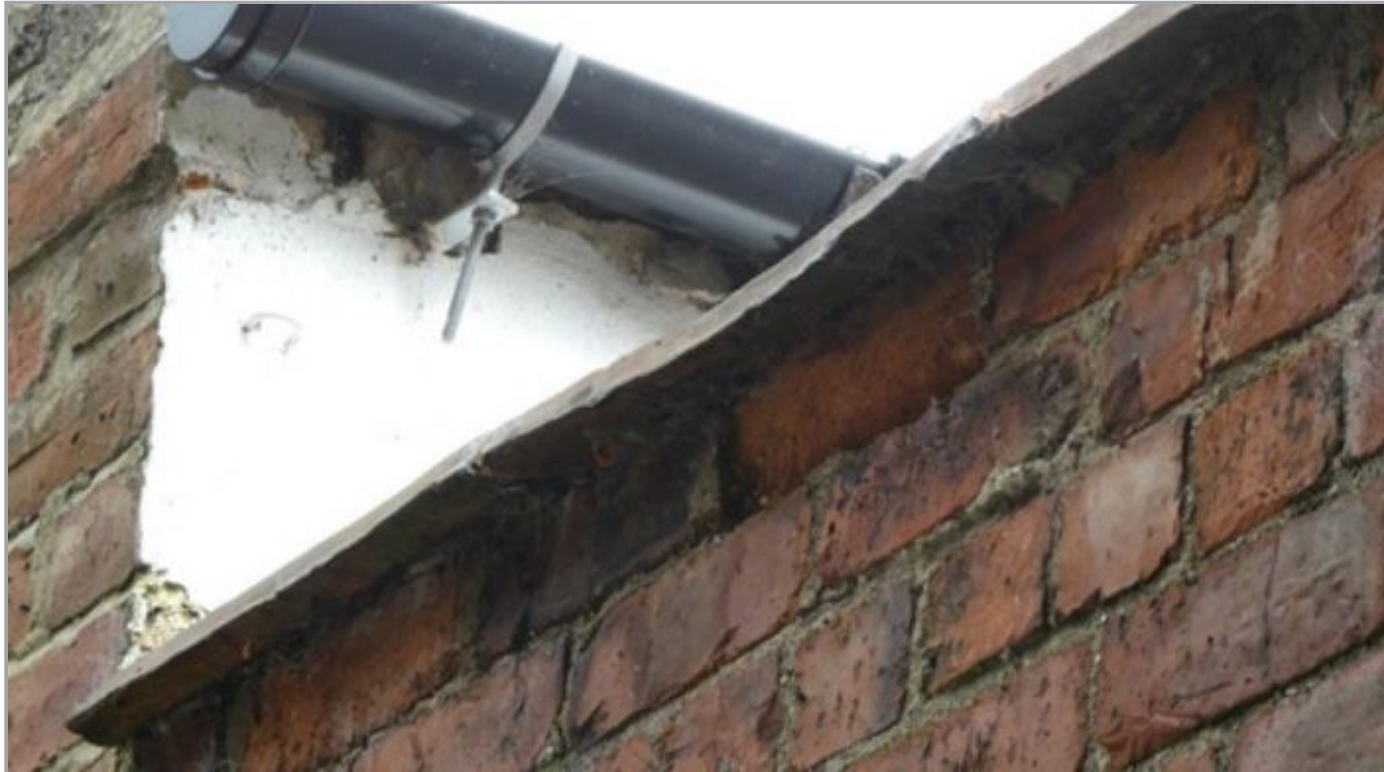
Solid Construction Eroding Pointing

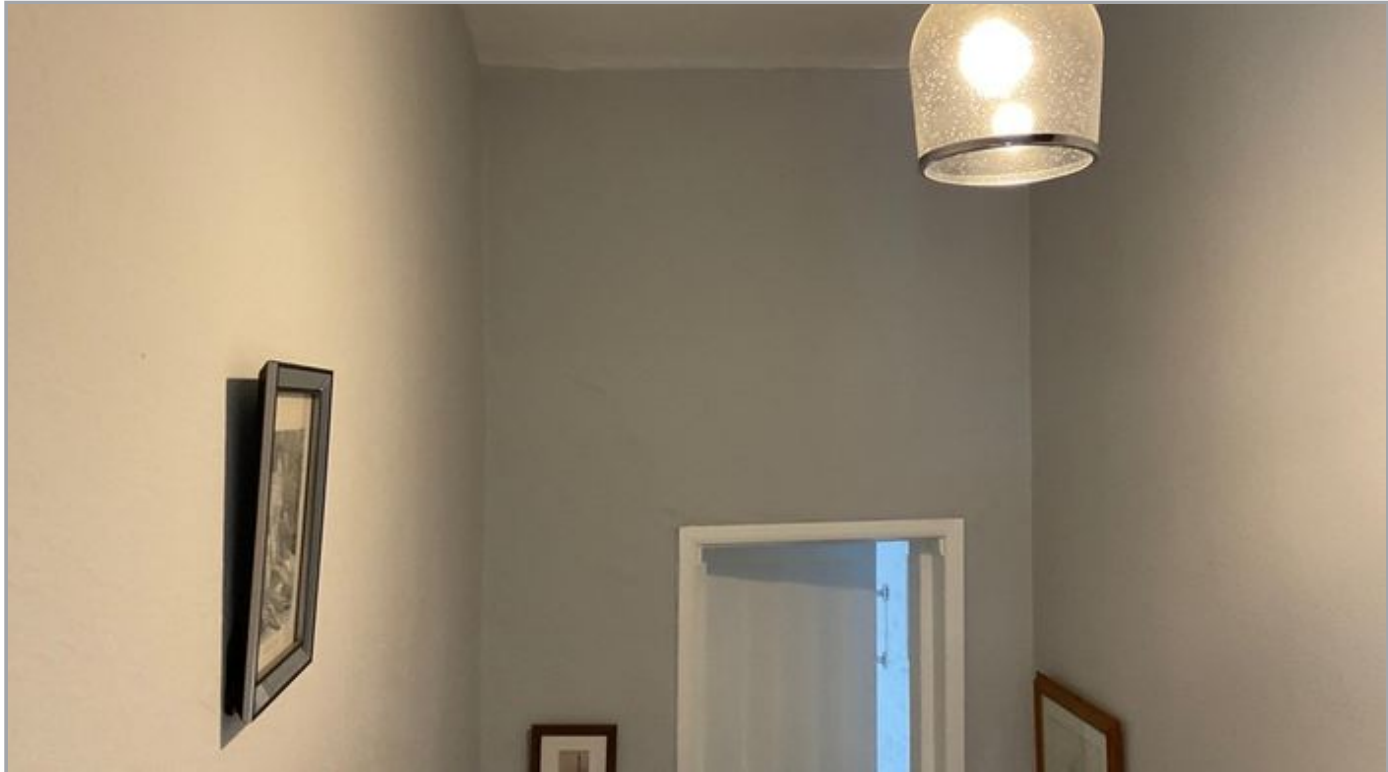
Possible Ongoing Structural Movement

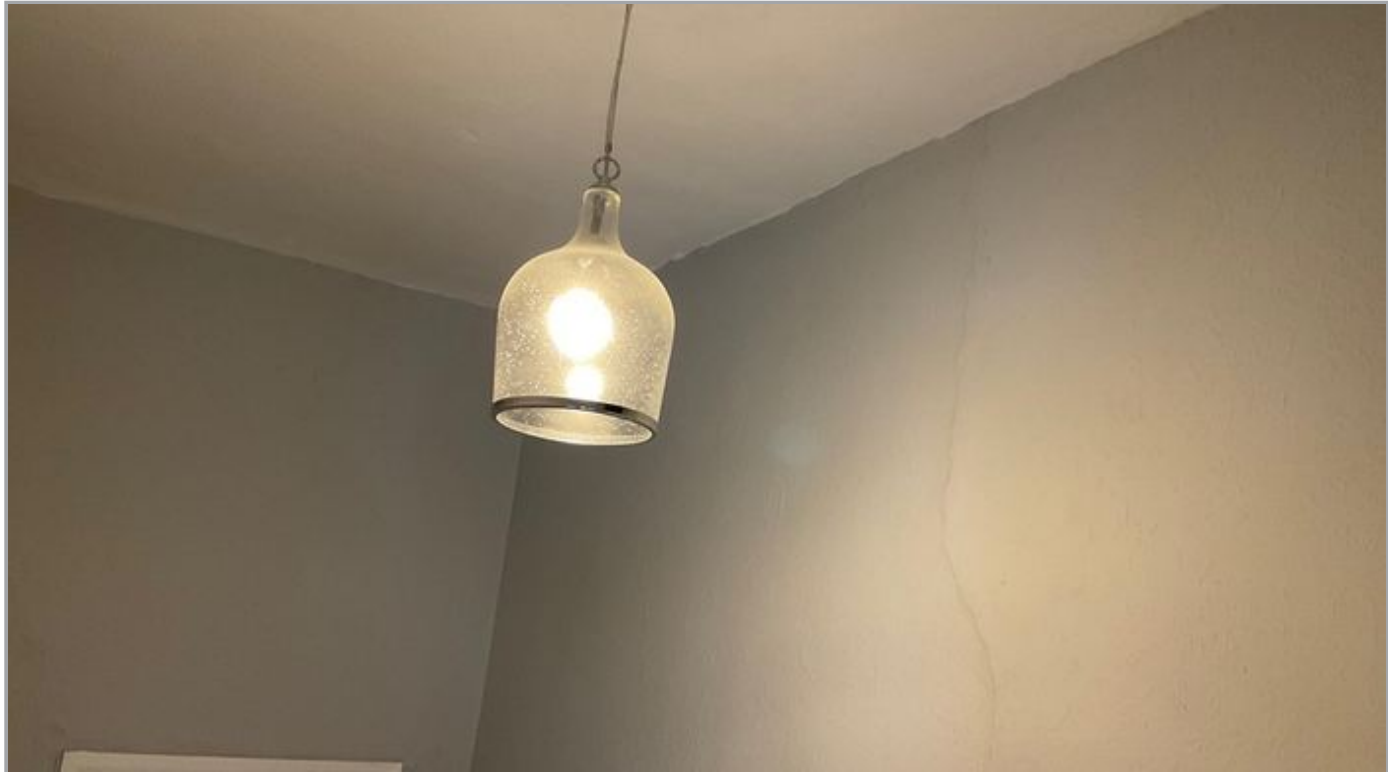
Possible Ongoing Structural Movement

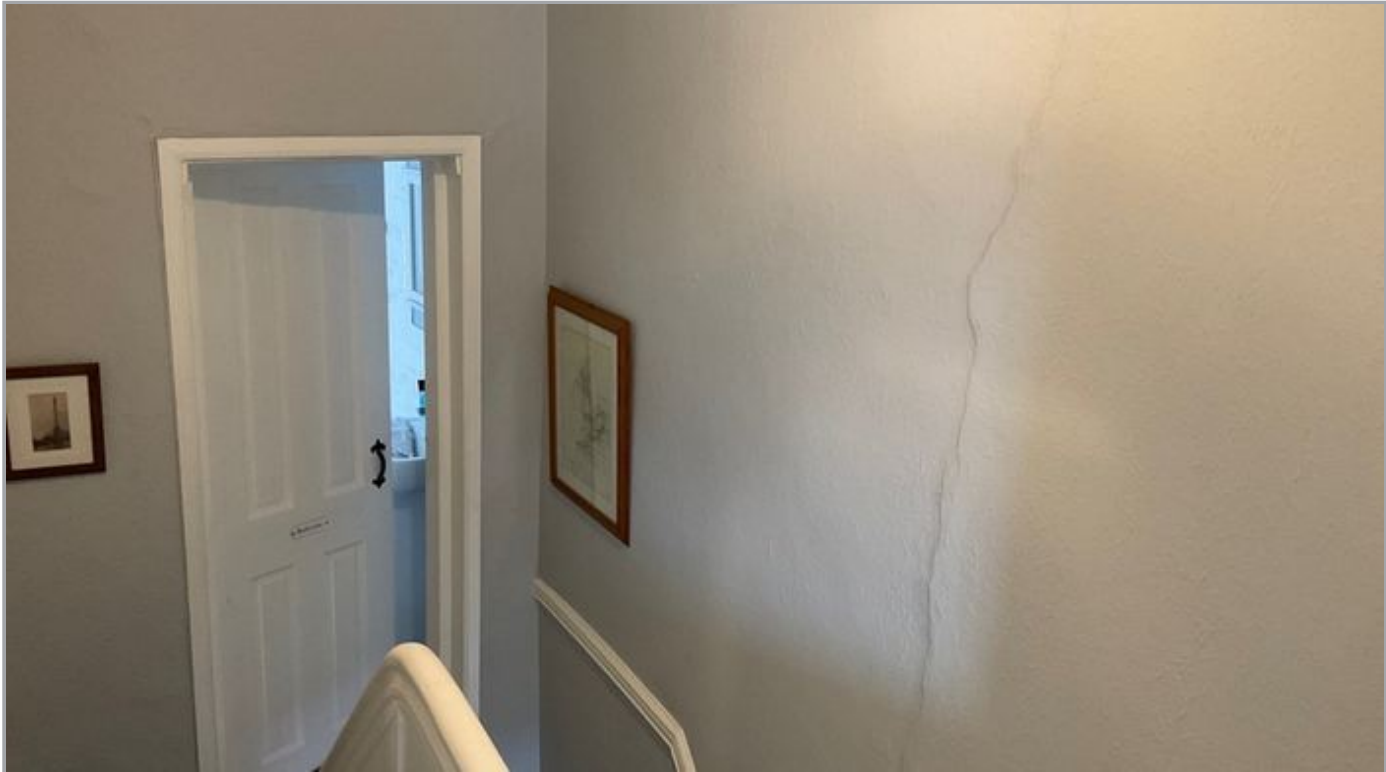
Possible Ongoing Structural Movement

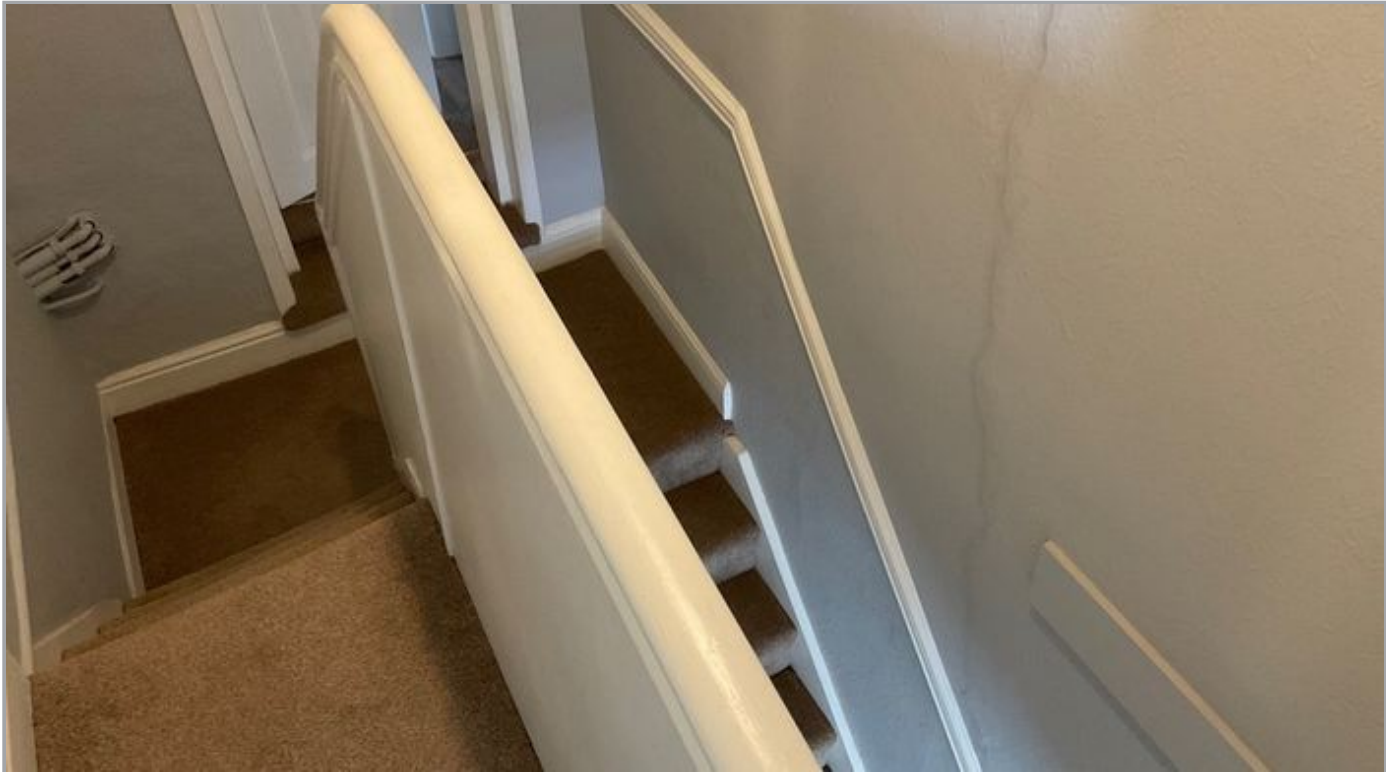
Possible Ongoing Structural Movement

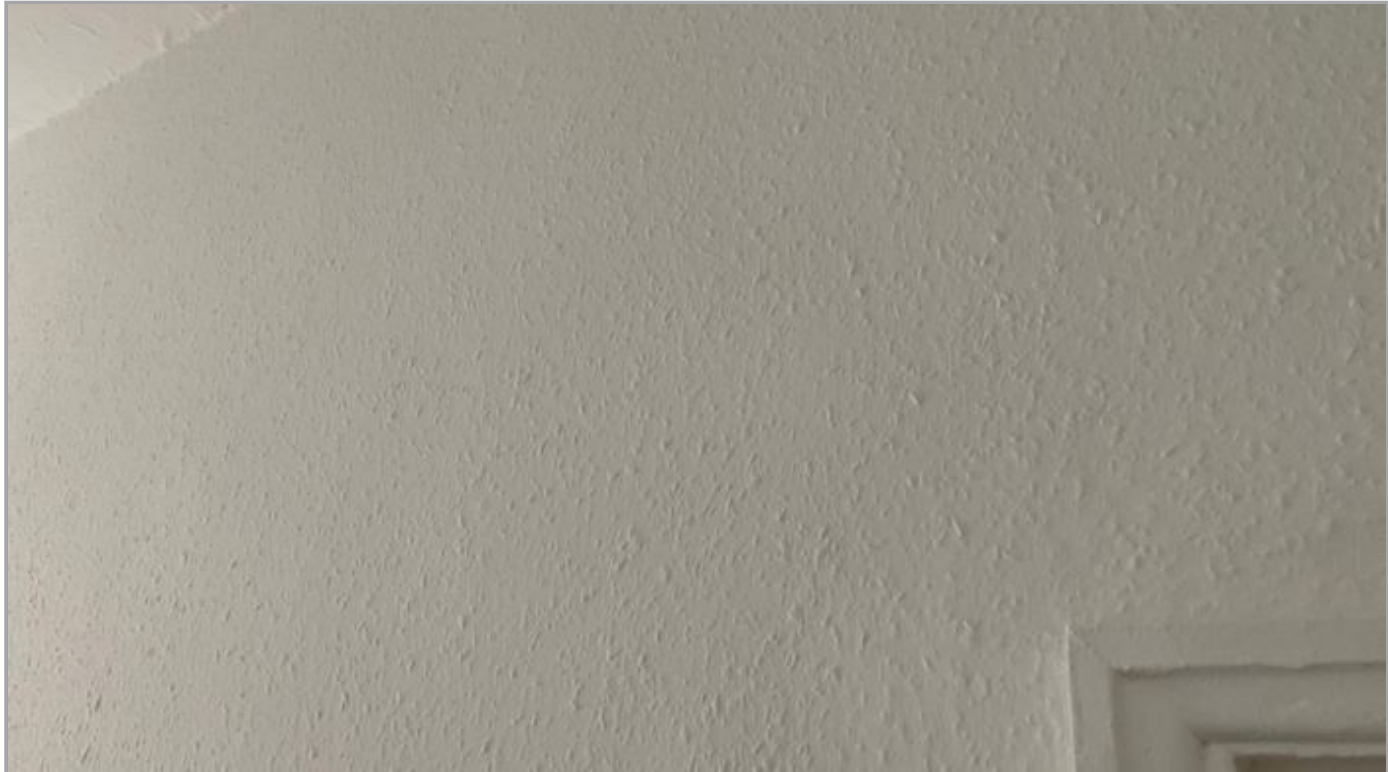
Wall Covered - See Limitations To Inspection

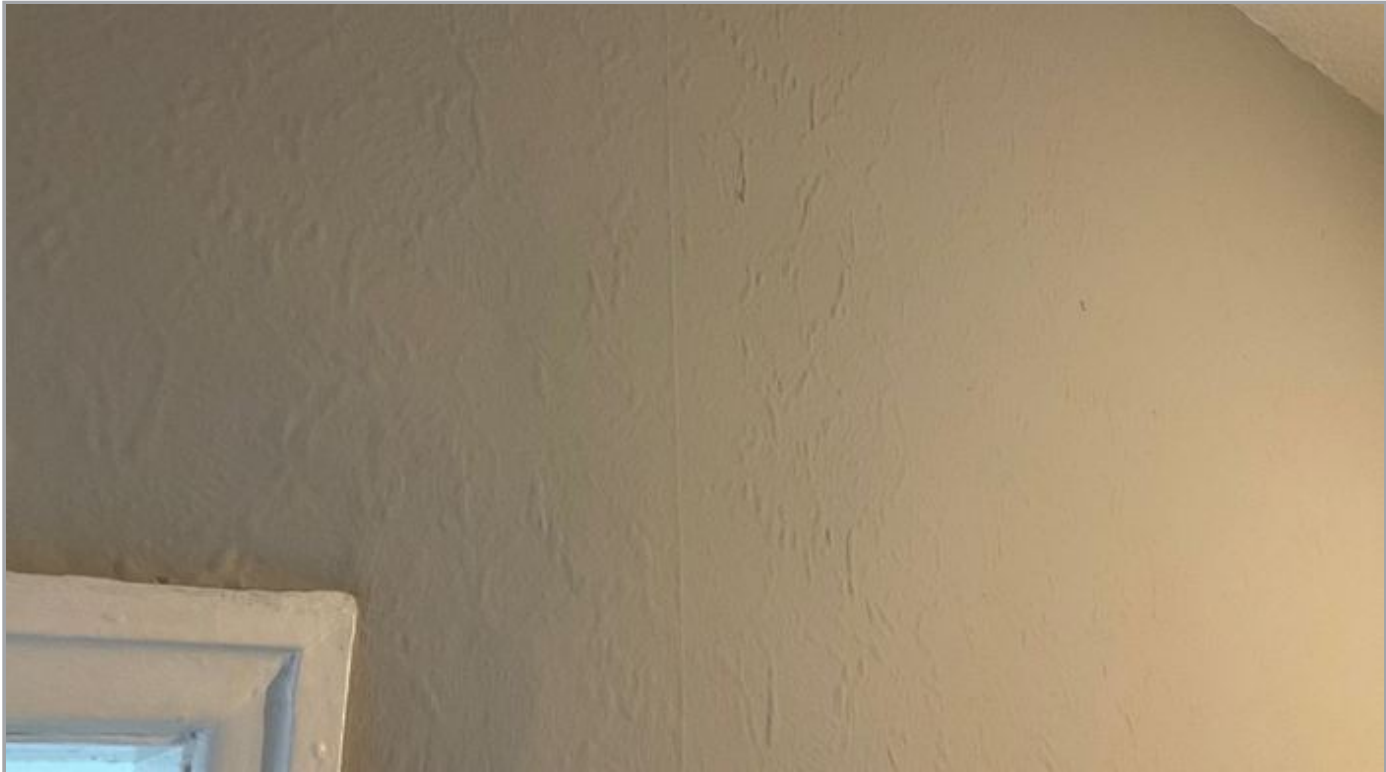
Wall Covered - See Limitations To Inspection

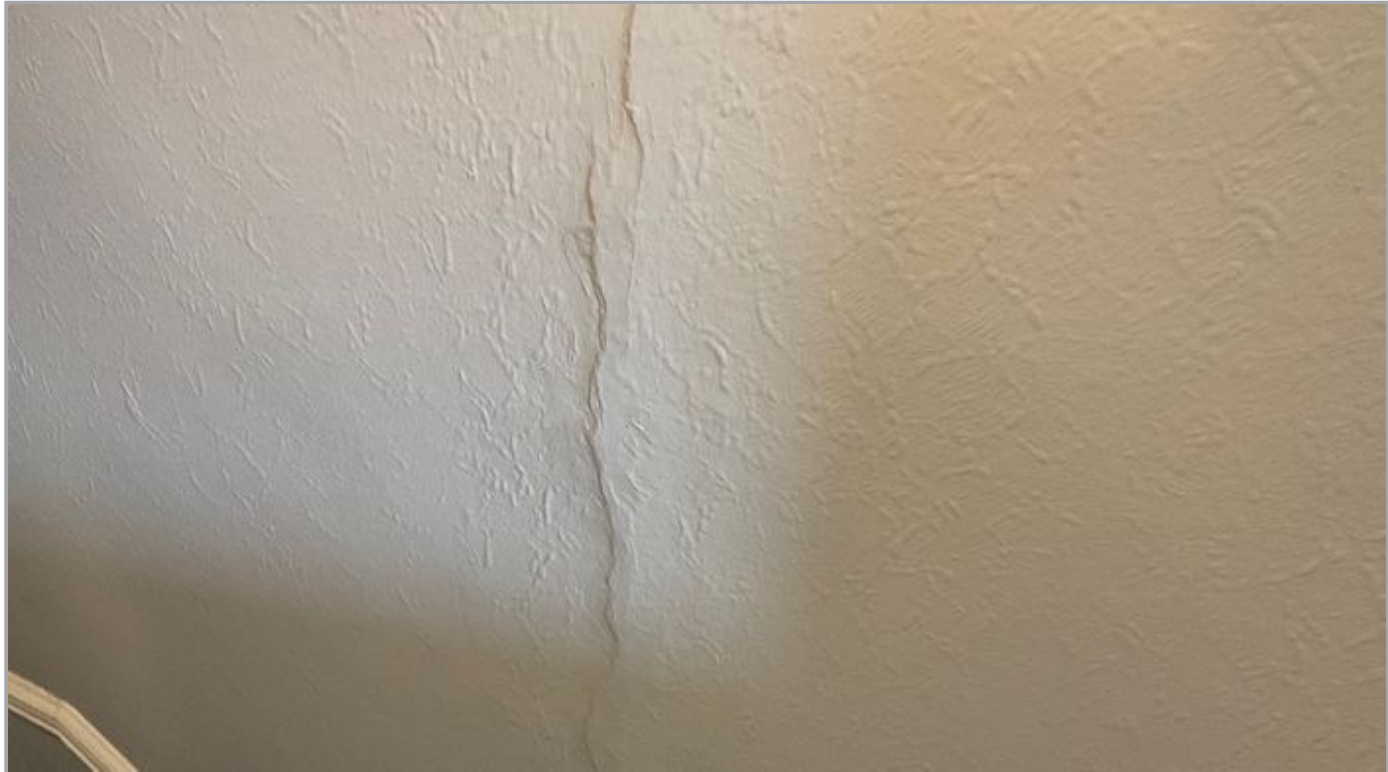
Wall Covered - See Limitations To Inspection

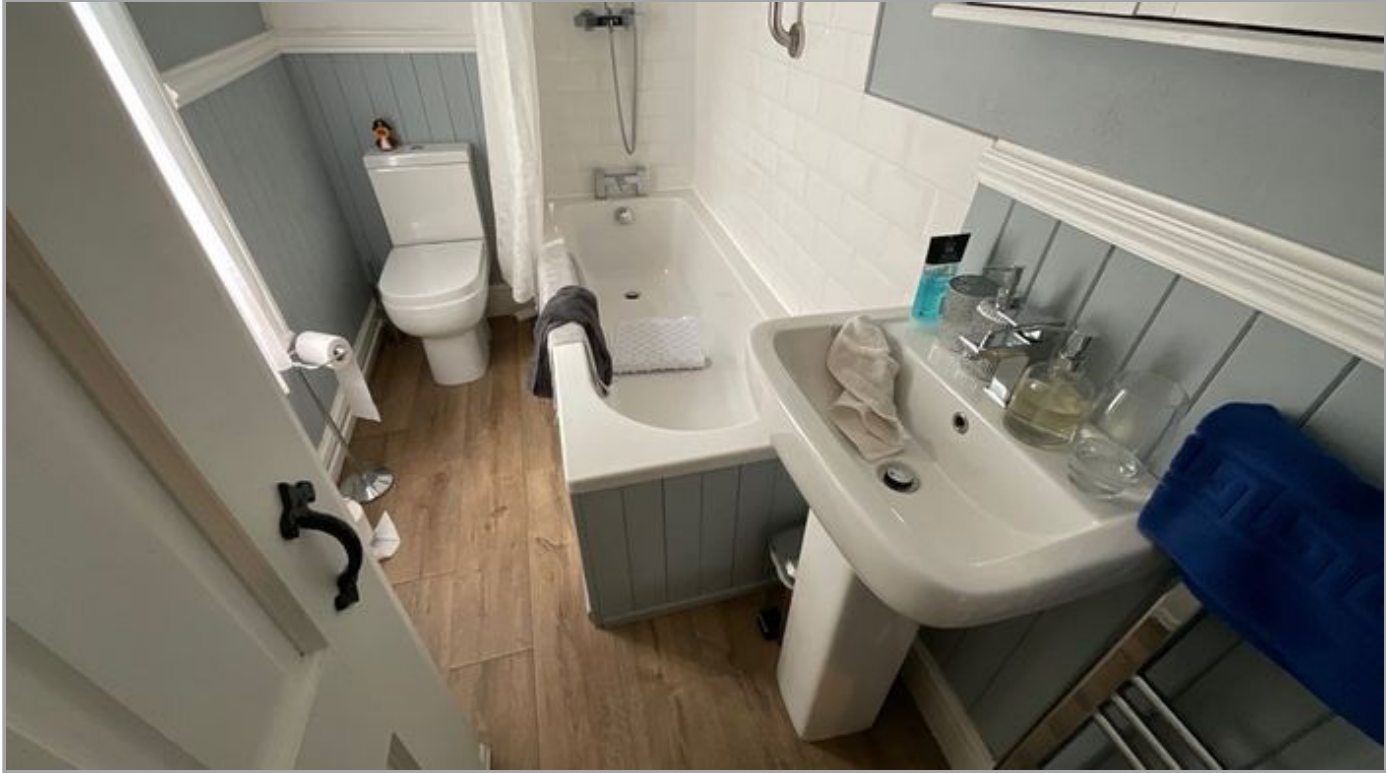
Wall Covered - See Limitations To Inspection

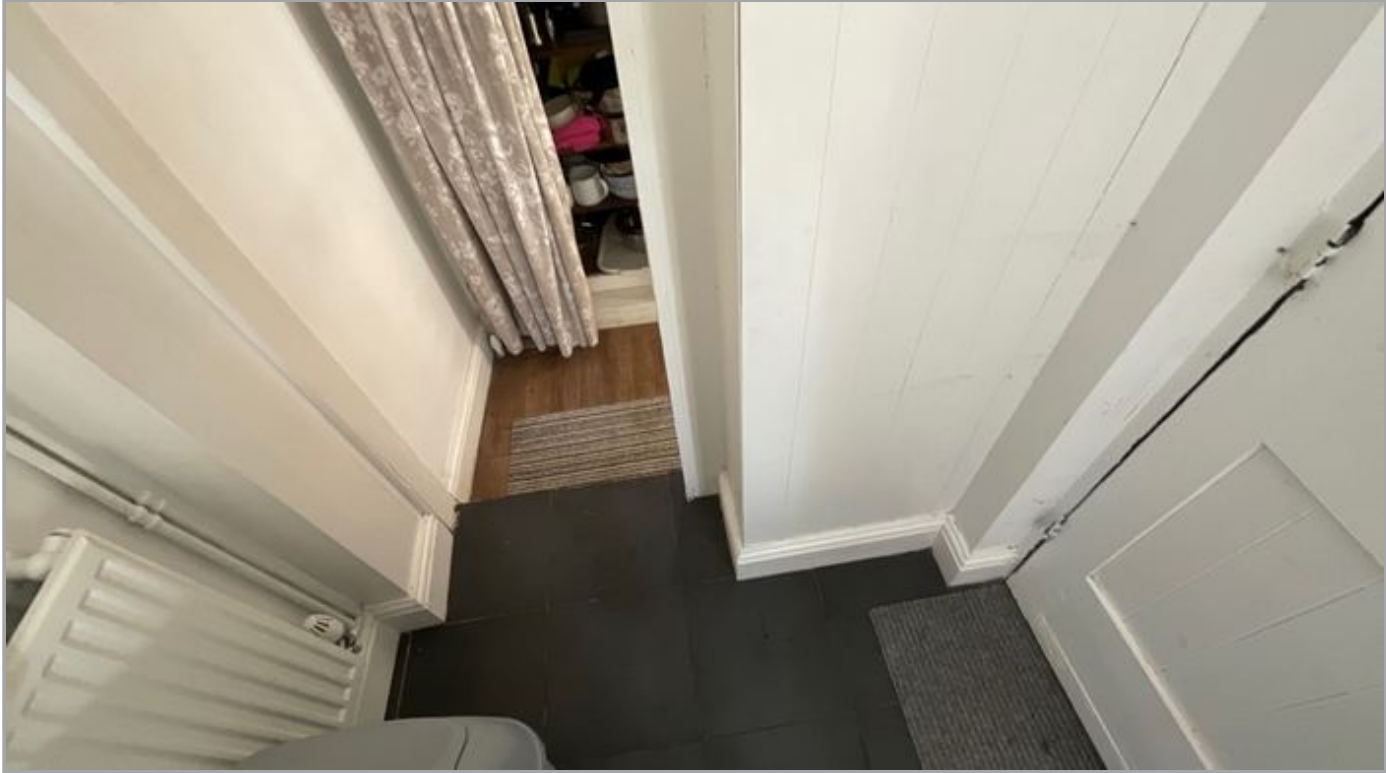
Wall Covered - See Limitations To Inspection

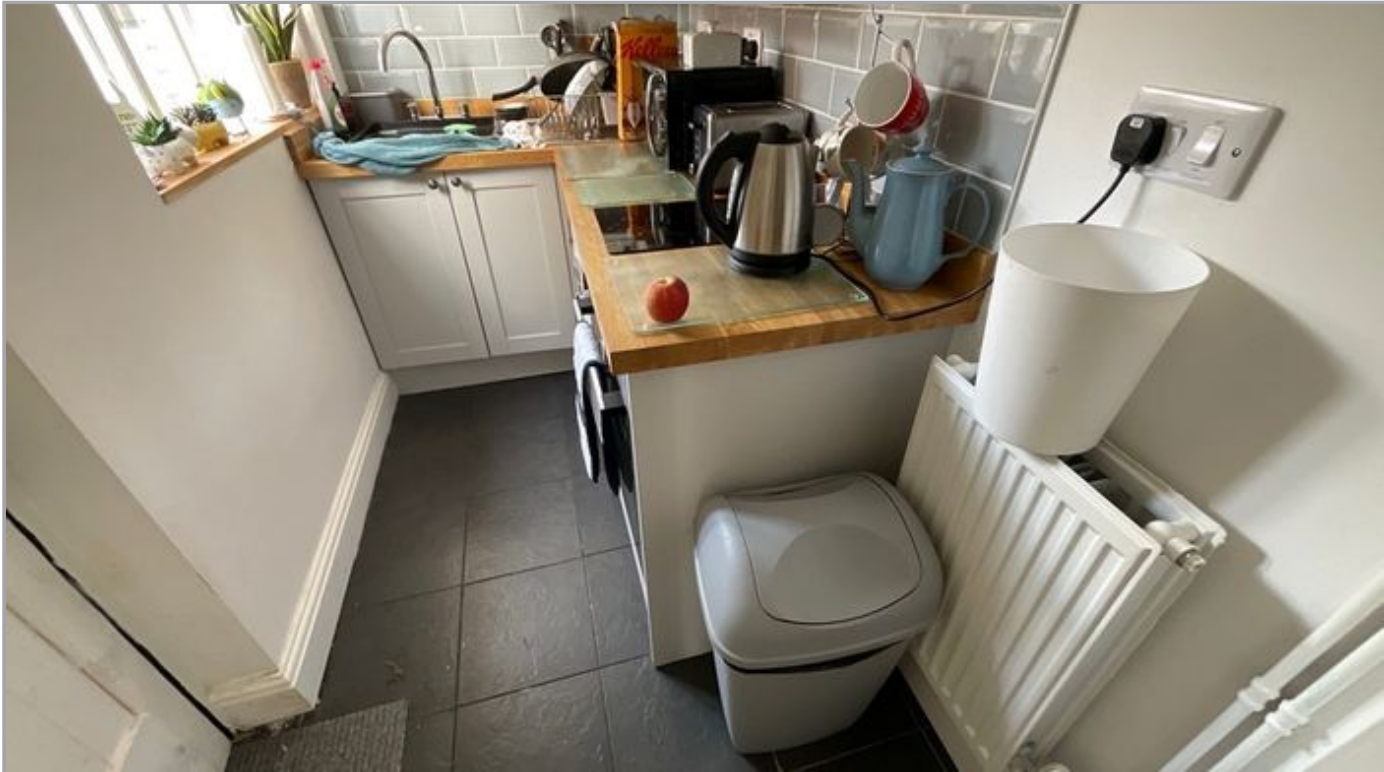
Wall Covered - See Limitations To Inspection

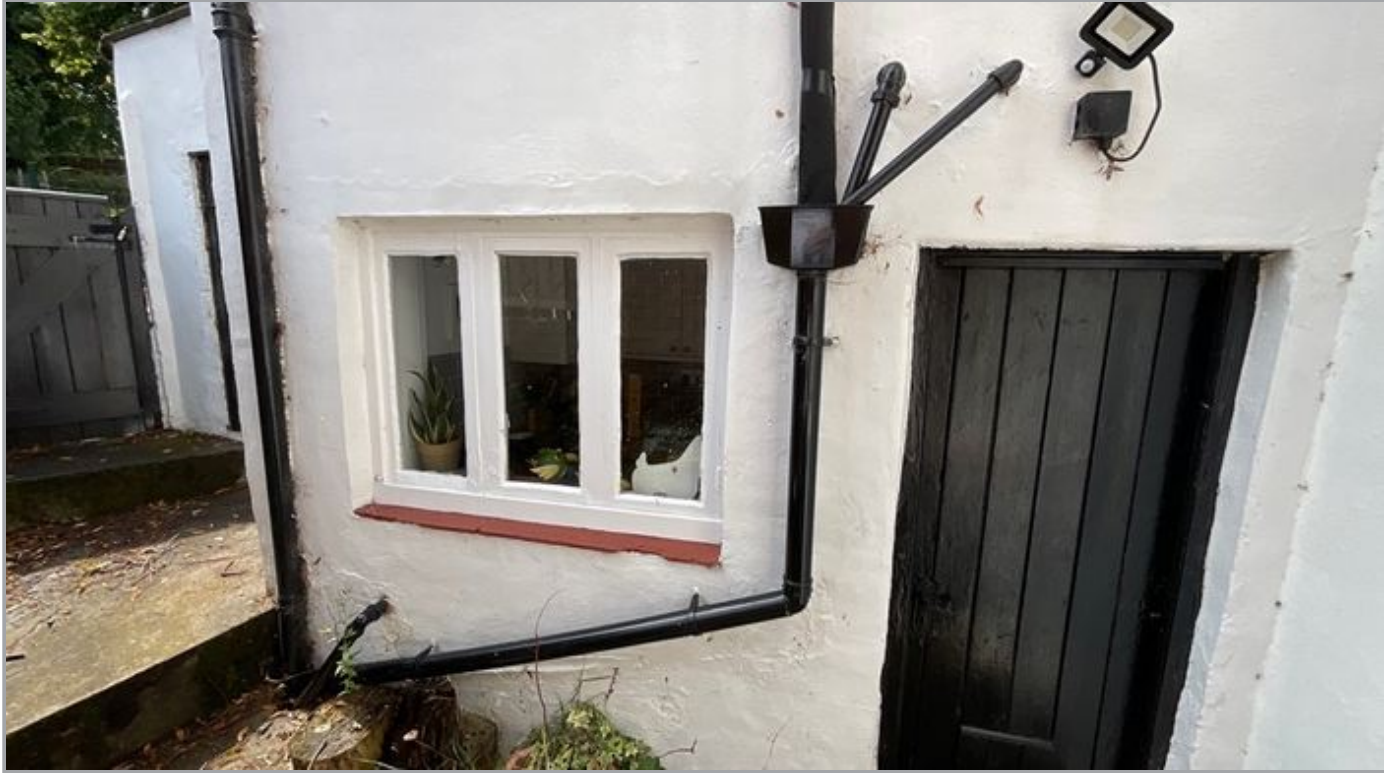
Misconnection/Overloading Drainage Pipework
