LEVEL 2

Your survey report

30 August 2023

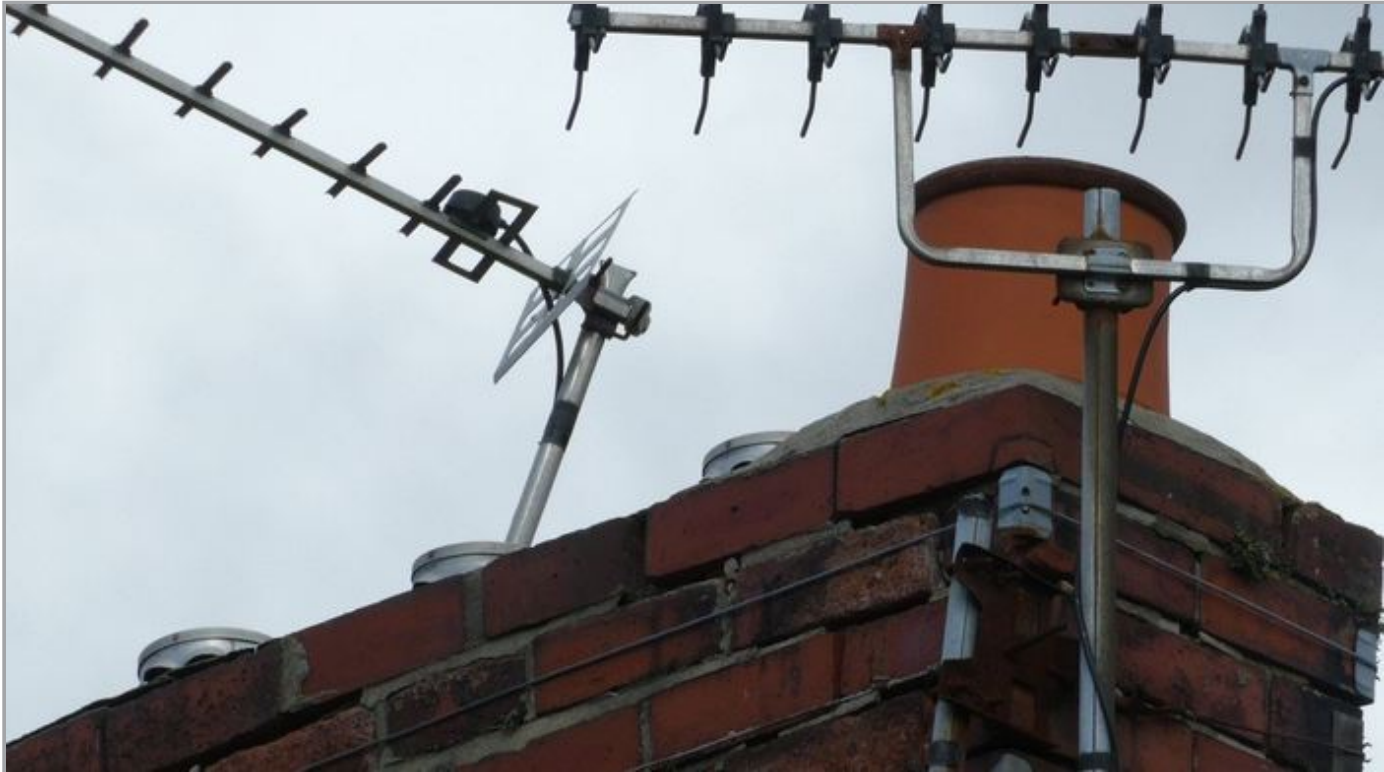
Open Pots

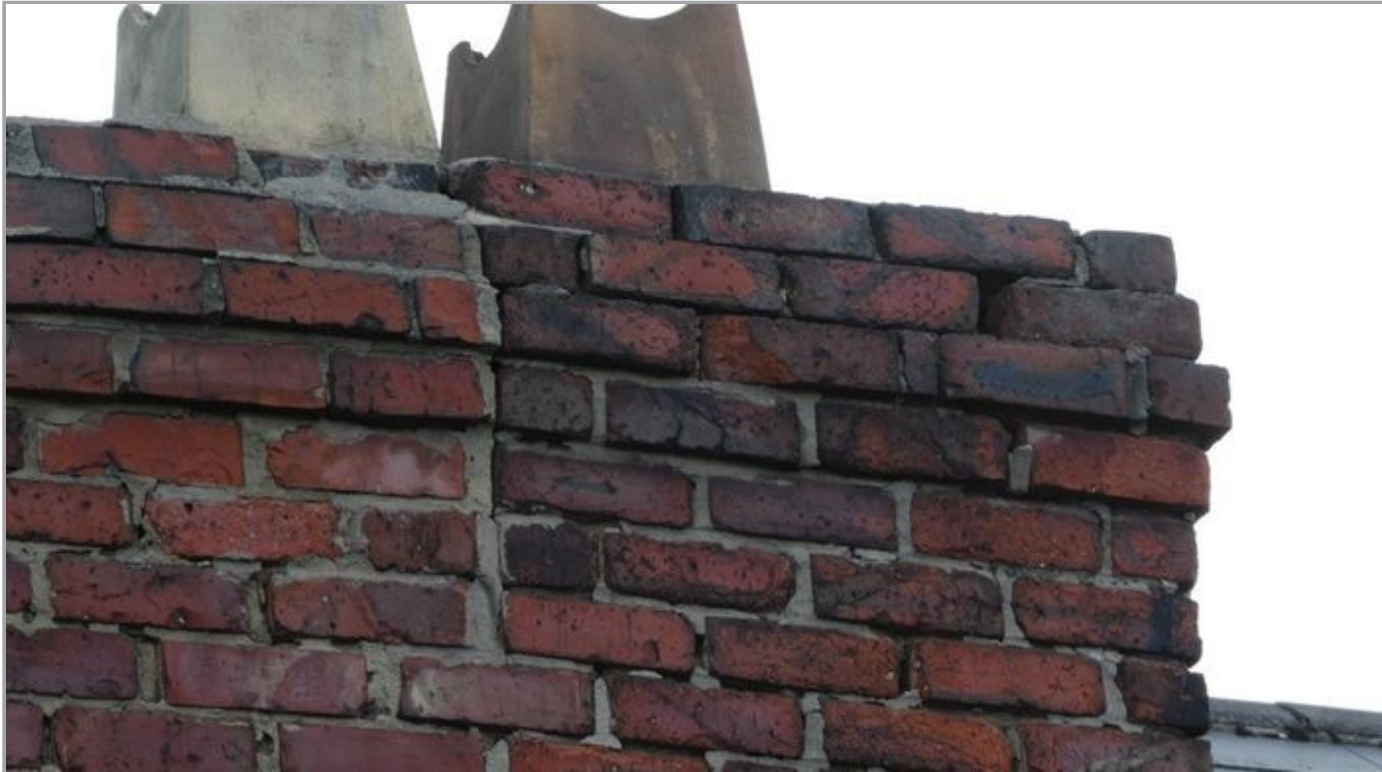
Eroding Pointing

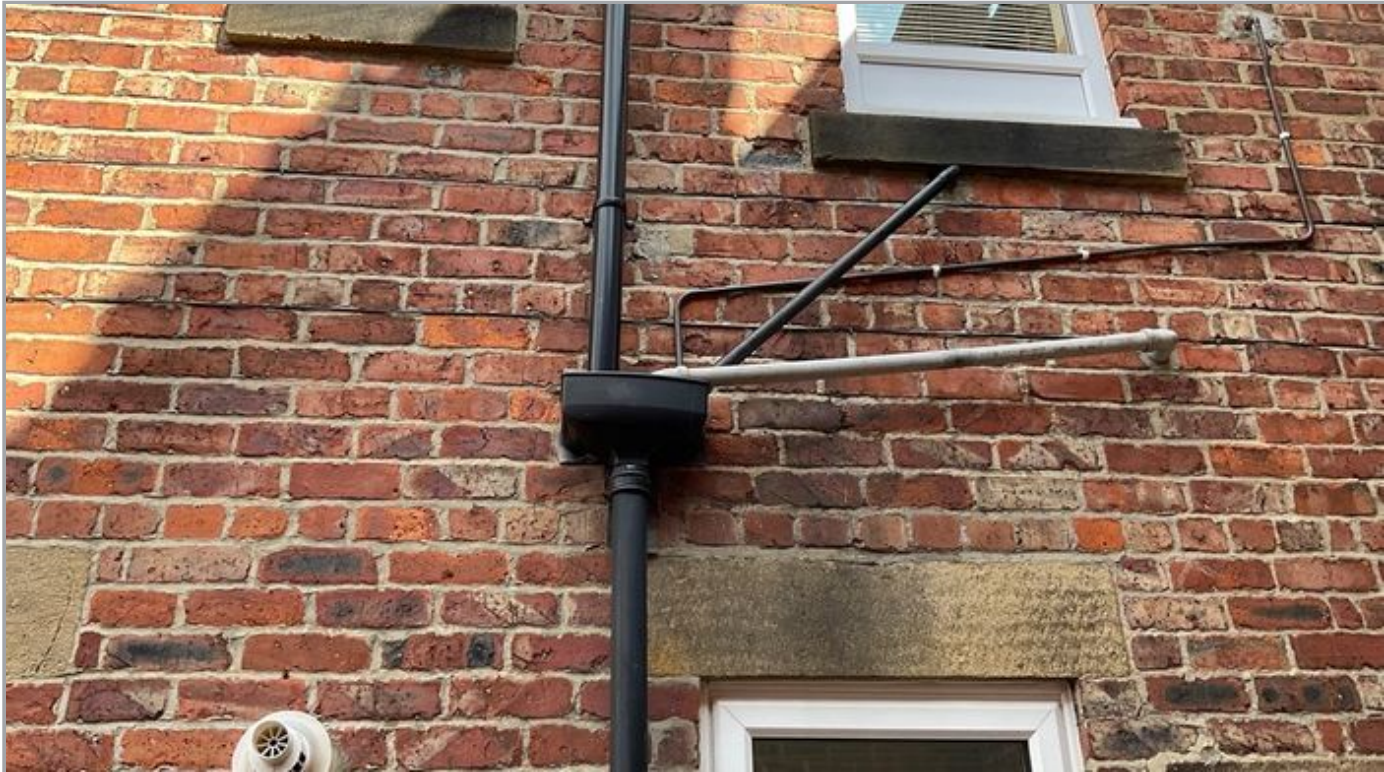
Hopper Head

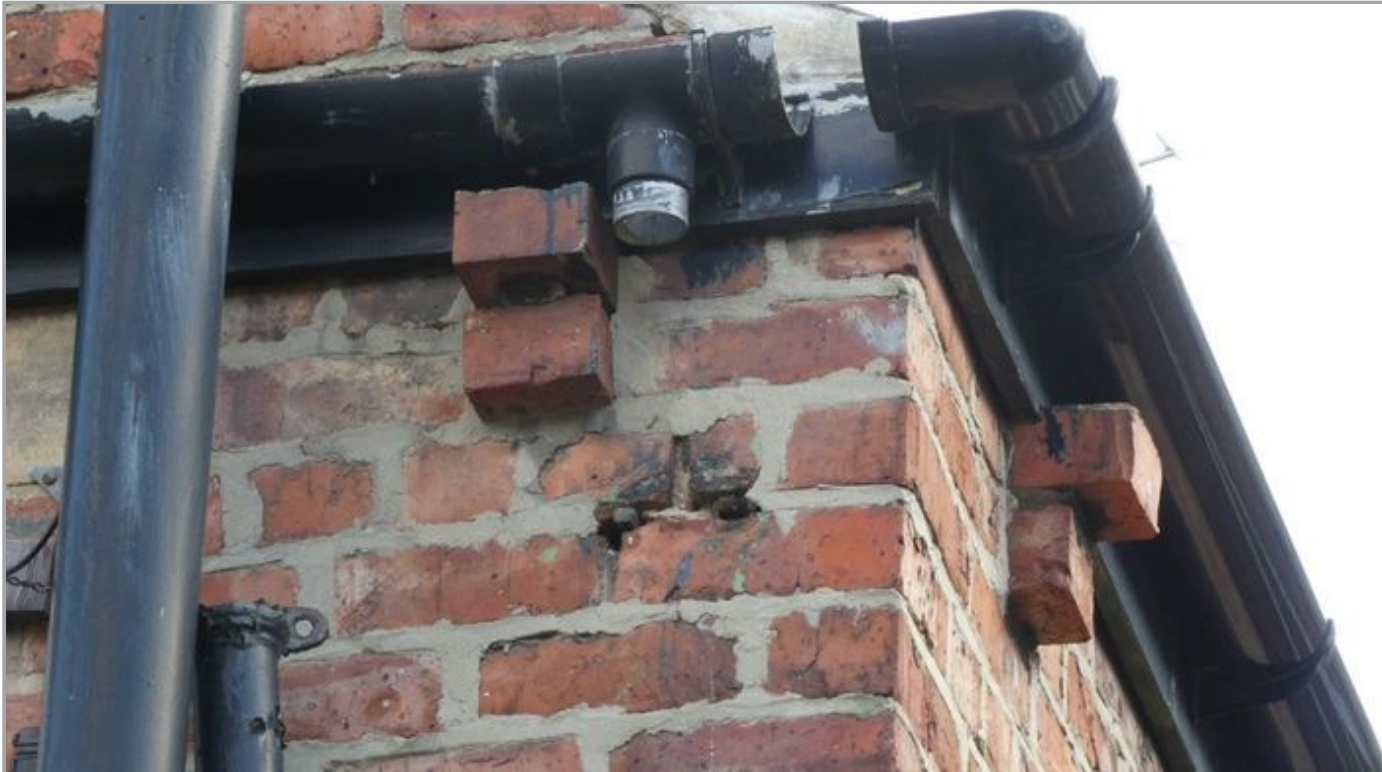
Disconnected Fittings

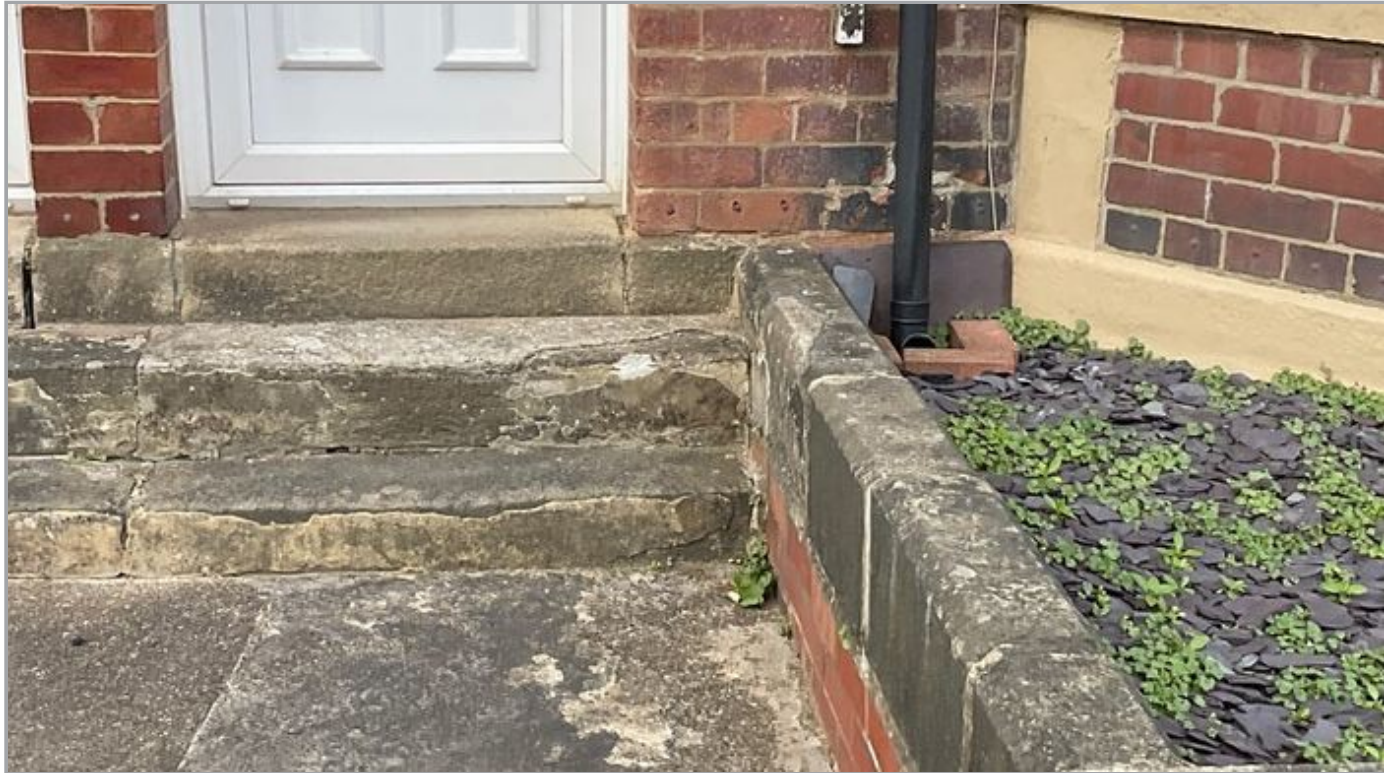
Chemical Damp-Proof Course

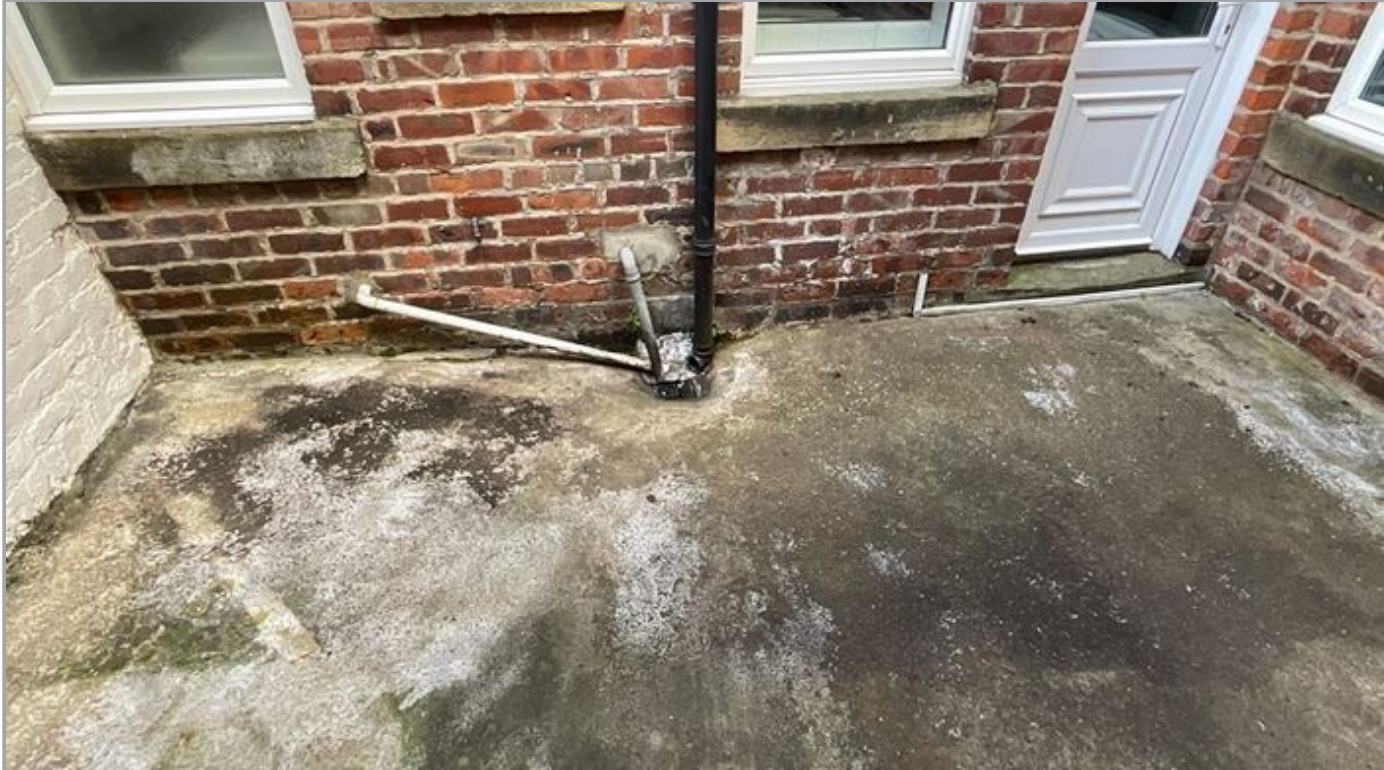
Bridging DPC

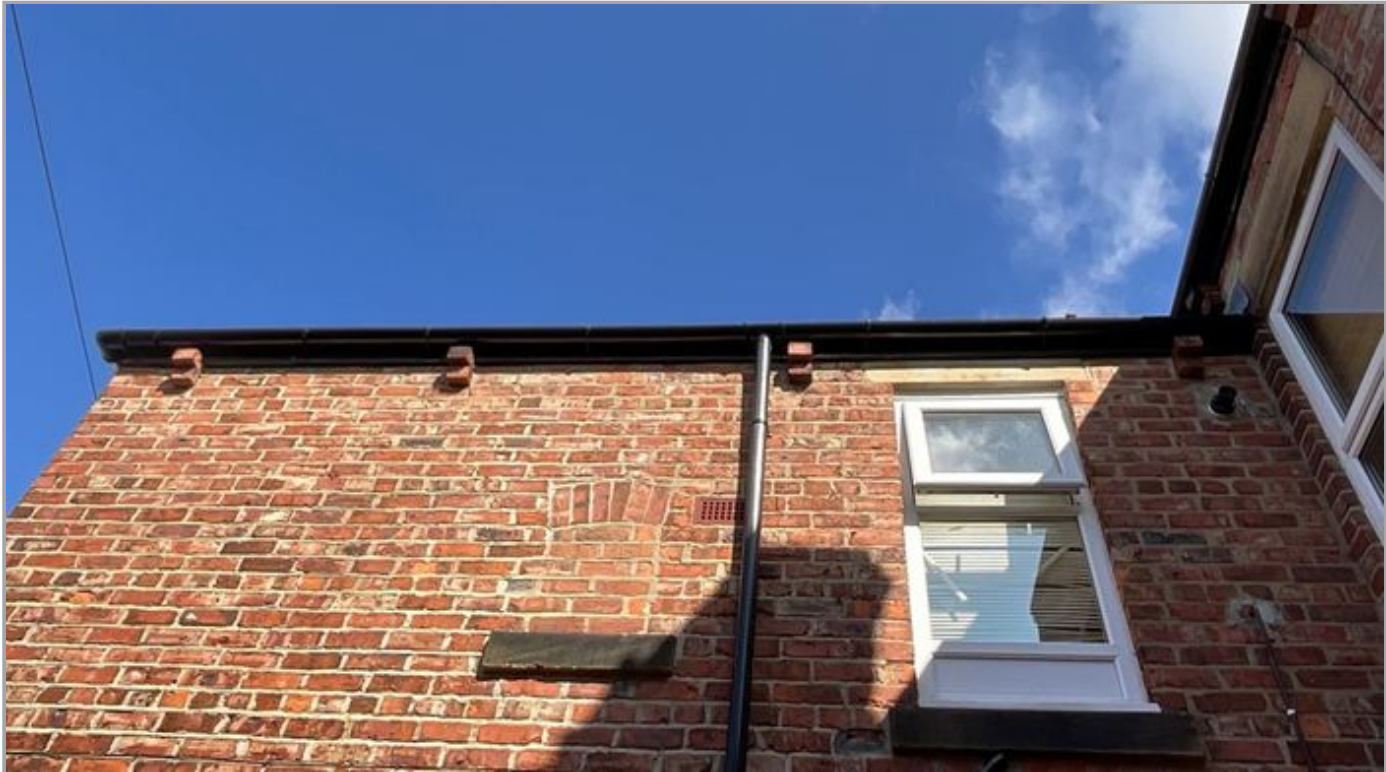
Weathered

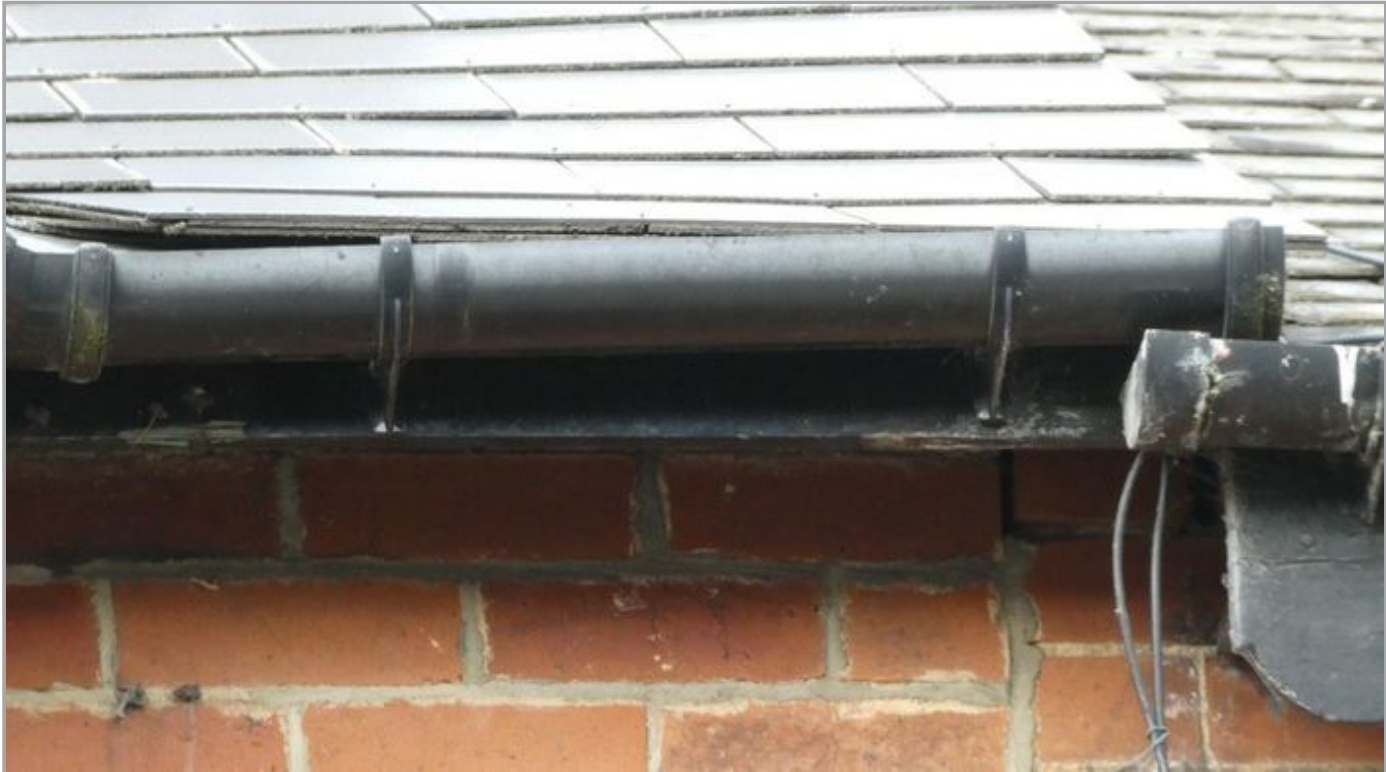
Weathered

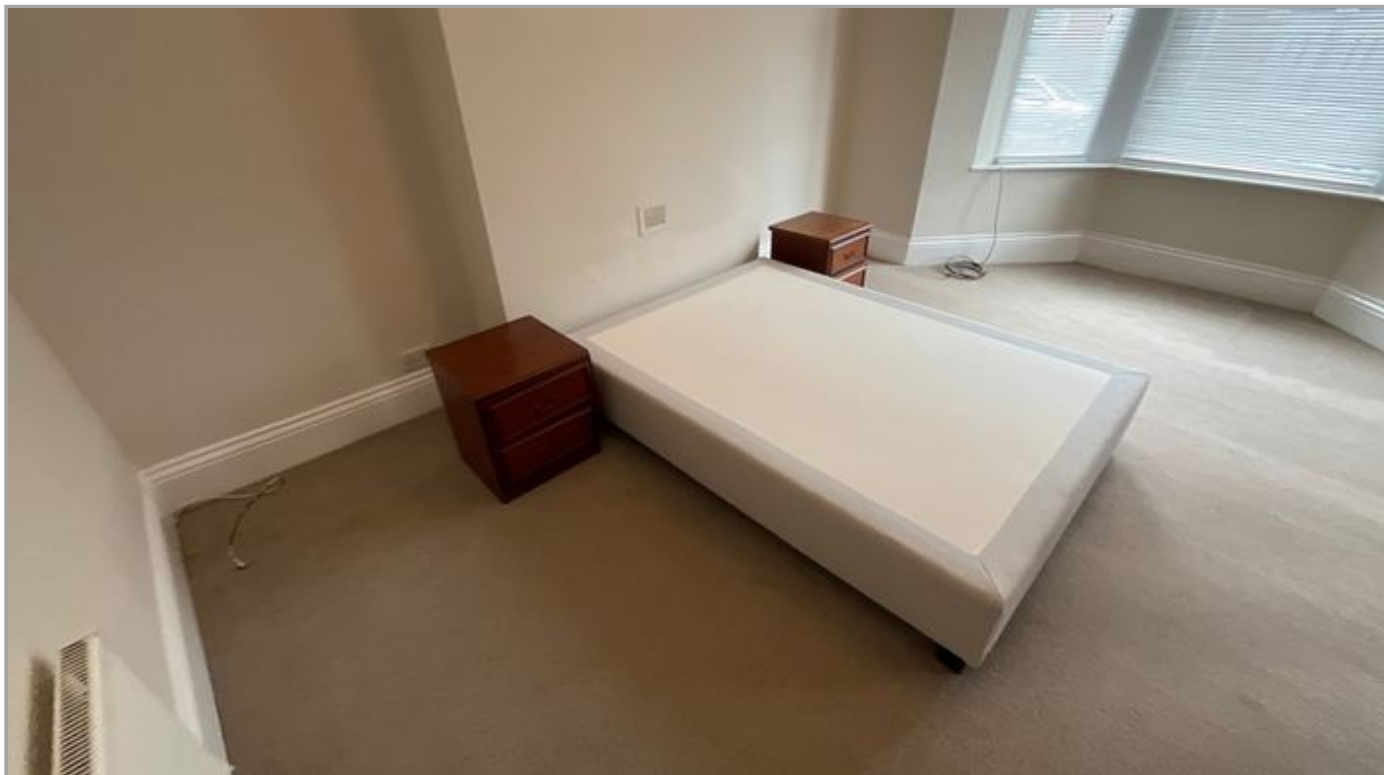
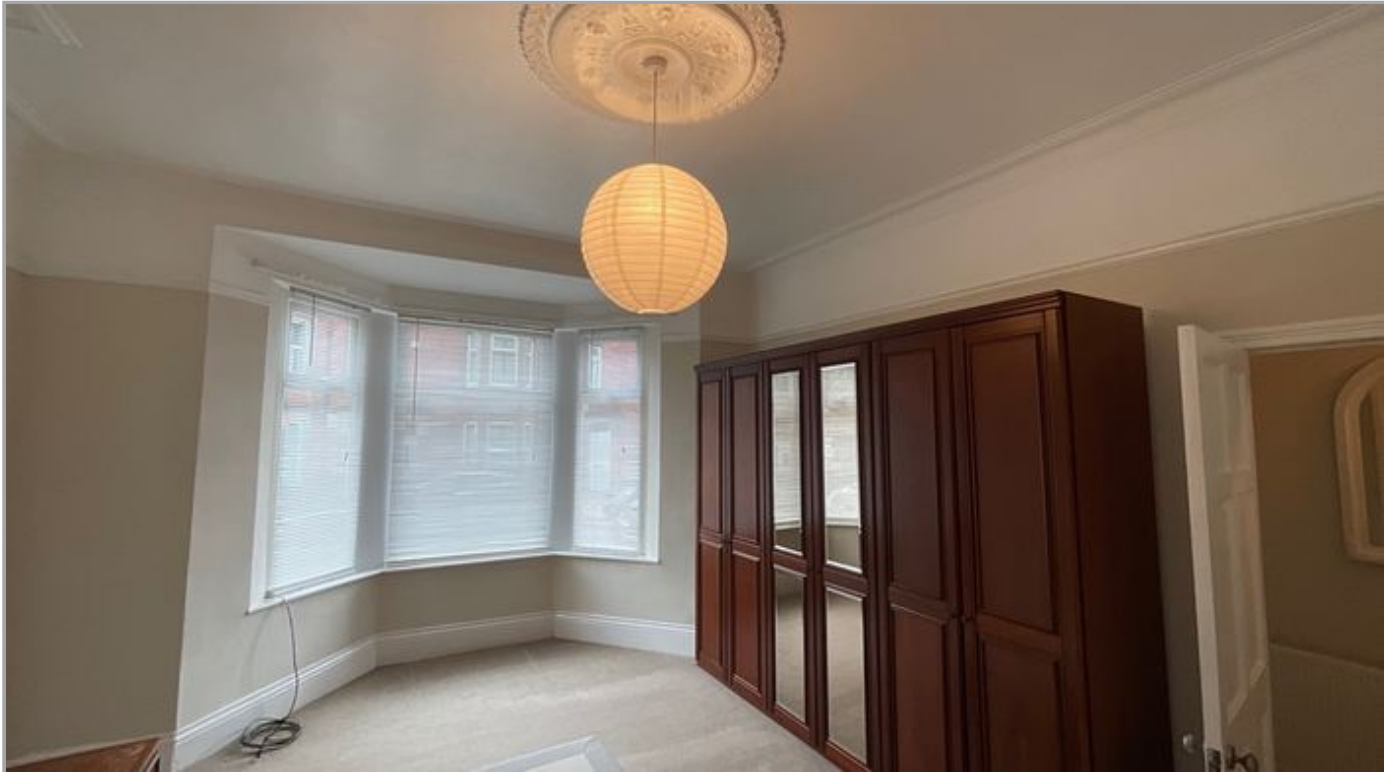
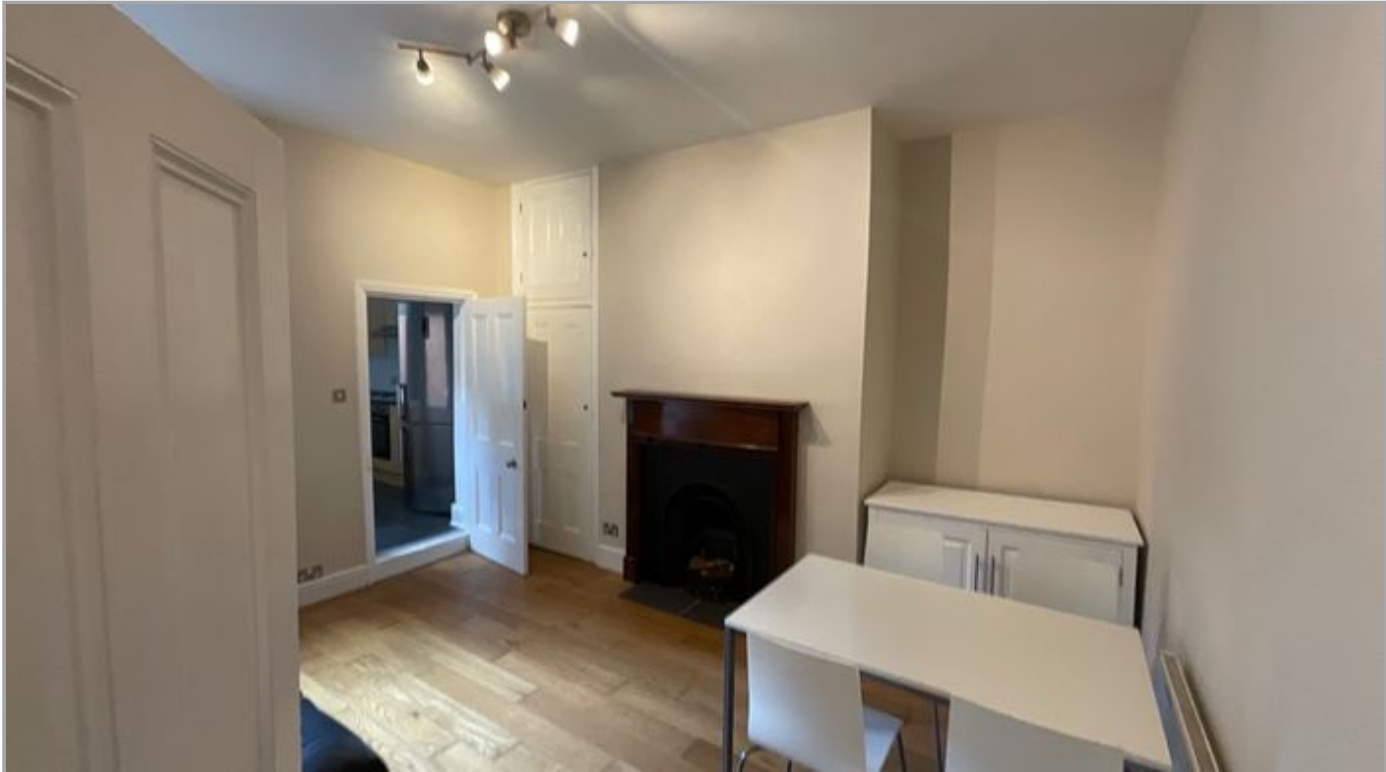
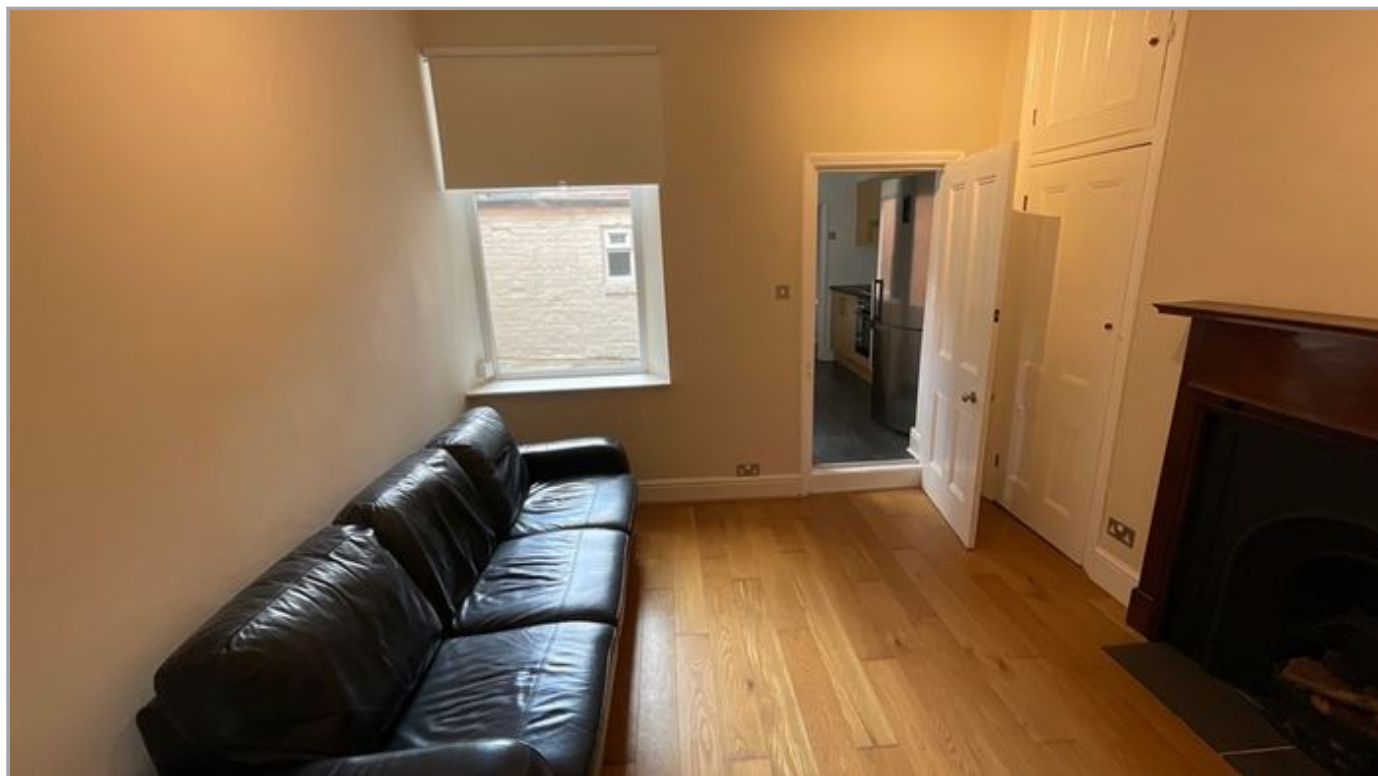
The stored items limited our inspection of the internal areas.

Therefore, where Condition Ratings have been allocated, these may well have been based on a limited inspection.

Restricted Inspection

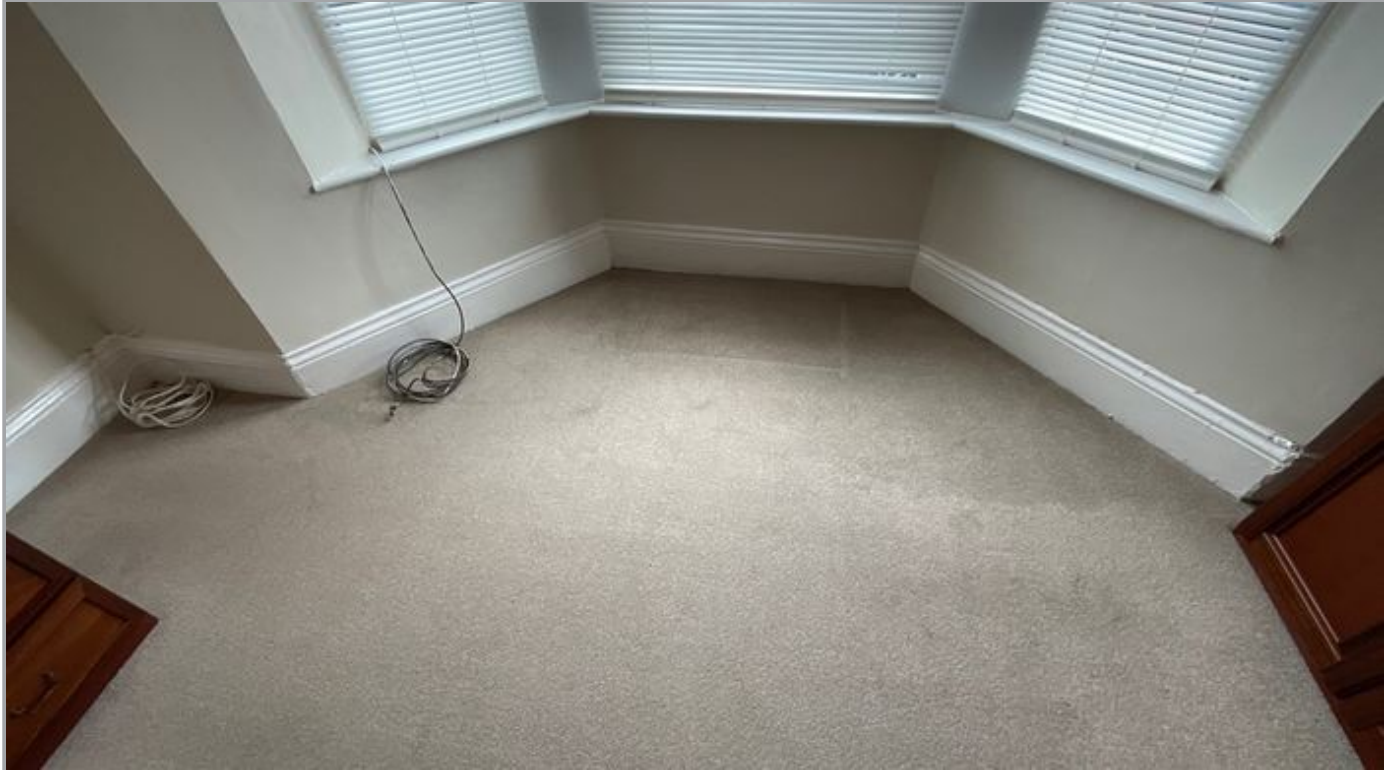
Significant Damp

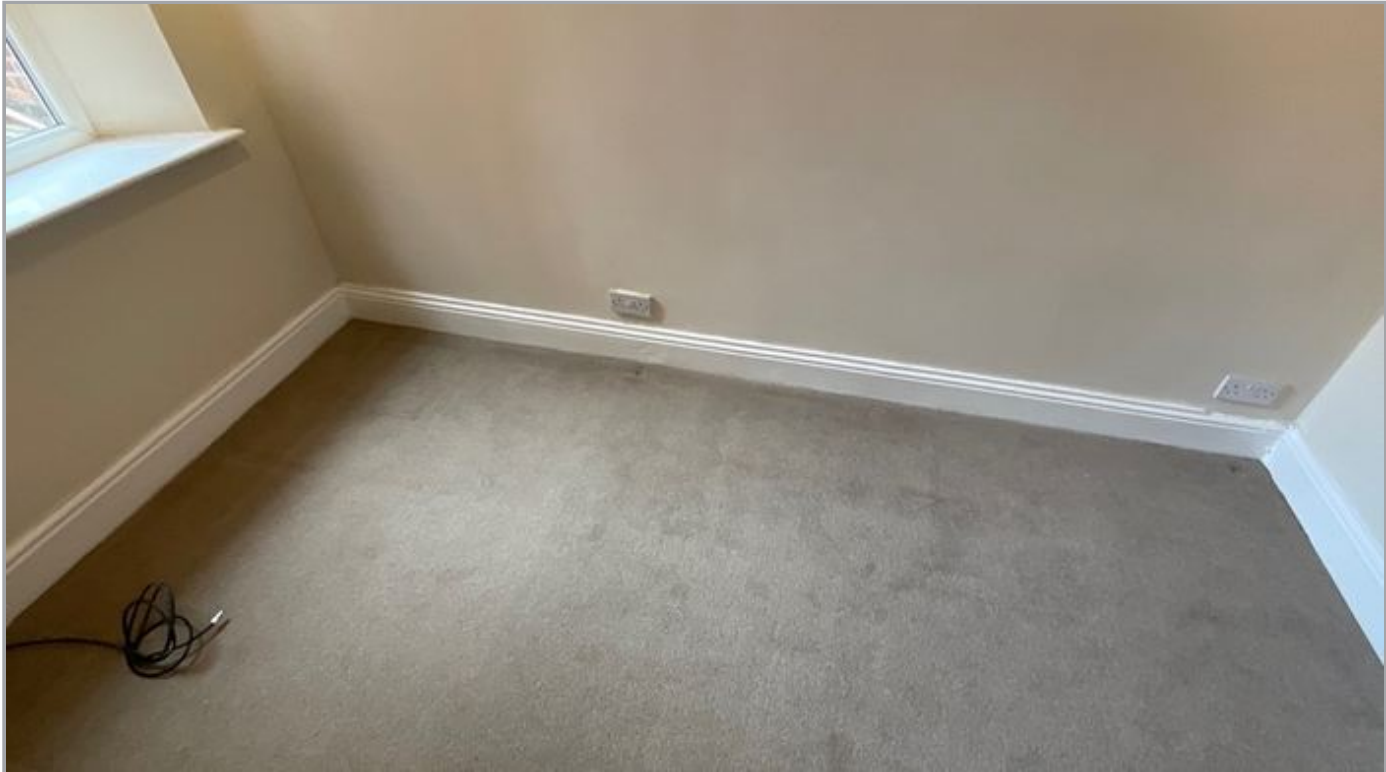
Significant Damp

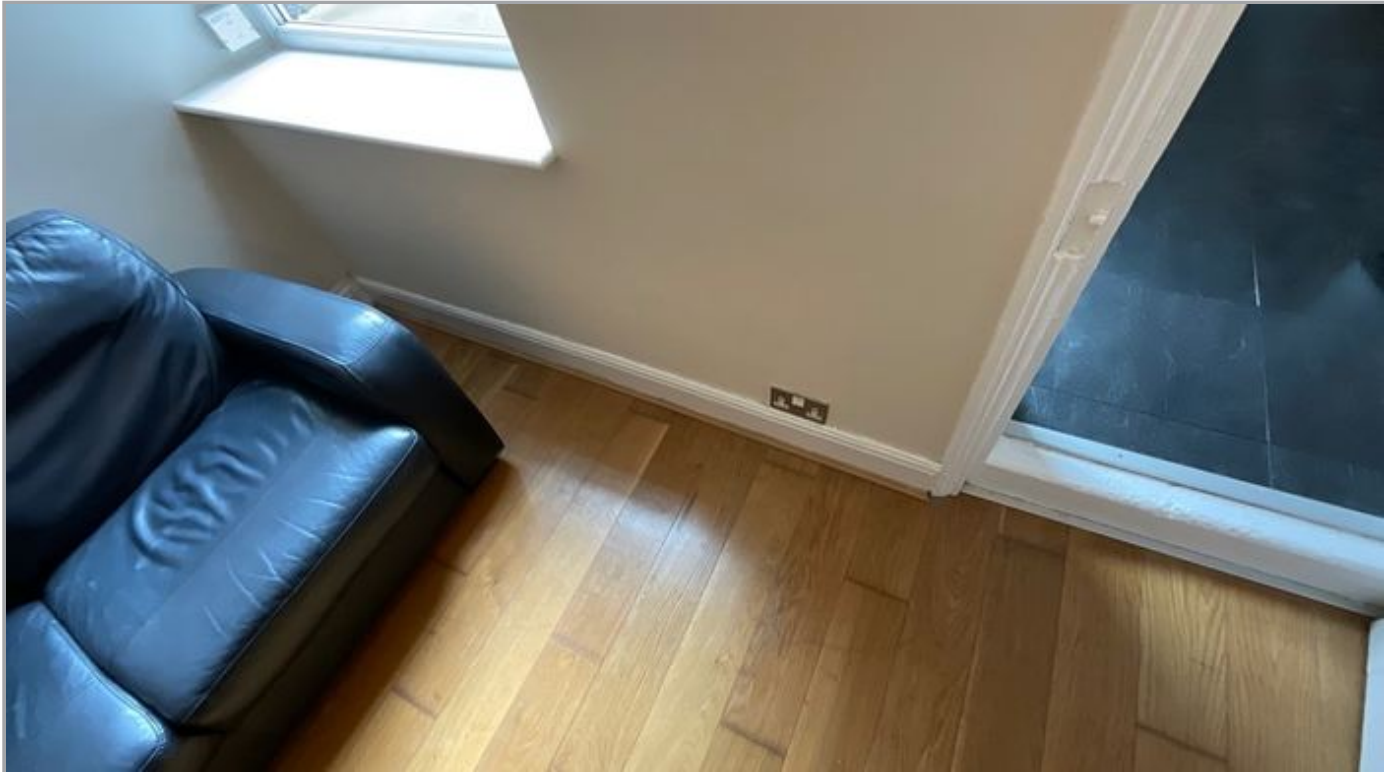
Significant Damp

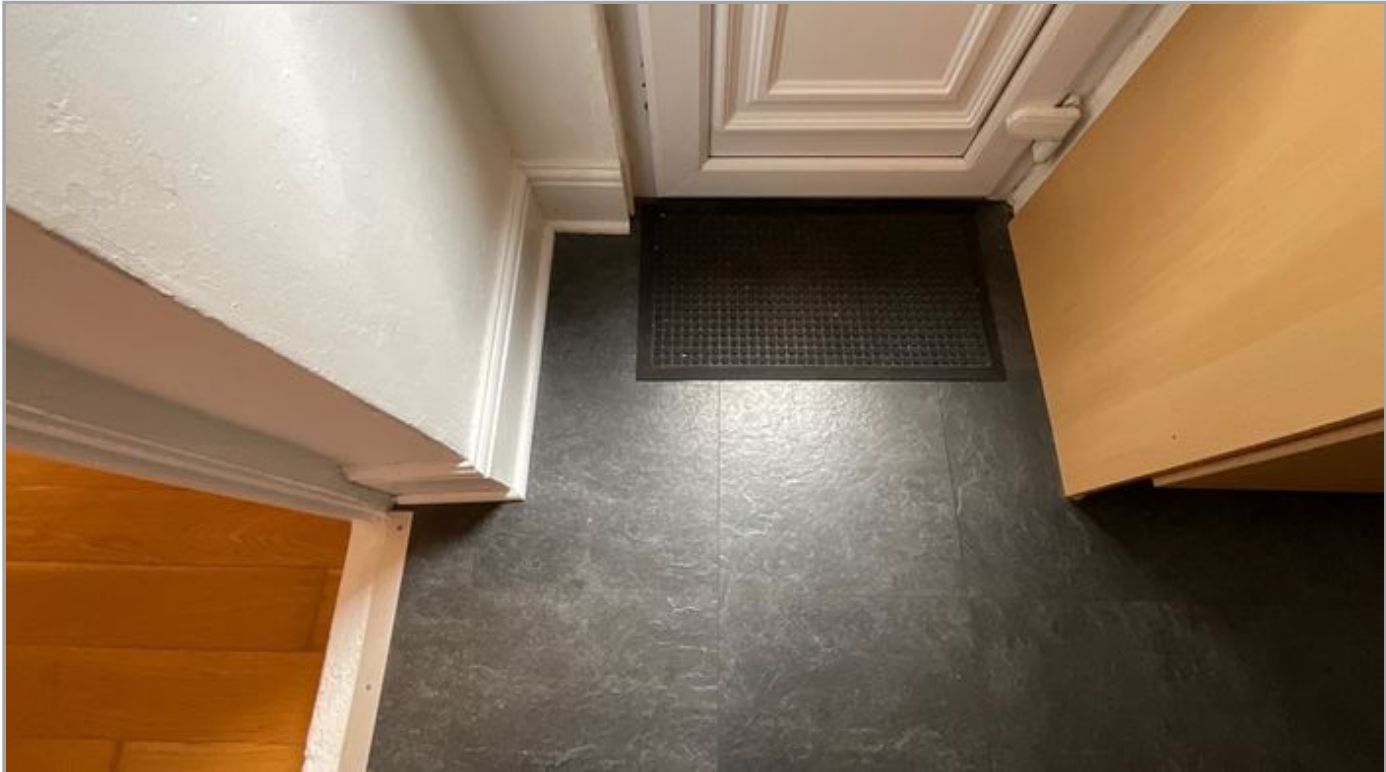
Significant Damp

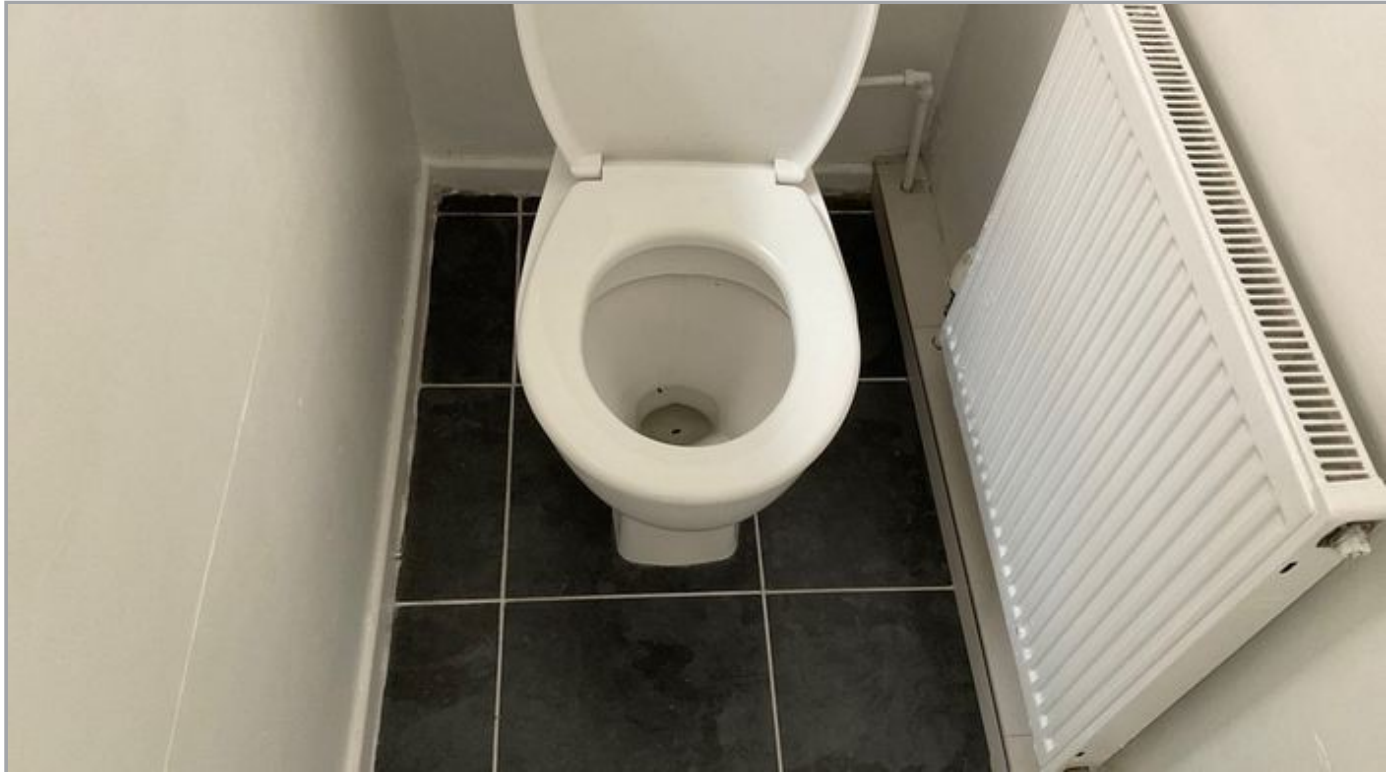
Significant Damp

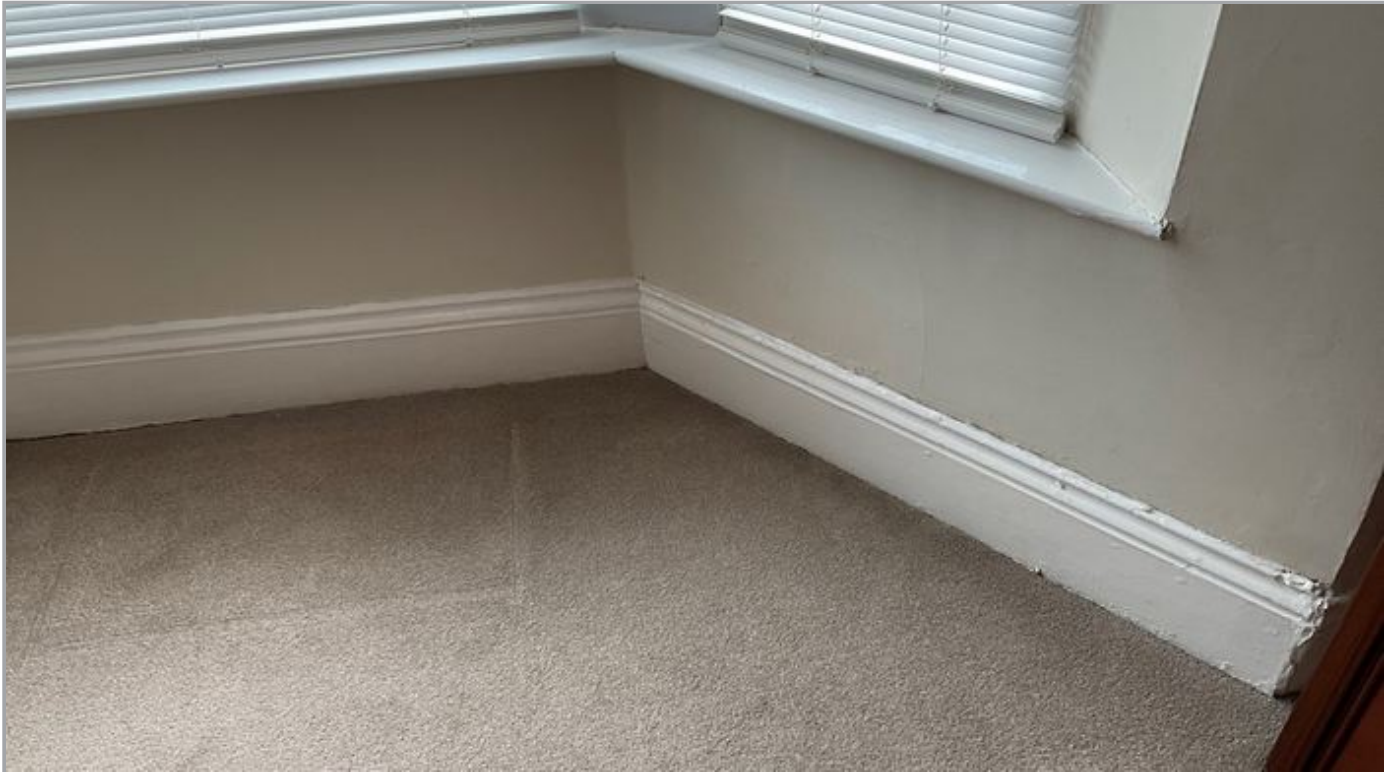
Springy Flooring Front Bedroom

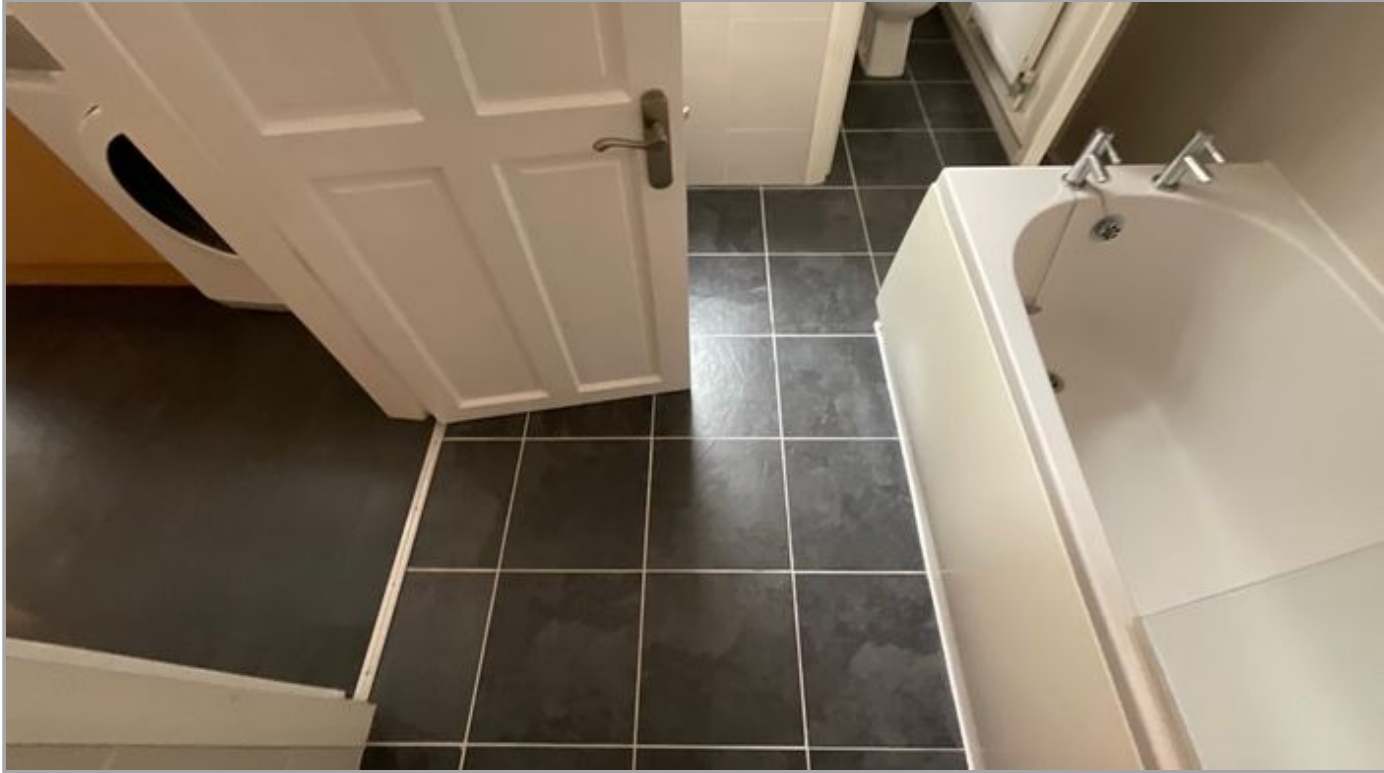
Deleterious Materials

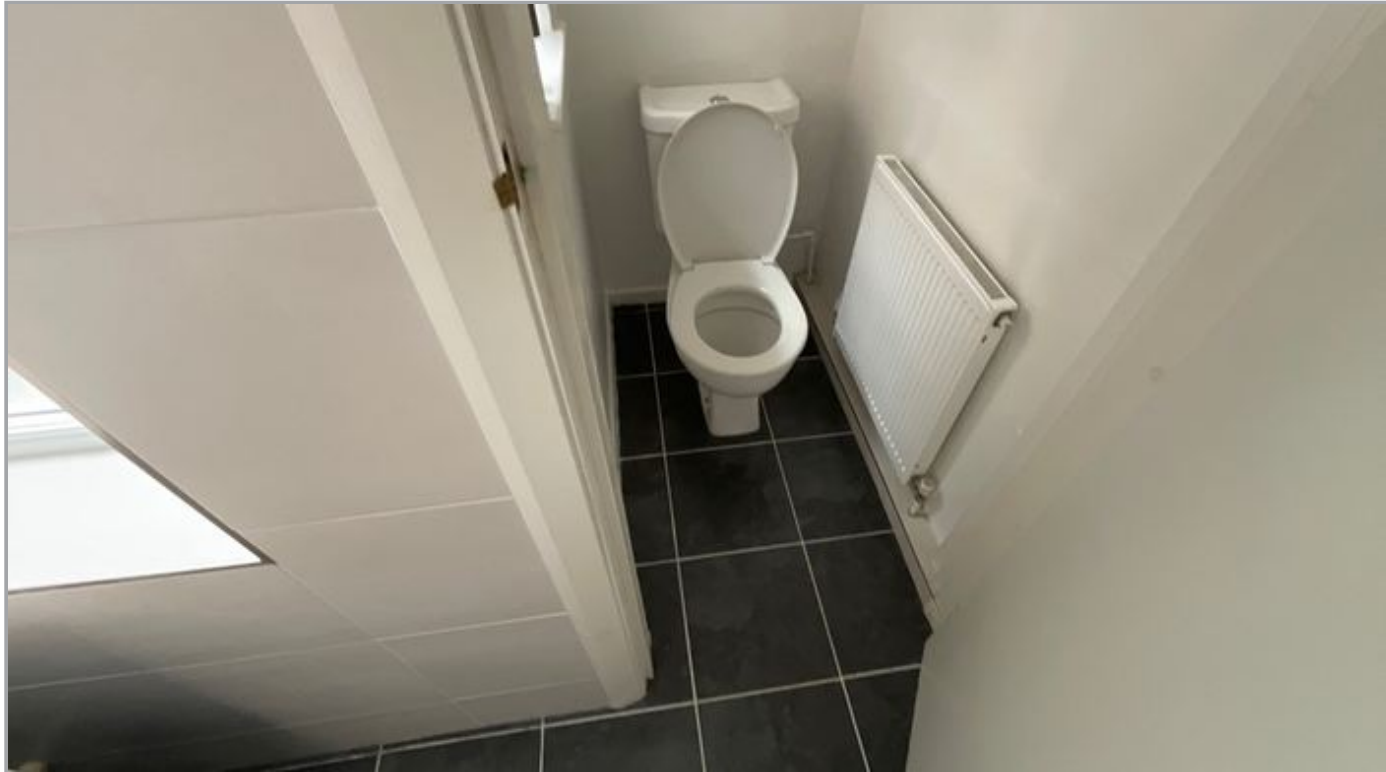
Deleterious Materials

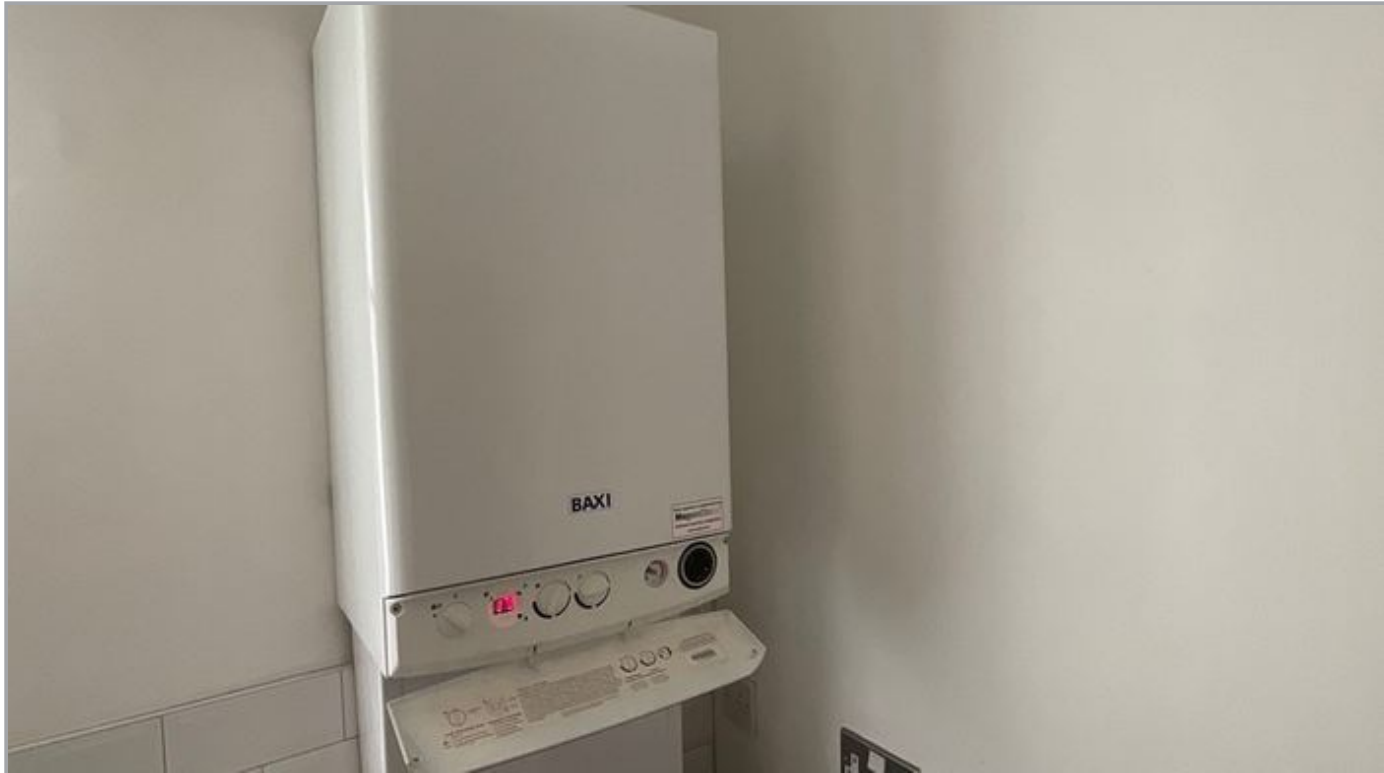
Gas Boiler

No obvious defects were seen but we have only carried out a visual inspection of the system and therefore cannot comment in detail on its working condition. This is a risk to the building and to persons, and we refer you to our comments in section I.

The boiler should have either Building Regulation approval or should have been fitted by a registered installer with the relevant competences. Your legal adviser should check that Local Authority approvals have been obtained or that a registered installer has been used for the work. We refer you to our comments in Section H. 3
