LEVEL 2

Your survey report

30 August 2023

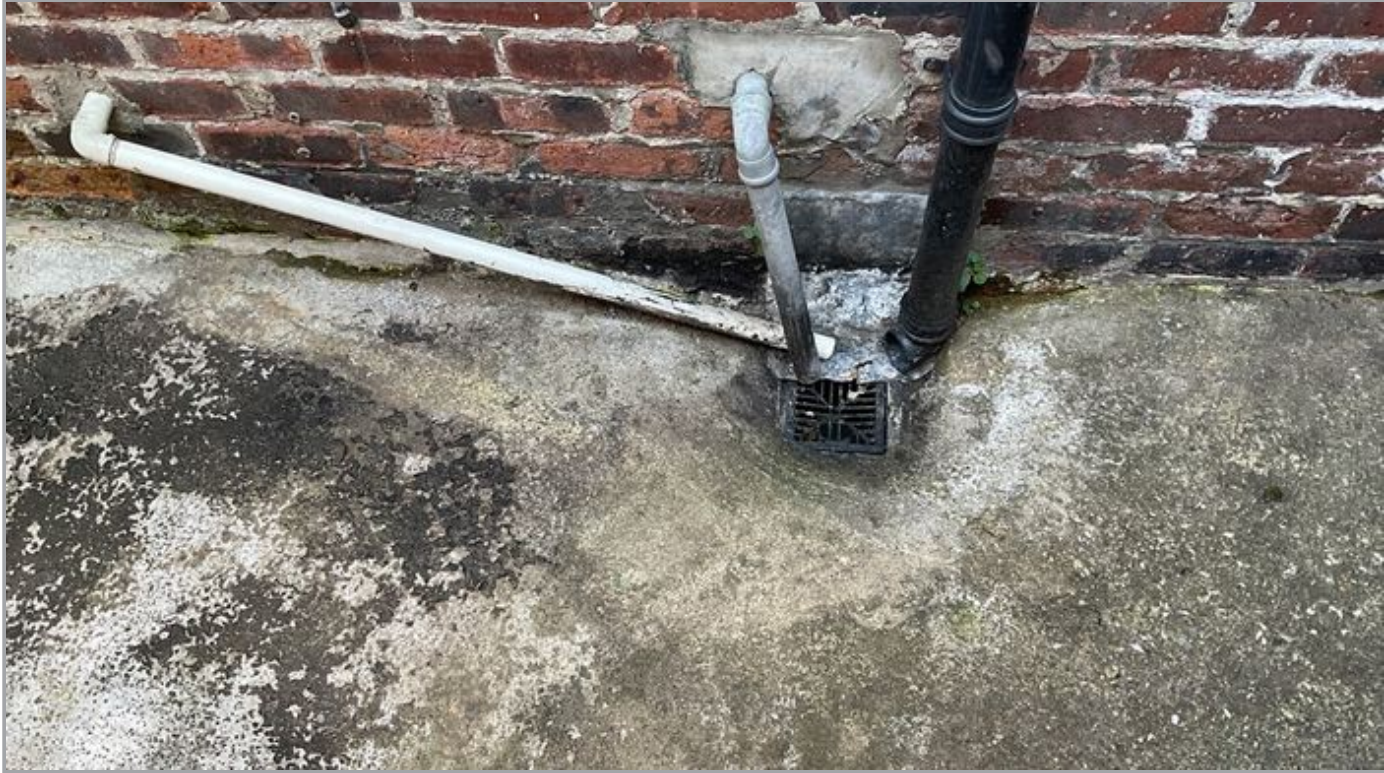
Open Gully

Where access could be obtained, the above ground surface water system was found to be clear and free from any serious blockage. However, we cannot comment on serviceability as most of the drainage system is hidden from view.
