LEVEL 2

Your survey report

Inspection date

21 July 2023

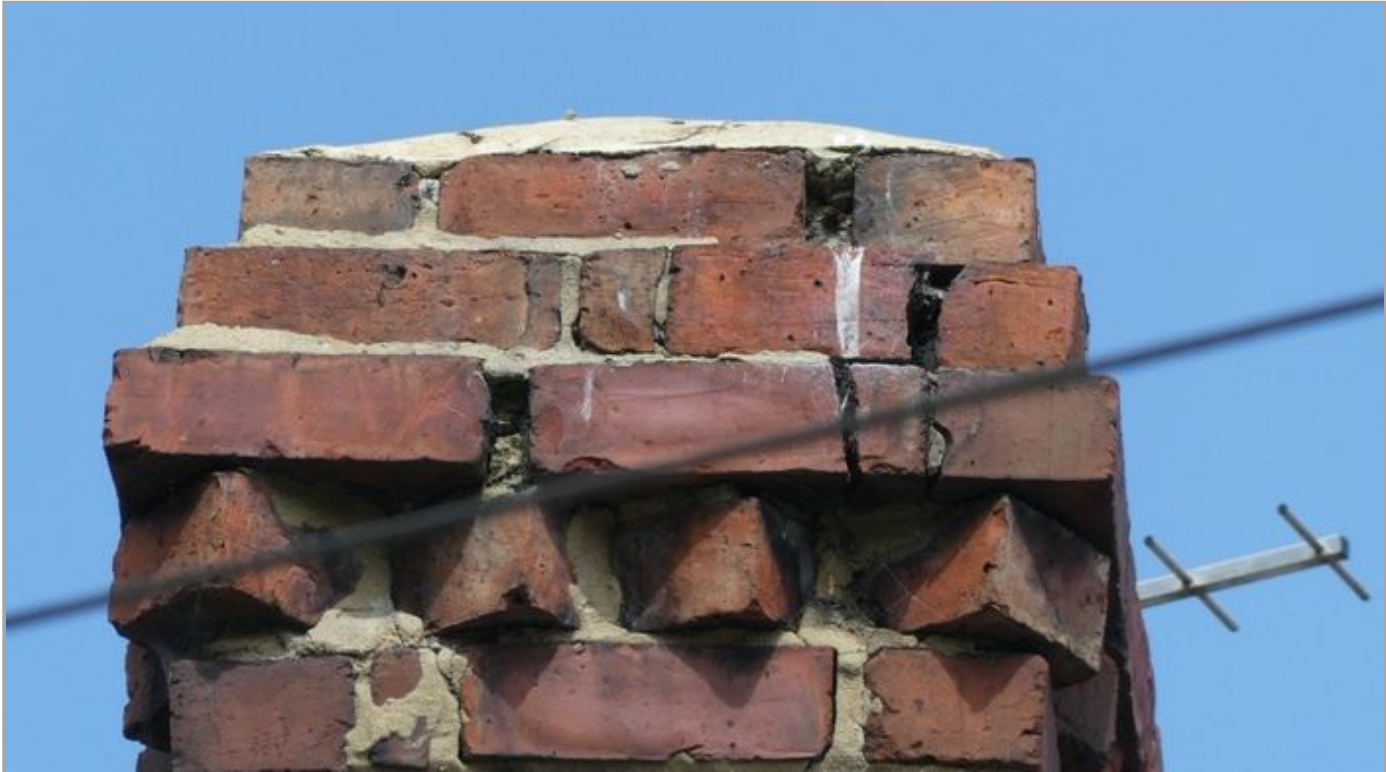
Eroding Pointing

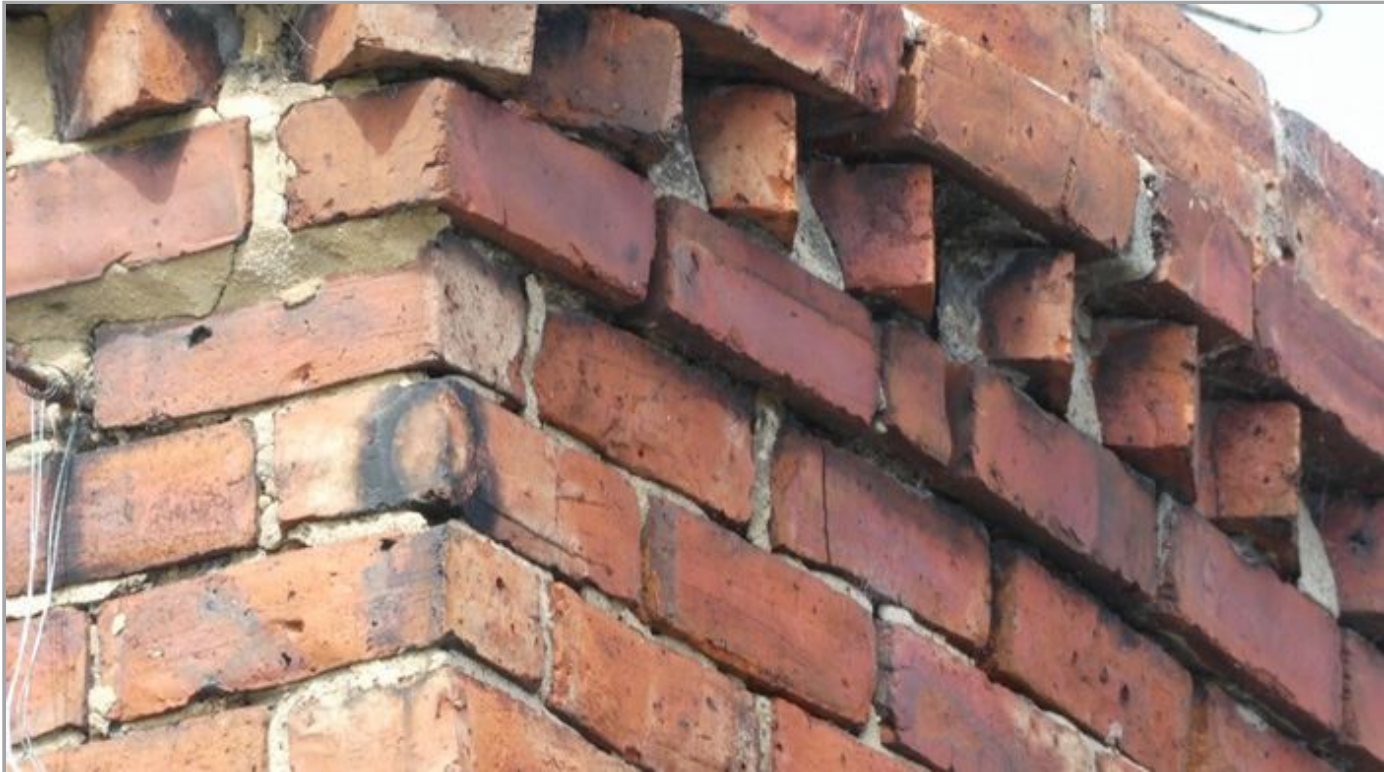
Eroding Pointing

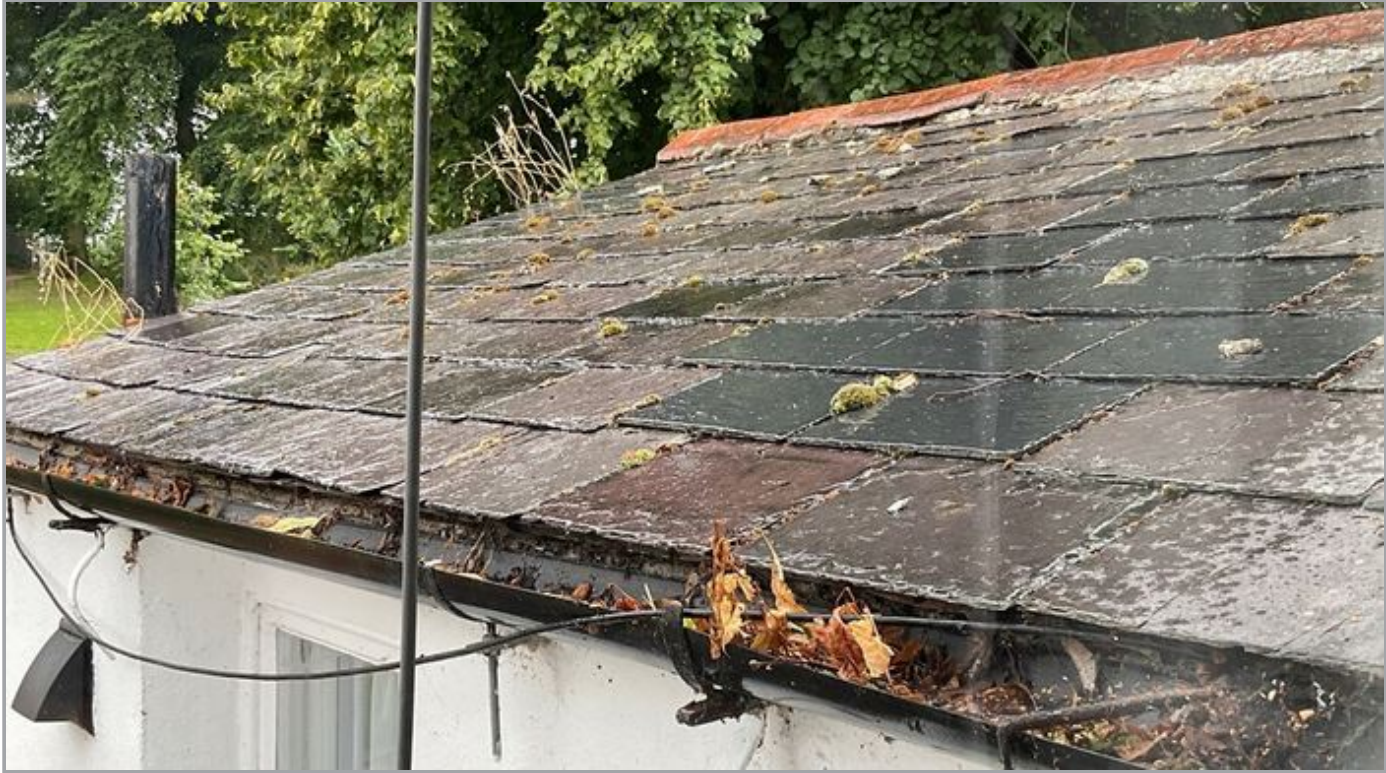
Moss/Algae

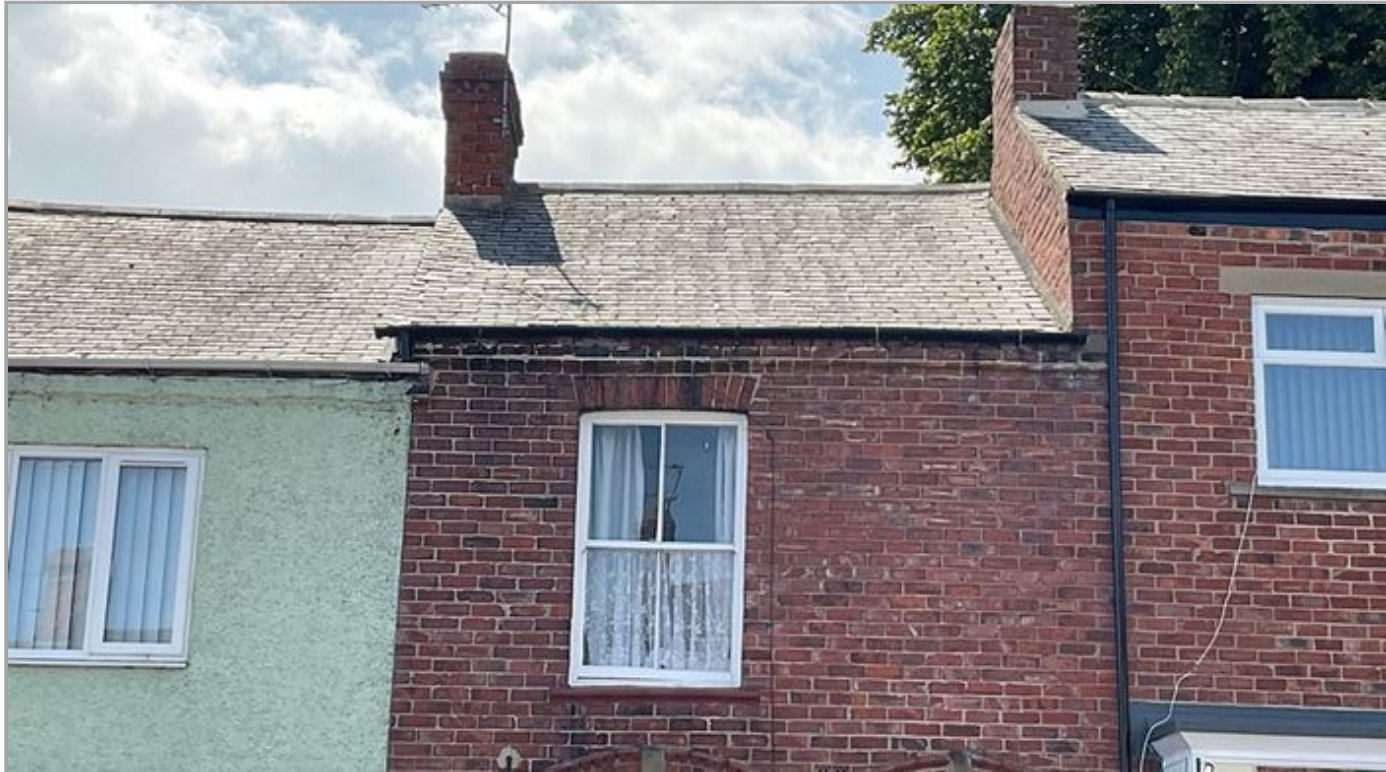
Misaligned Guttering

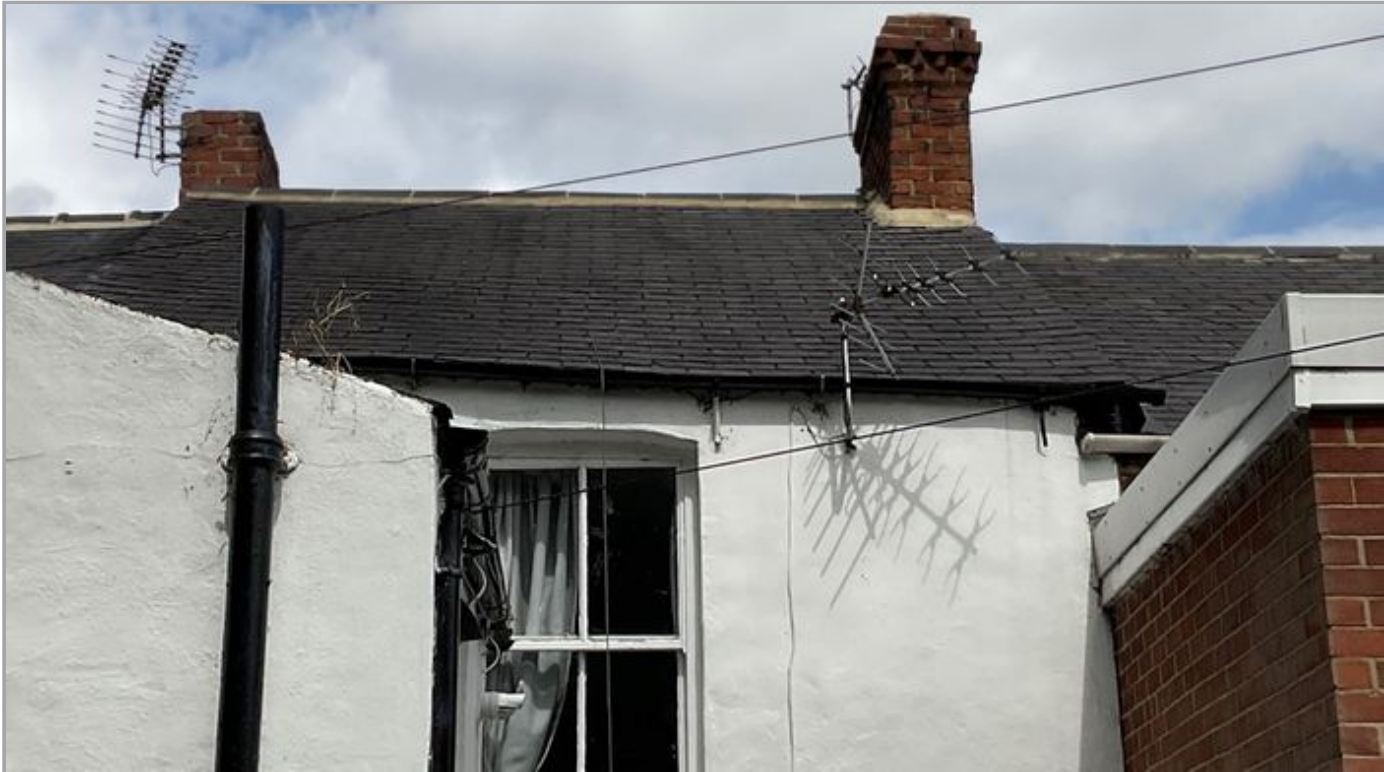
Shared Fittings

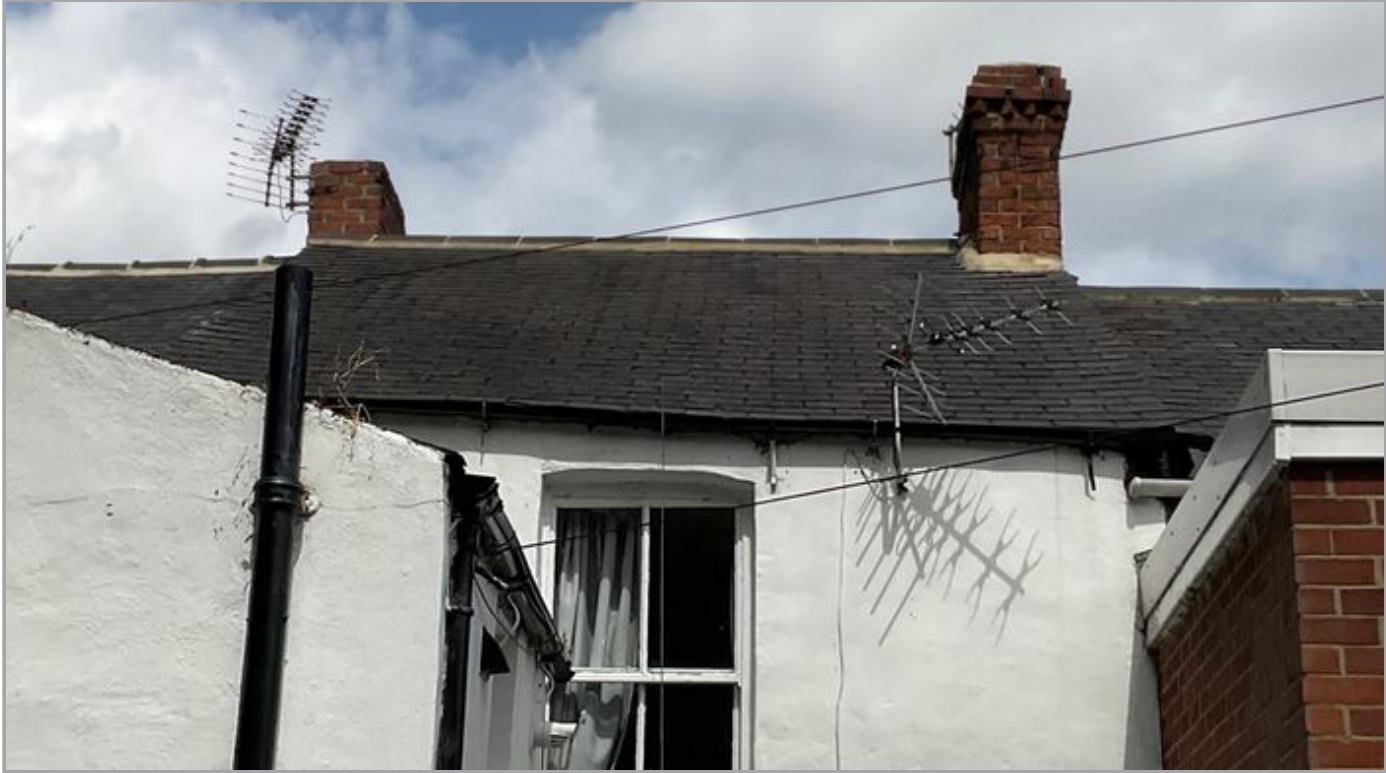
Misaligned Guttering

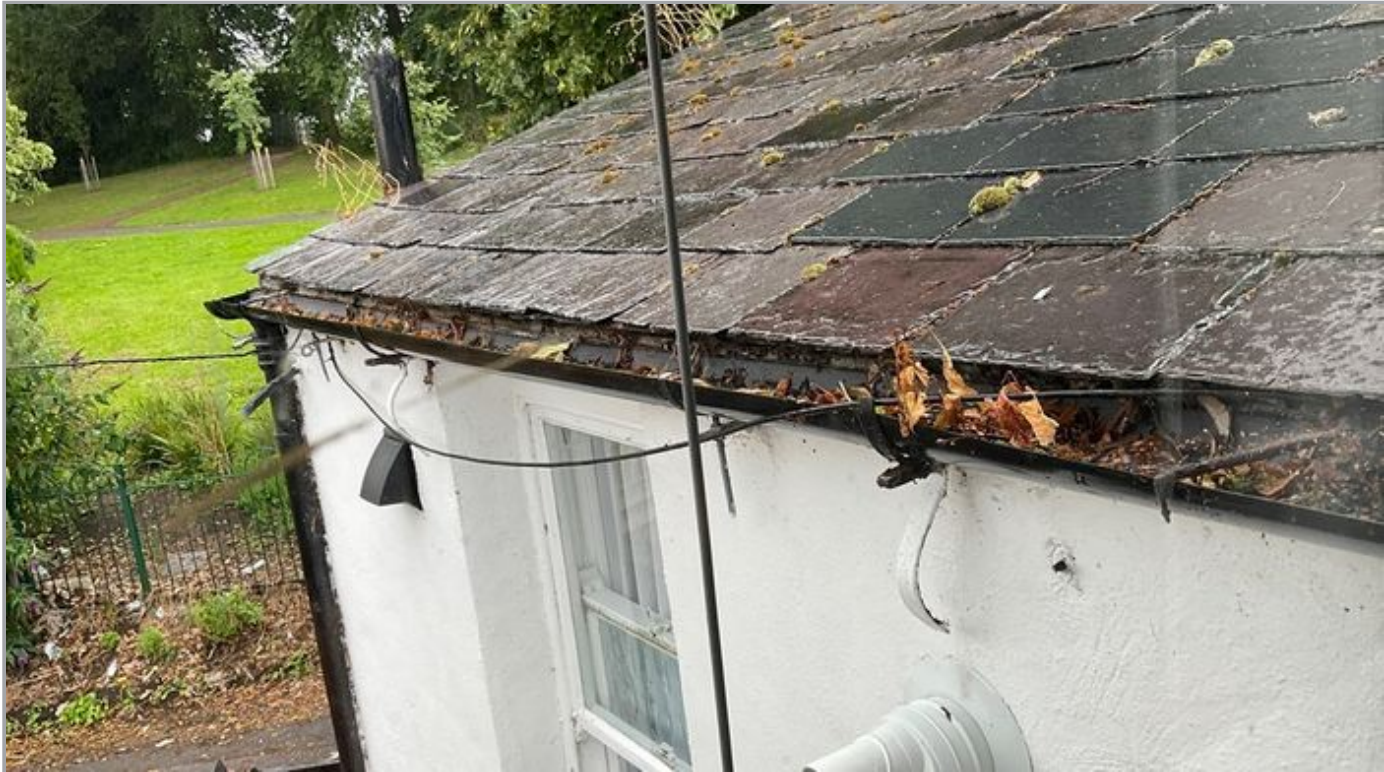
Blocked Guttering

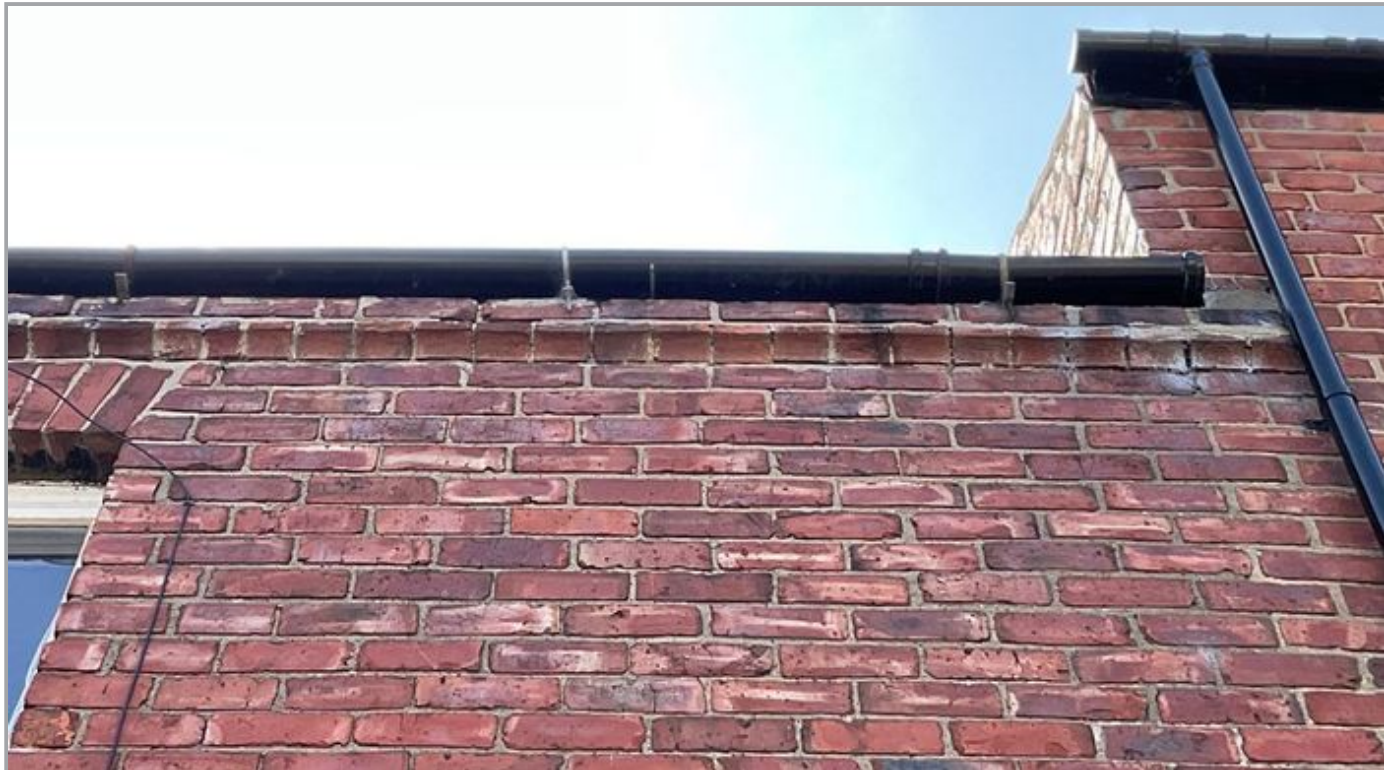
Eroding Pointing

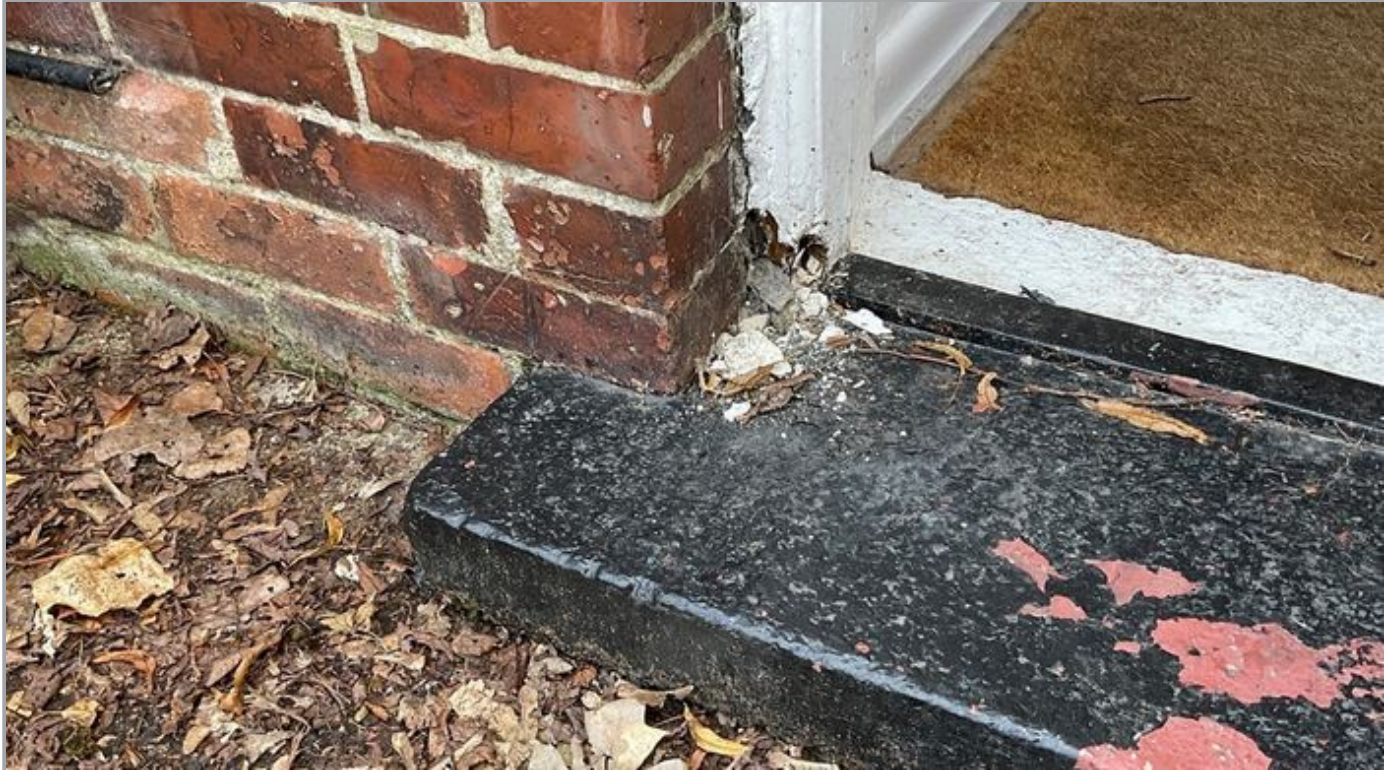
Bridging DPC

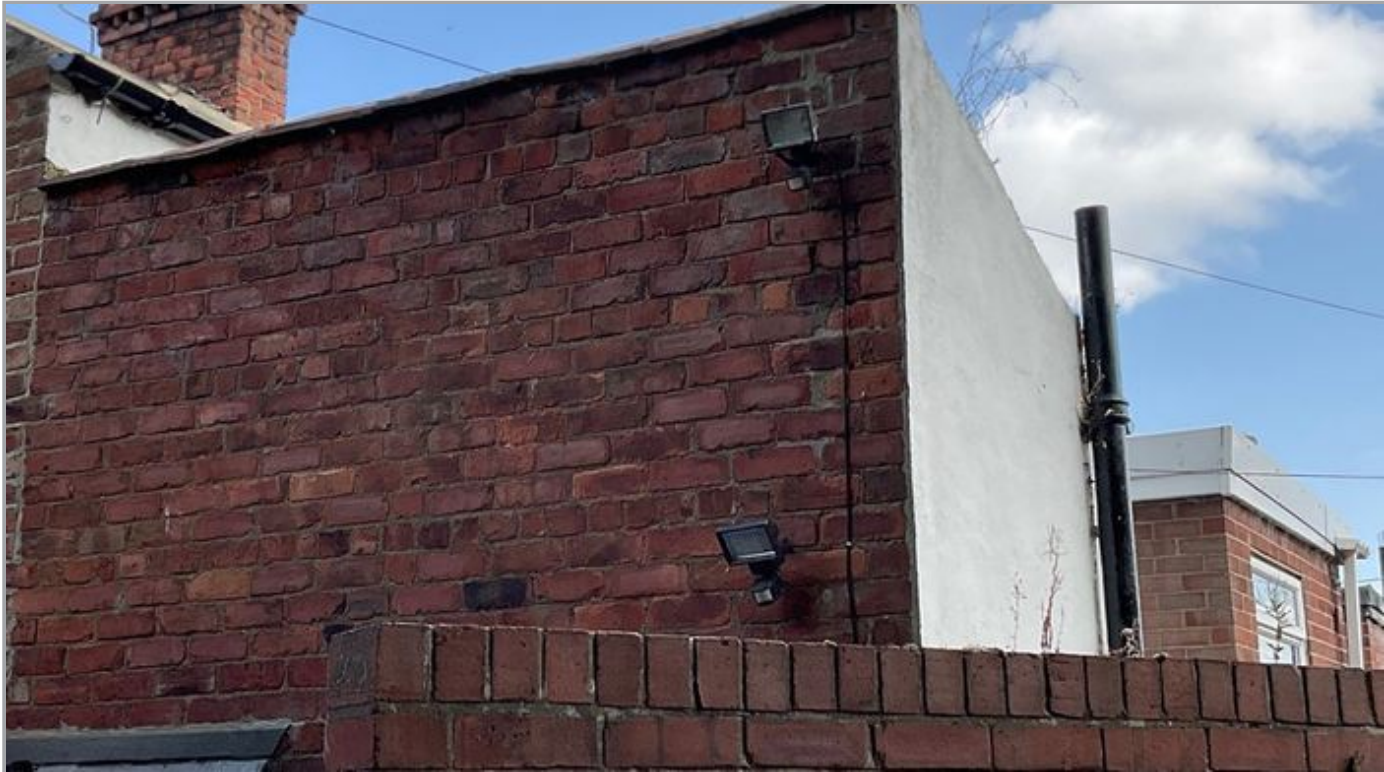
Solid brick walls should be properly insulated as there is little to no gap between the courses of bricks and this makes this type of wall construction vulnerable to damp problems and heat loss. Should you need to deal with any condensation, mould, or damp within the property, this should be taken into consideration and any remedial work carried out by a reputable contractor, as poor installation of insulation to a solid wall can create new damp problems.

Solid Construction Limited Insulation

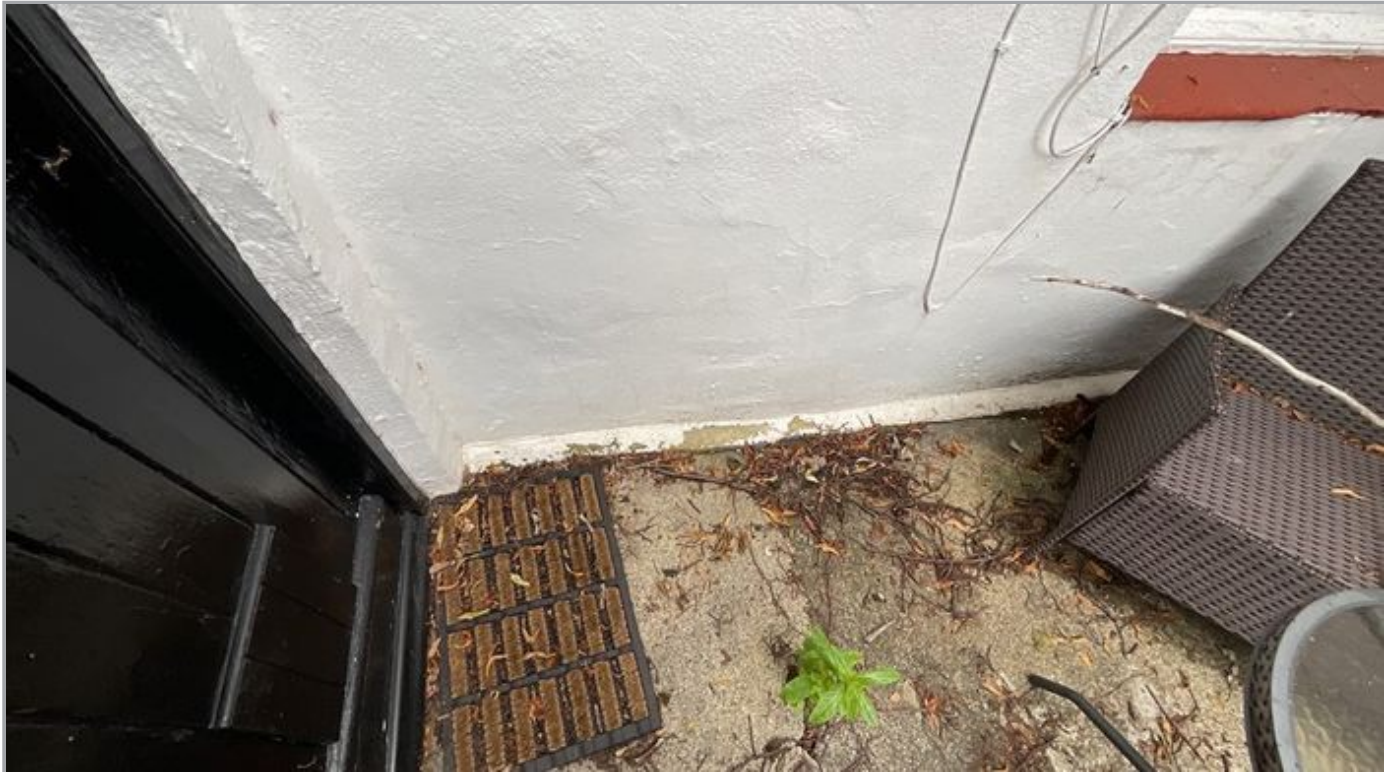
Bridging DPC

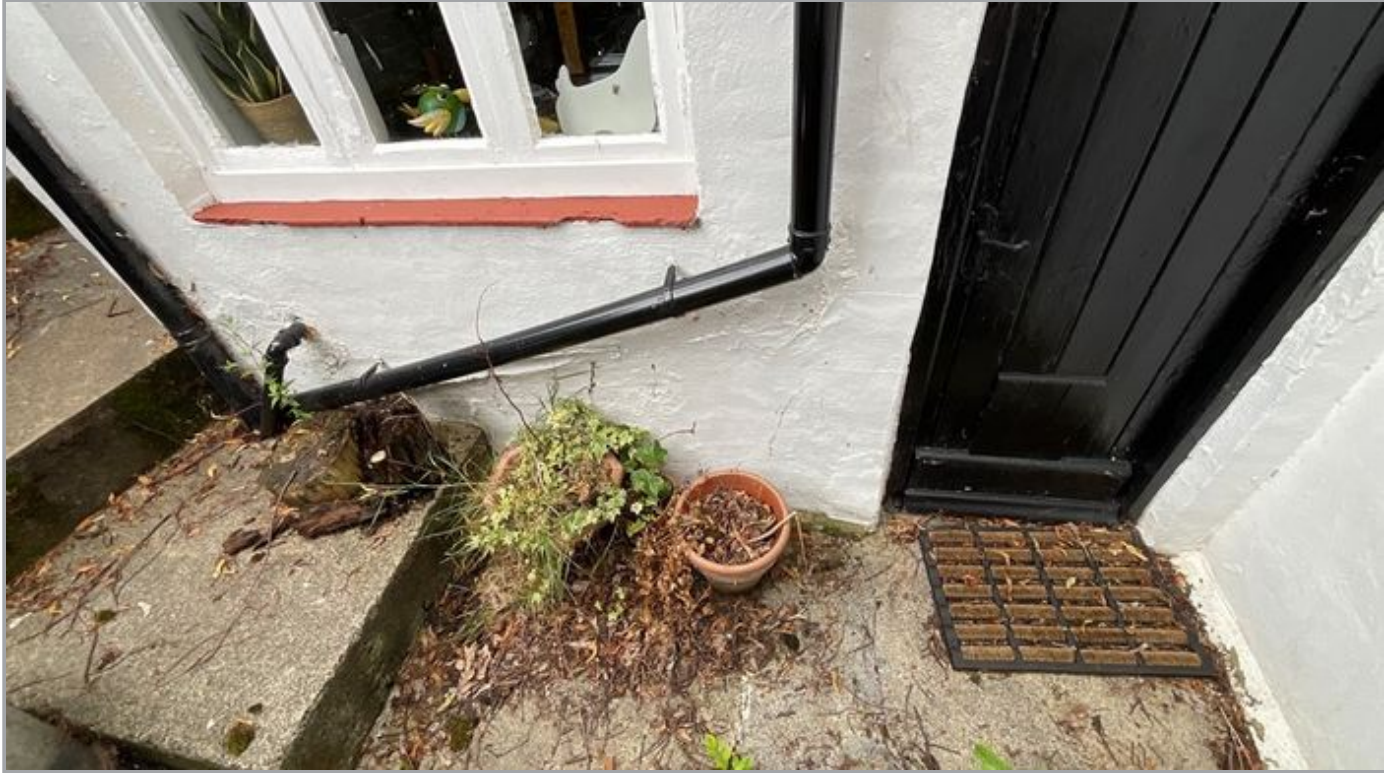
Bridging DPC

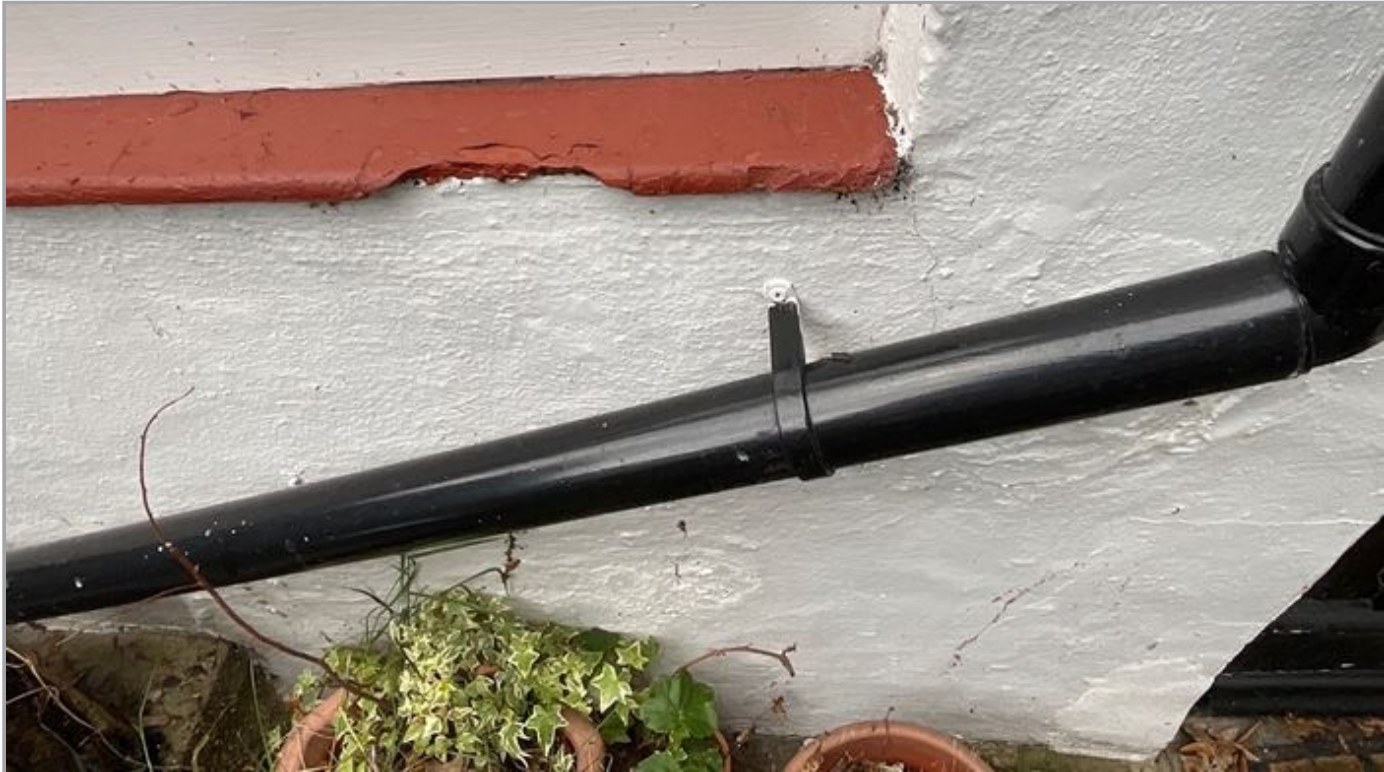
Painted Surfaces

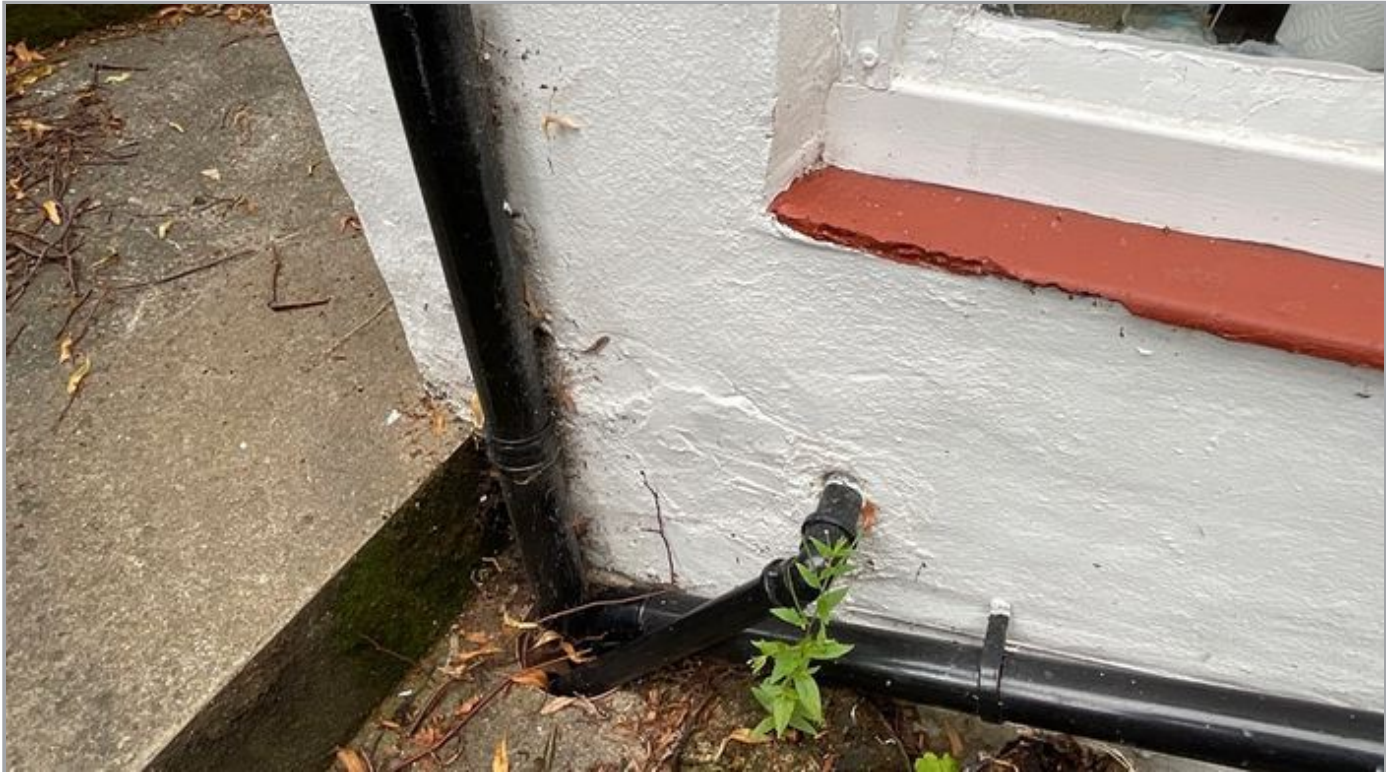
Efflorescence/Paintwork

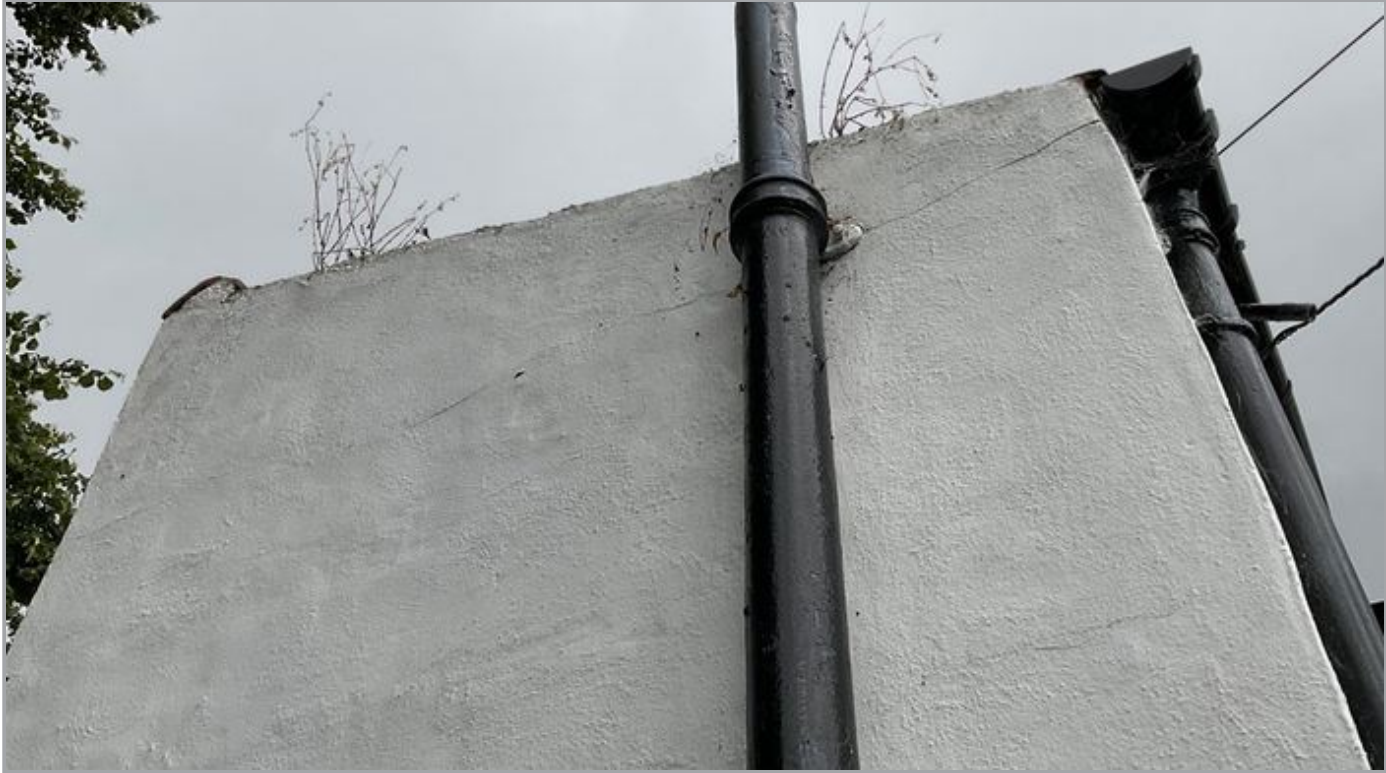
Thermal Movement

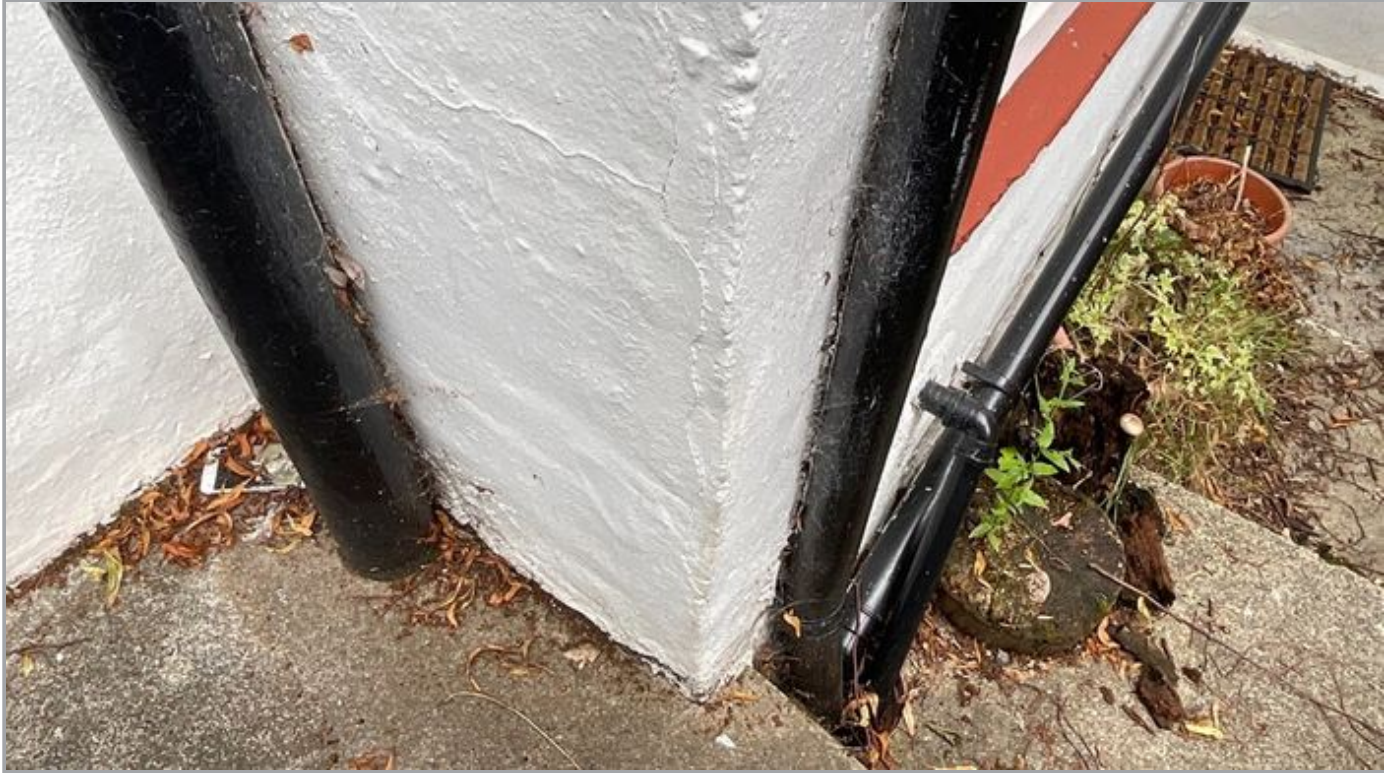
Bridging DPC

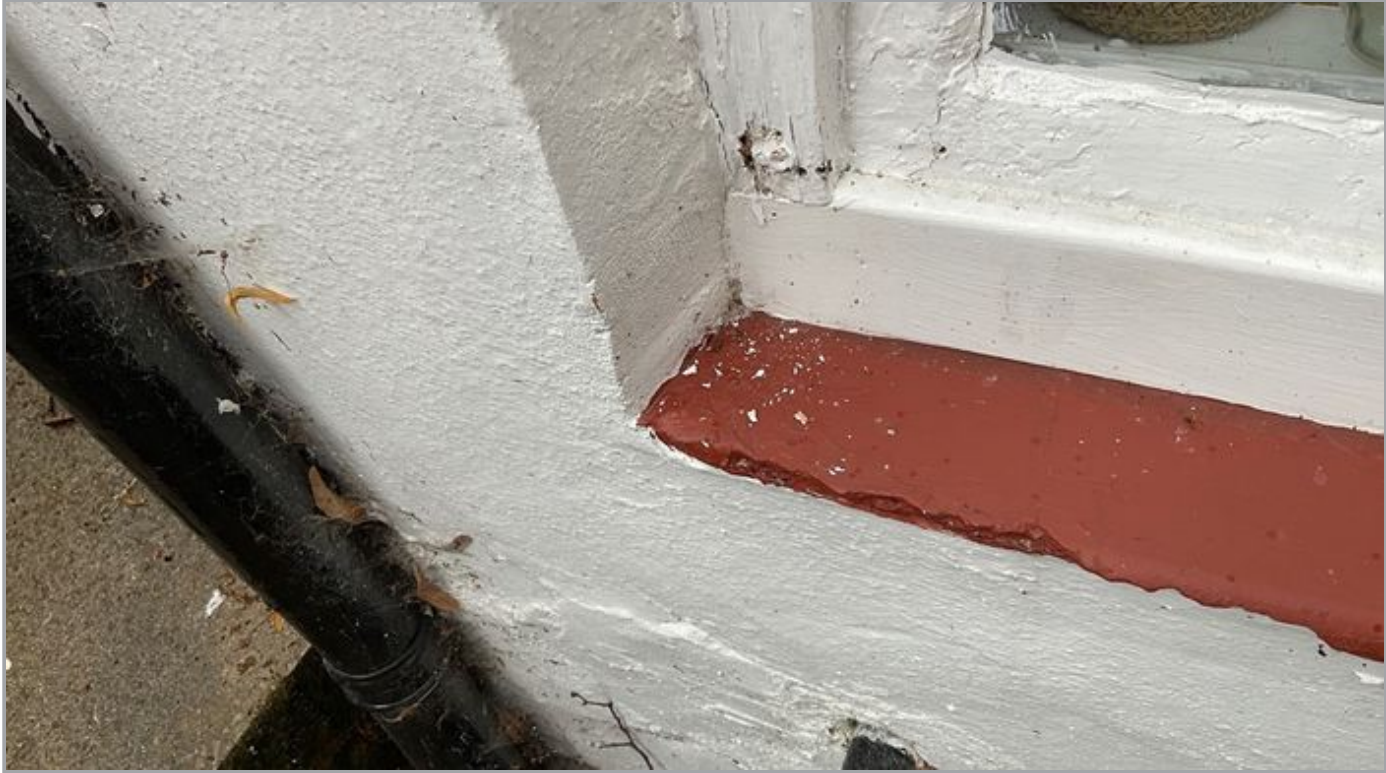
Rotten Framework

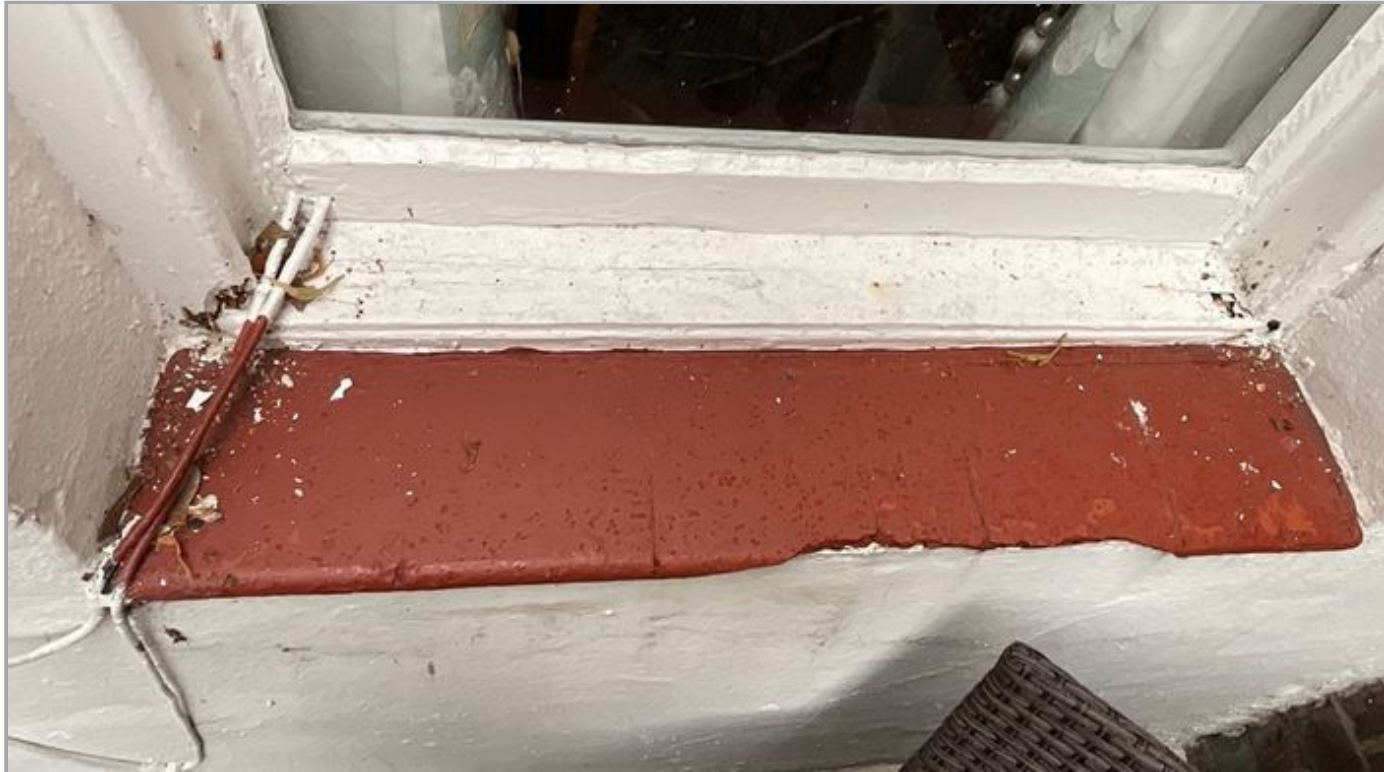
Rotten Framework

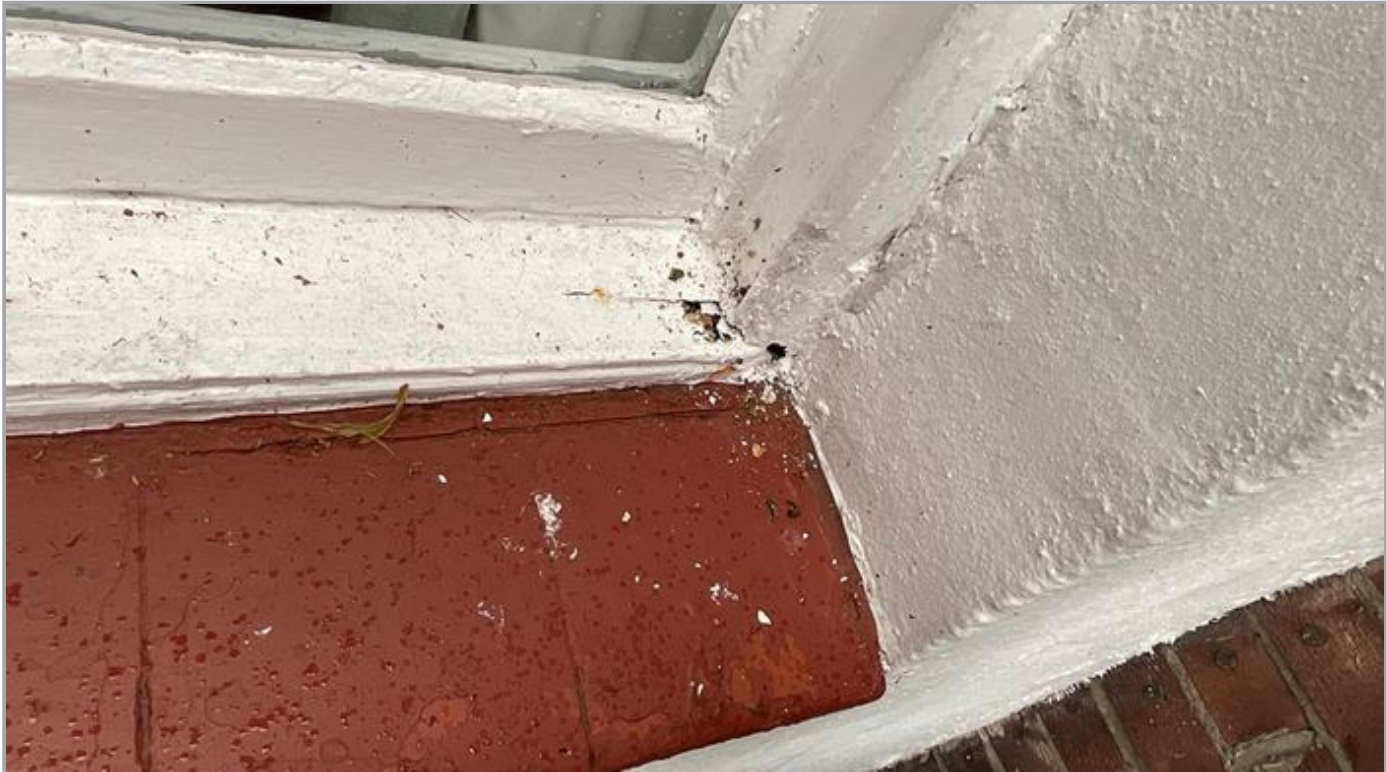
Rotten Framework

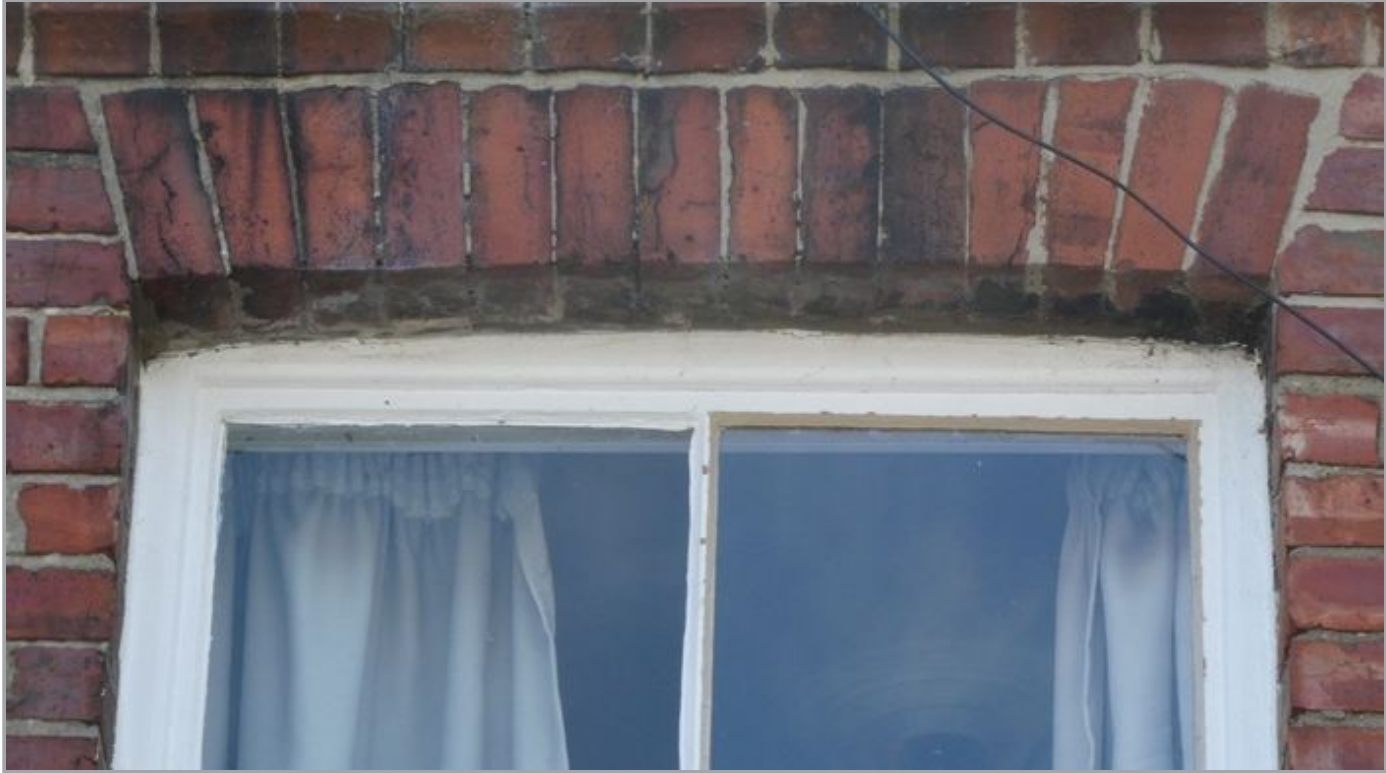
Protective Sealant

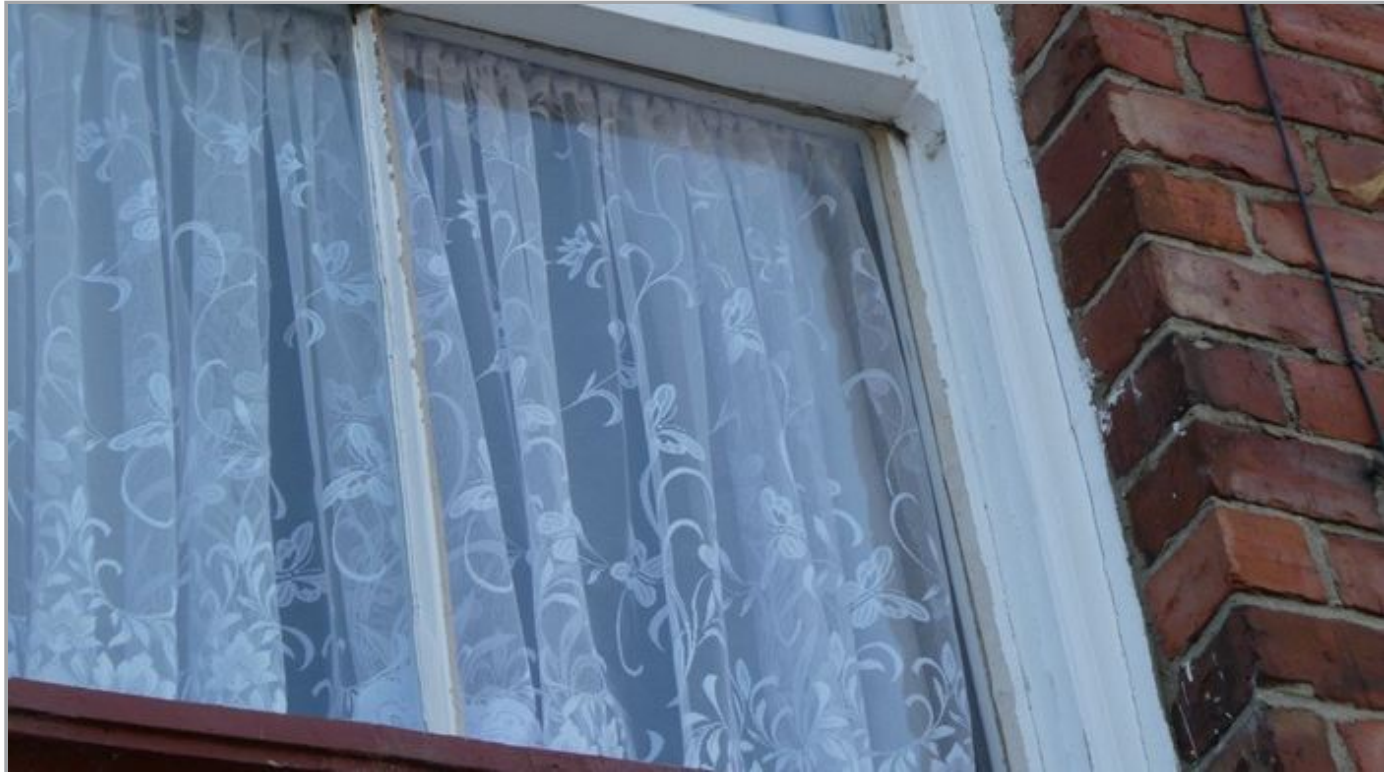
Weathered Framework
