LEVEL 2

Your survey report

Inspection date

21 July 2023

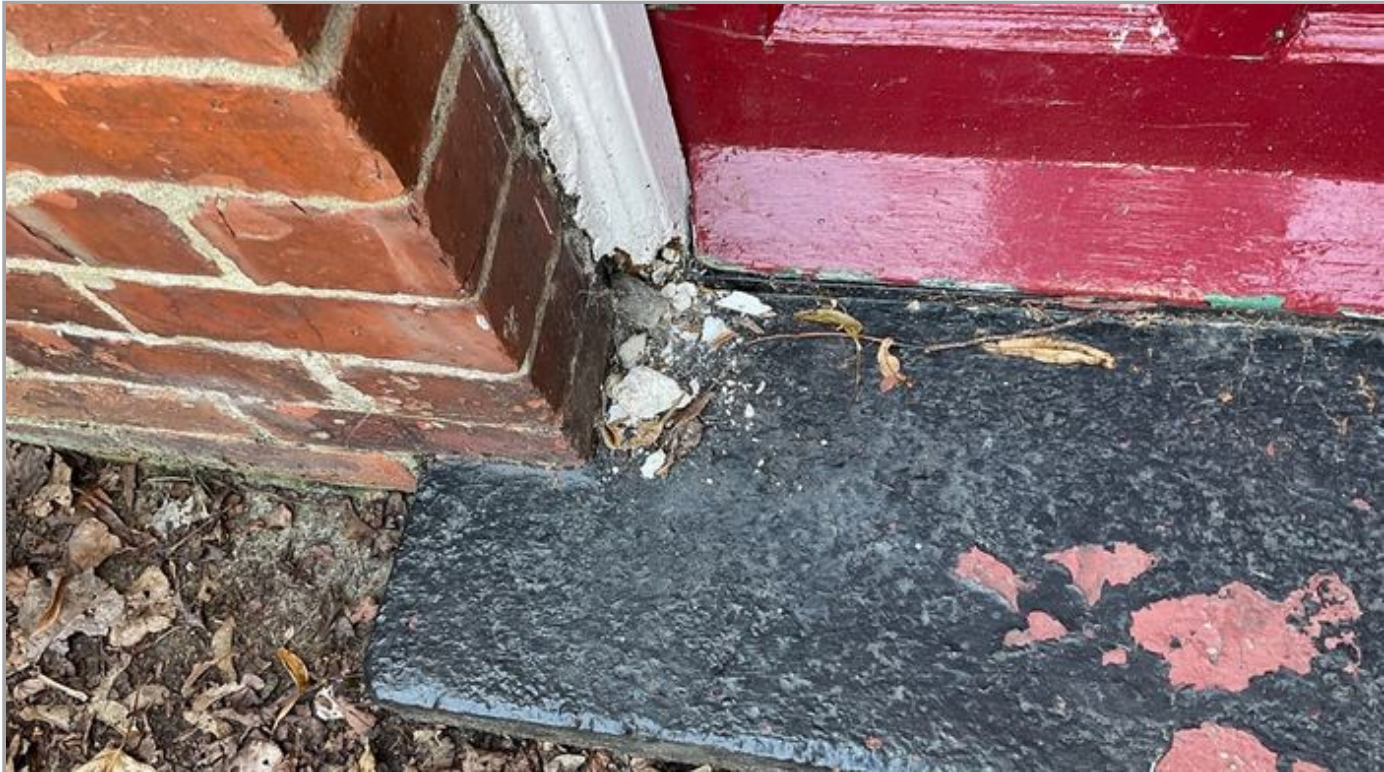
Rotten

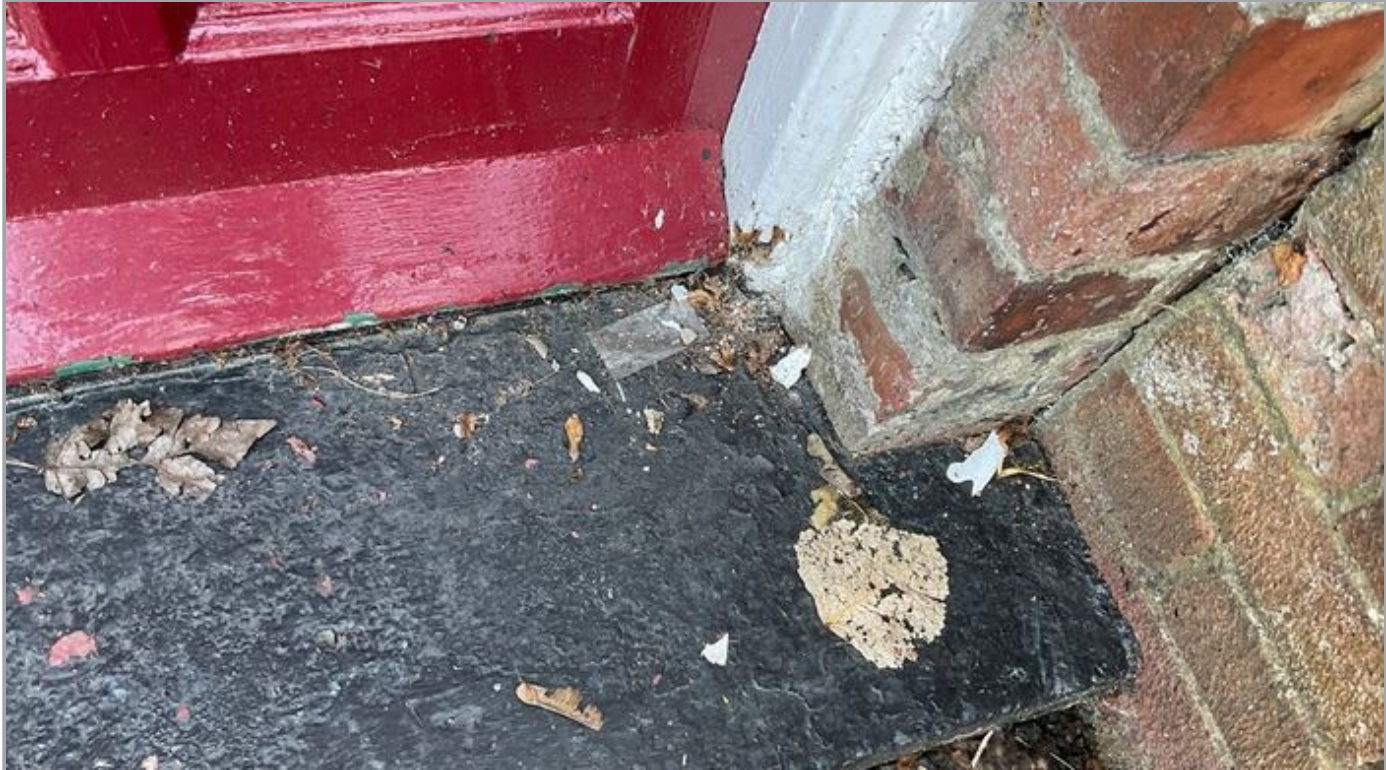
Rotten

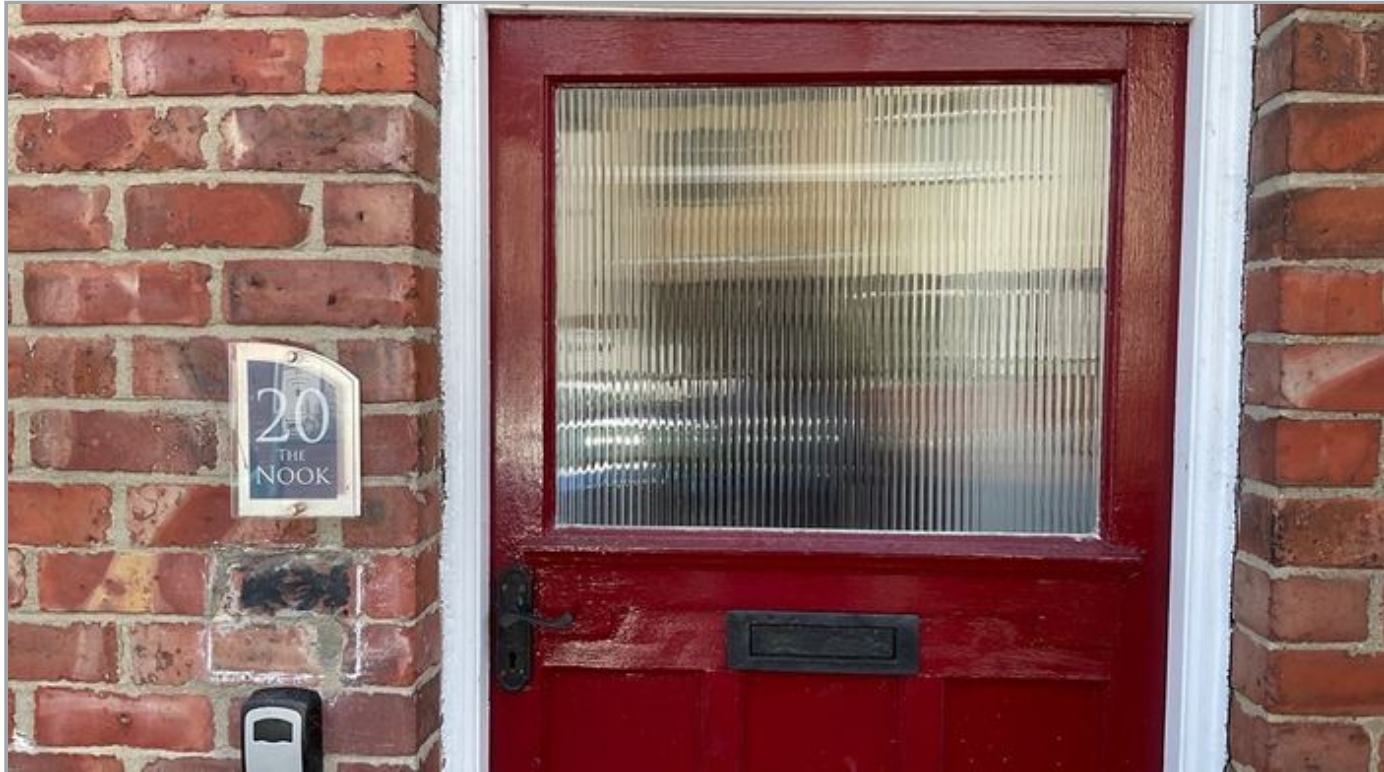
Safety Glass

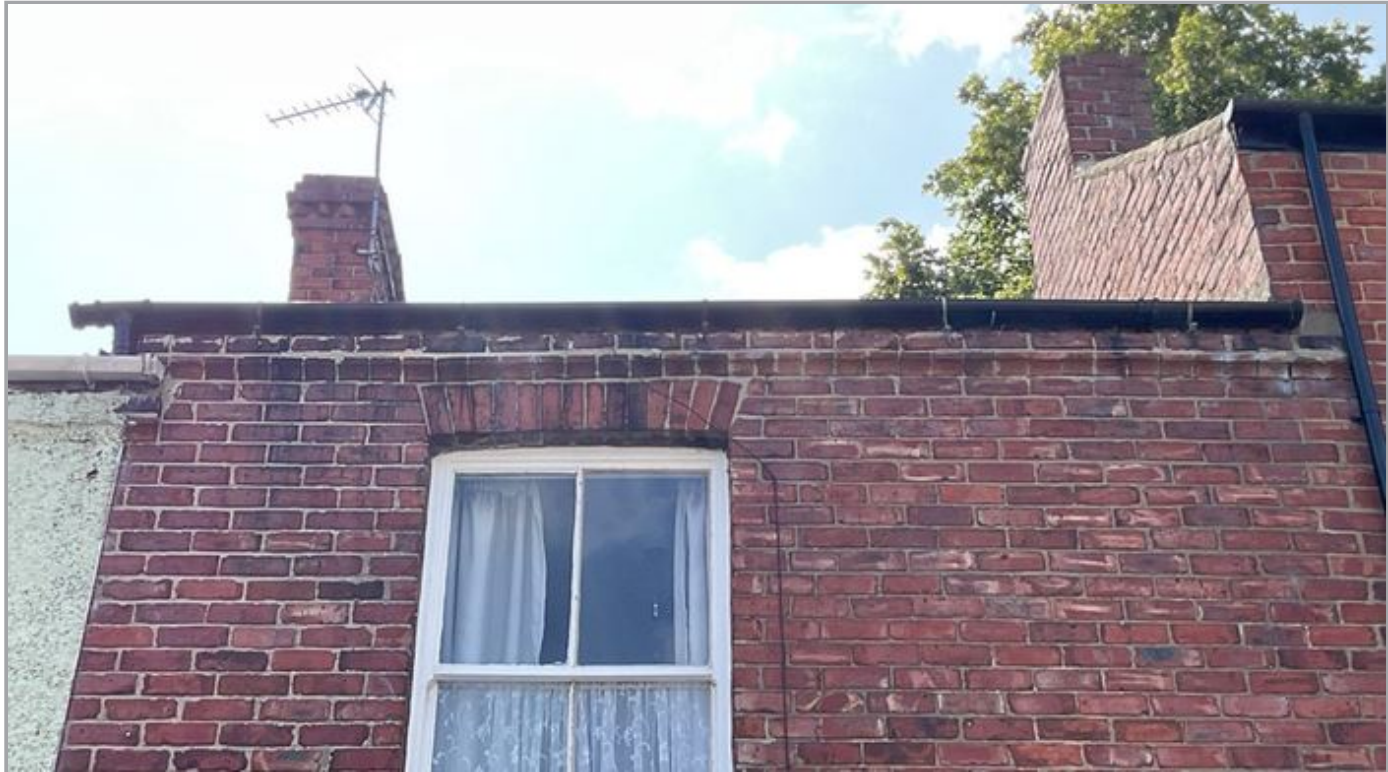
No Fascias

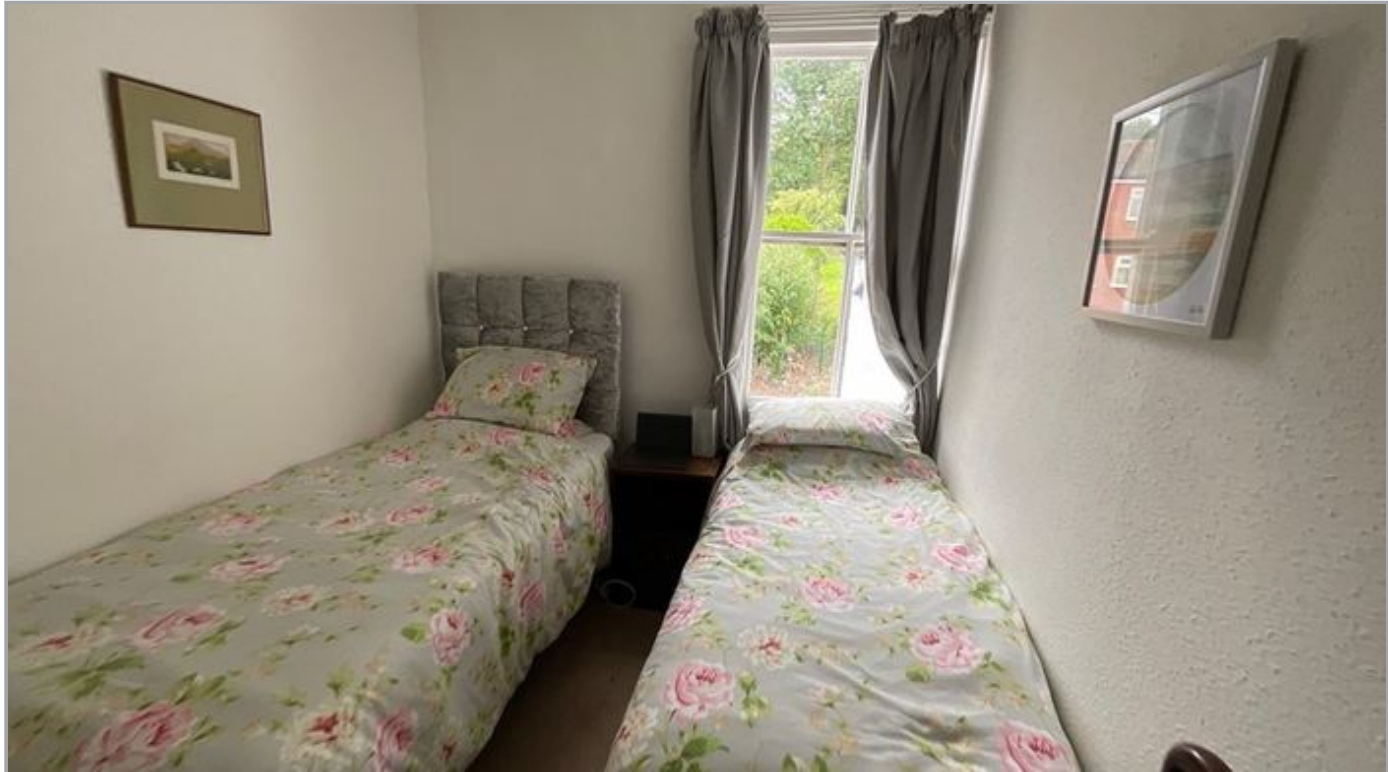
Restricted Inspection

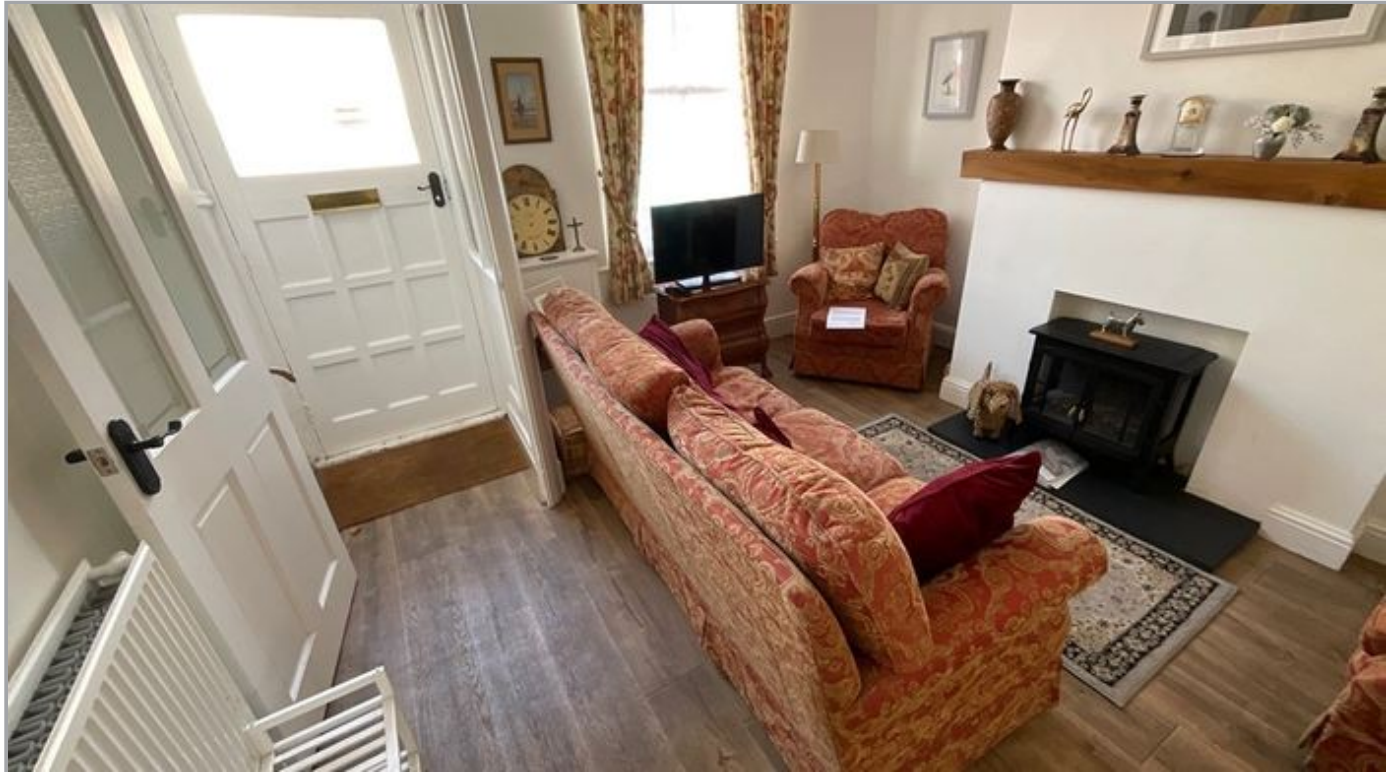
Restricted Inspection

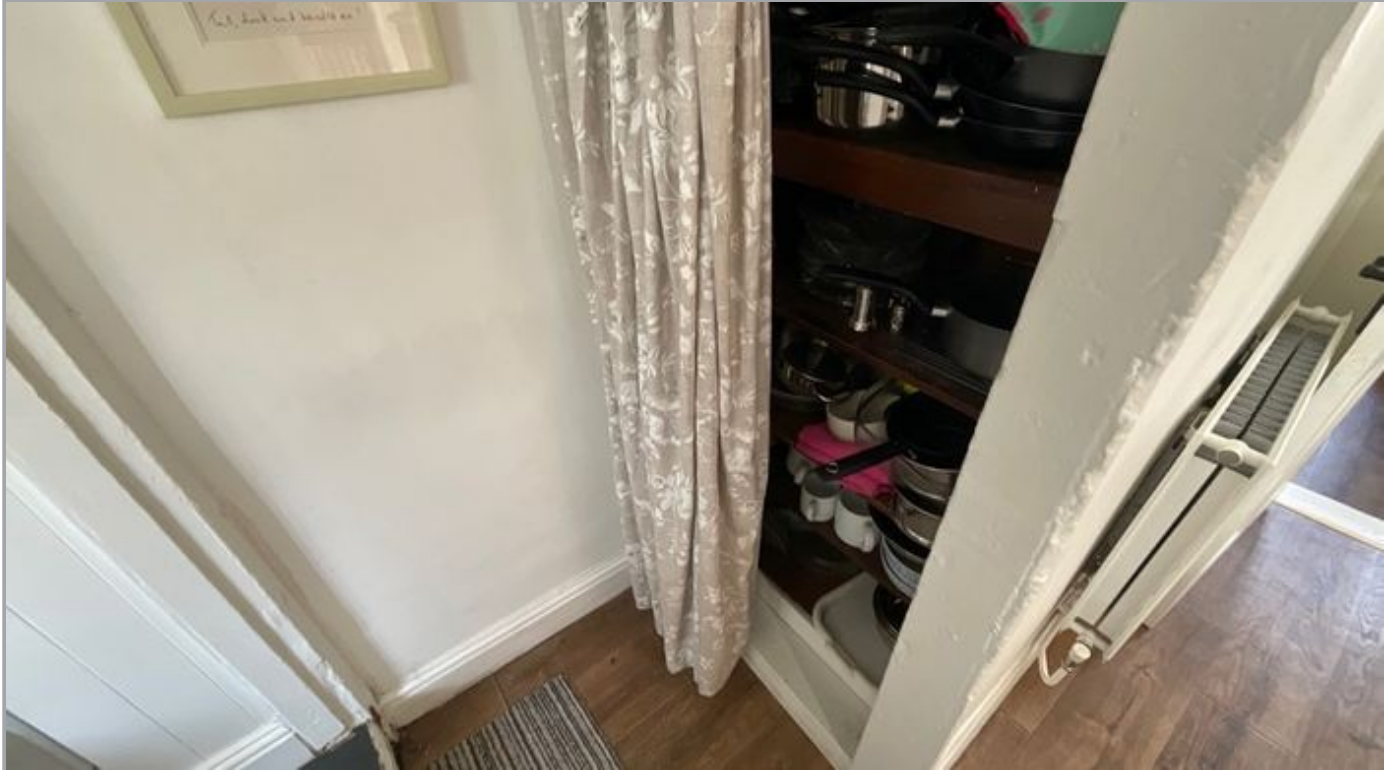
Restricted Inspection

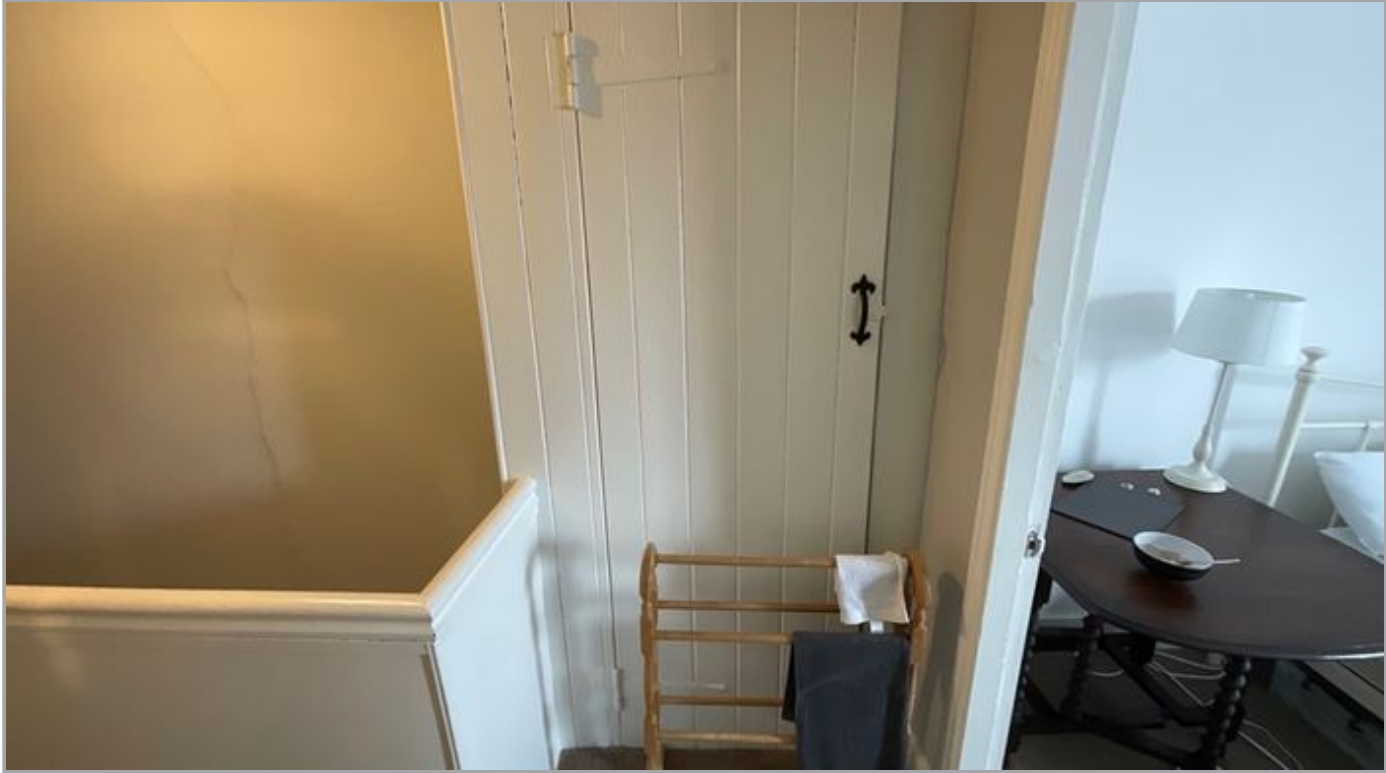
Restricted Inspection

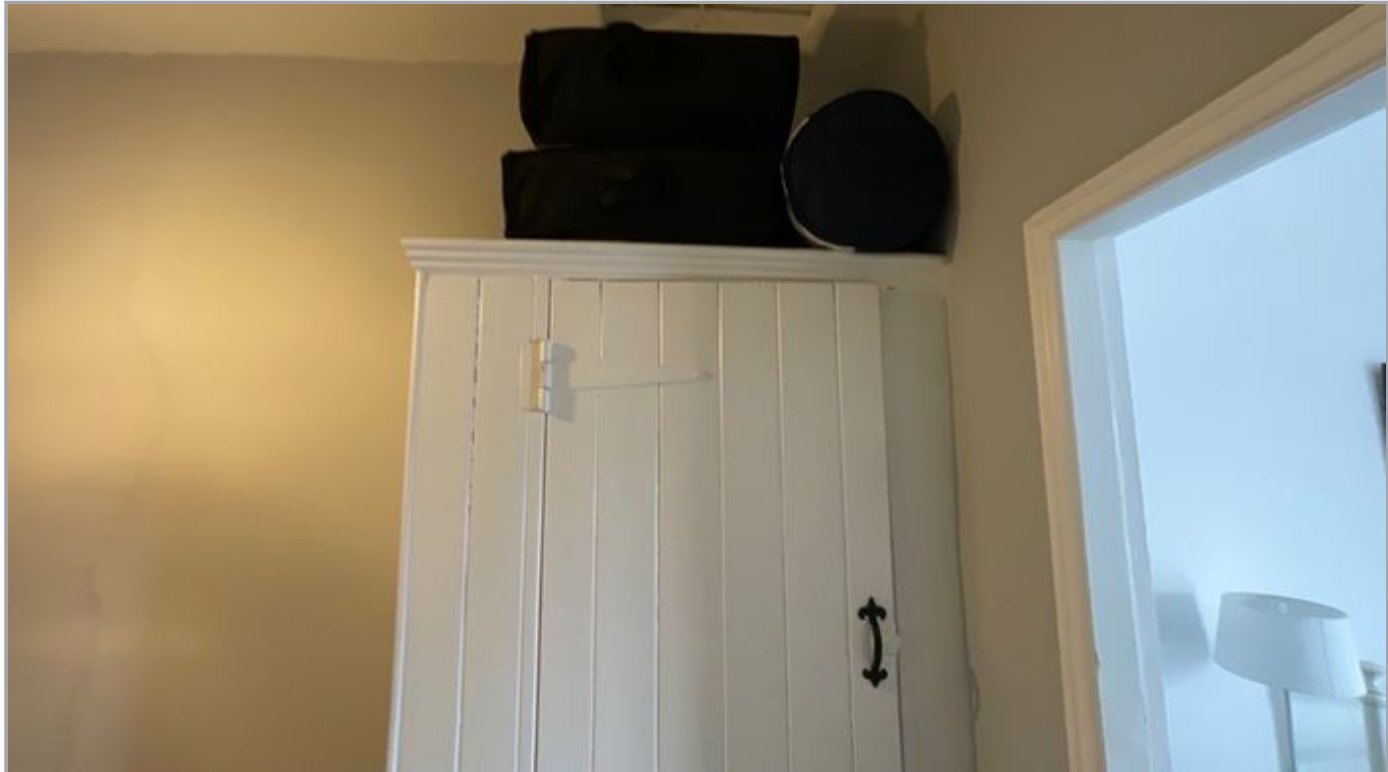
Restricted Inspection

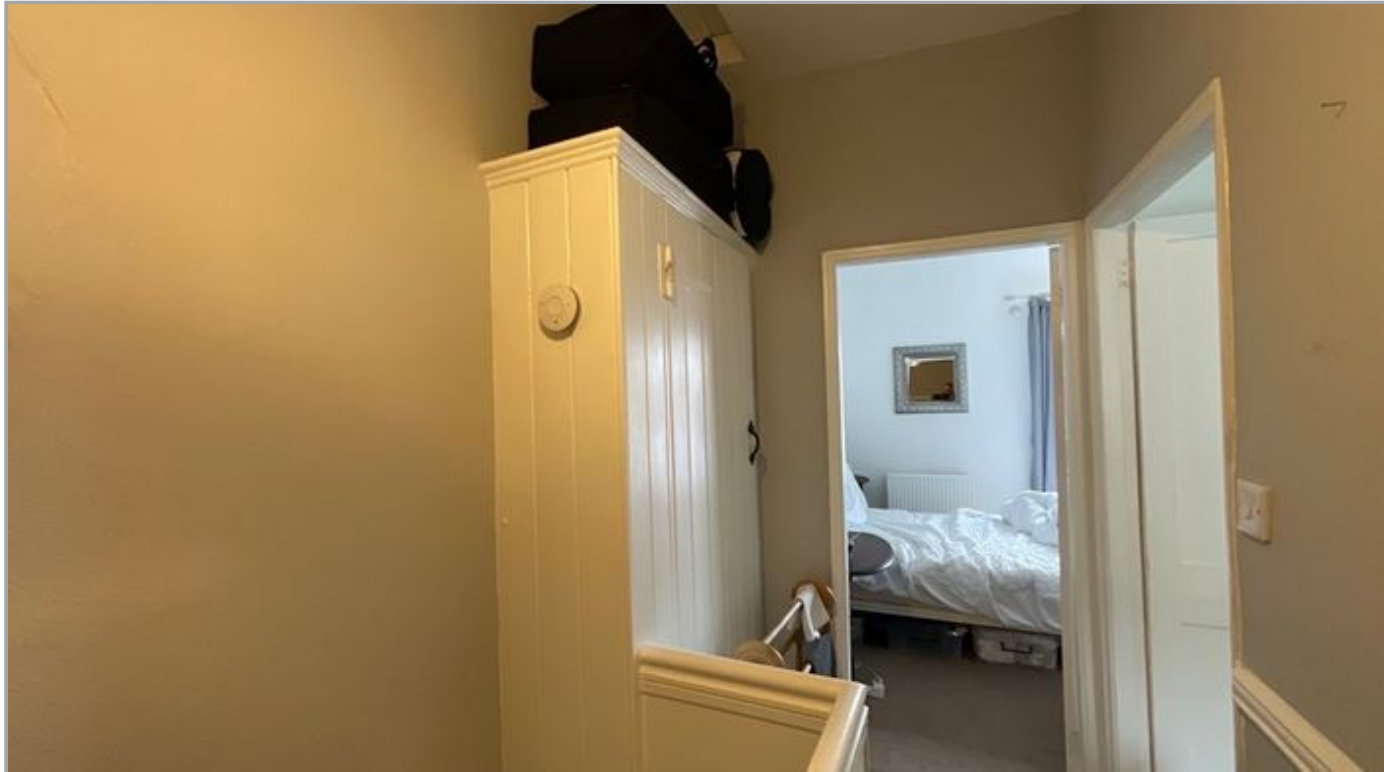
Restricted Inspection

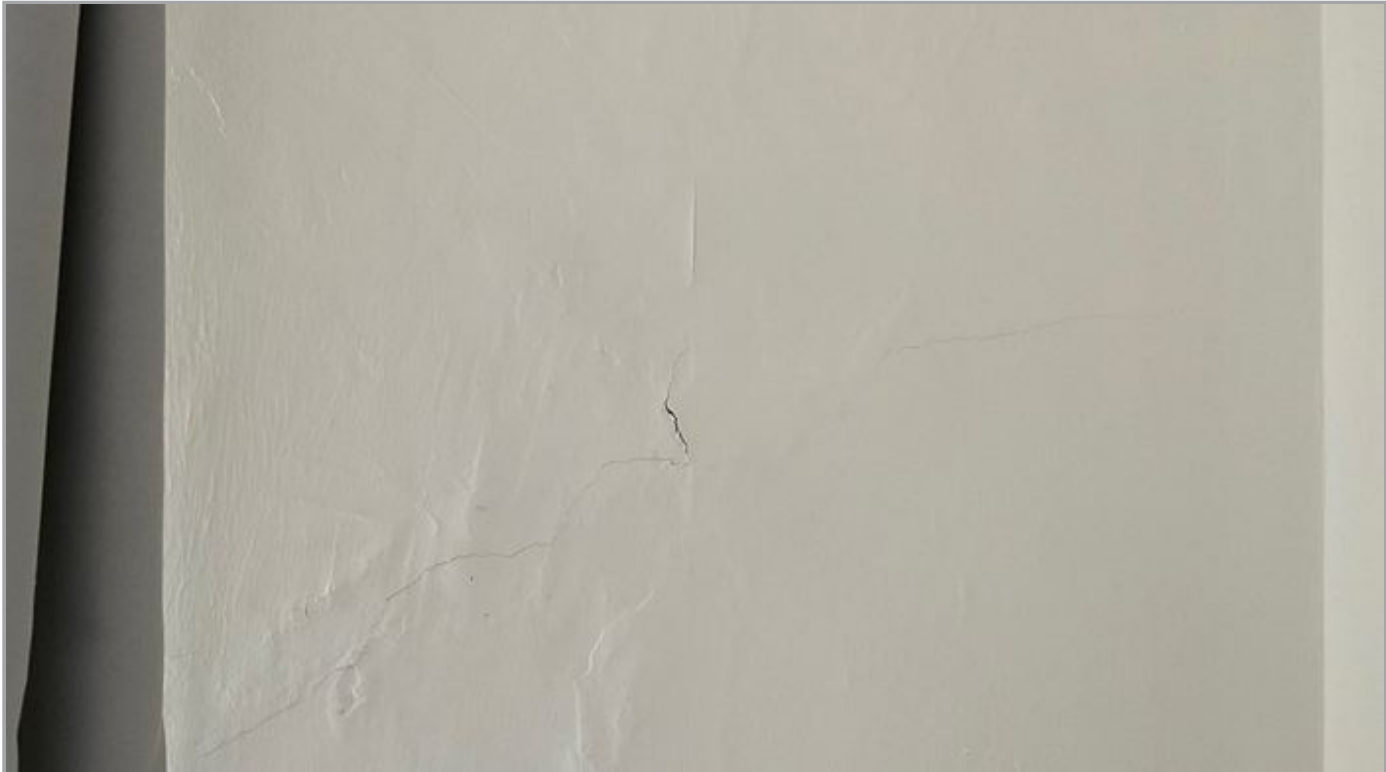
Shrinkage/De-bonding

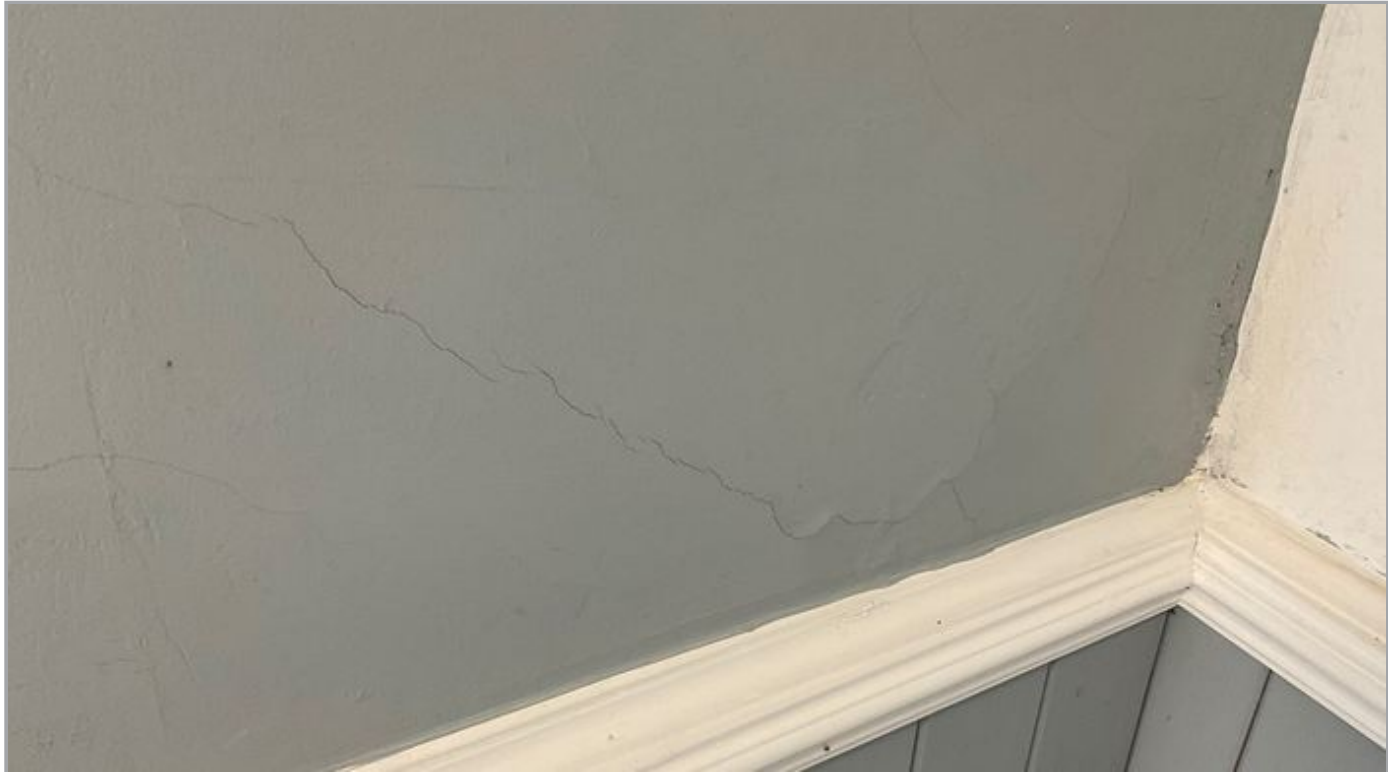
Shrinkage/De-bonding

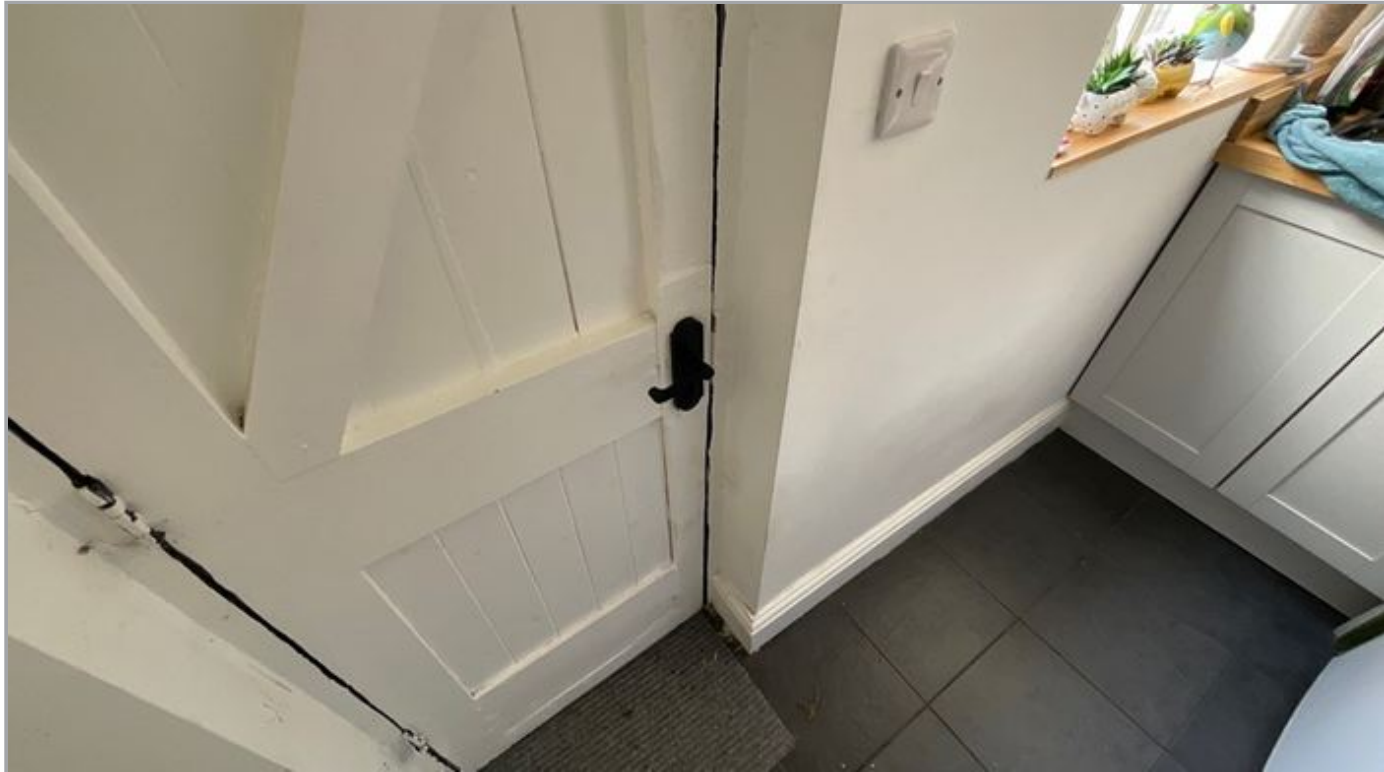
Plasterboard Lining

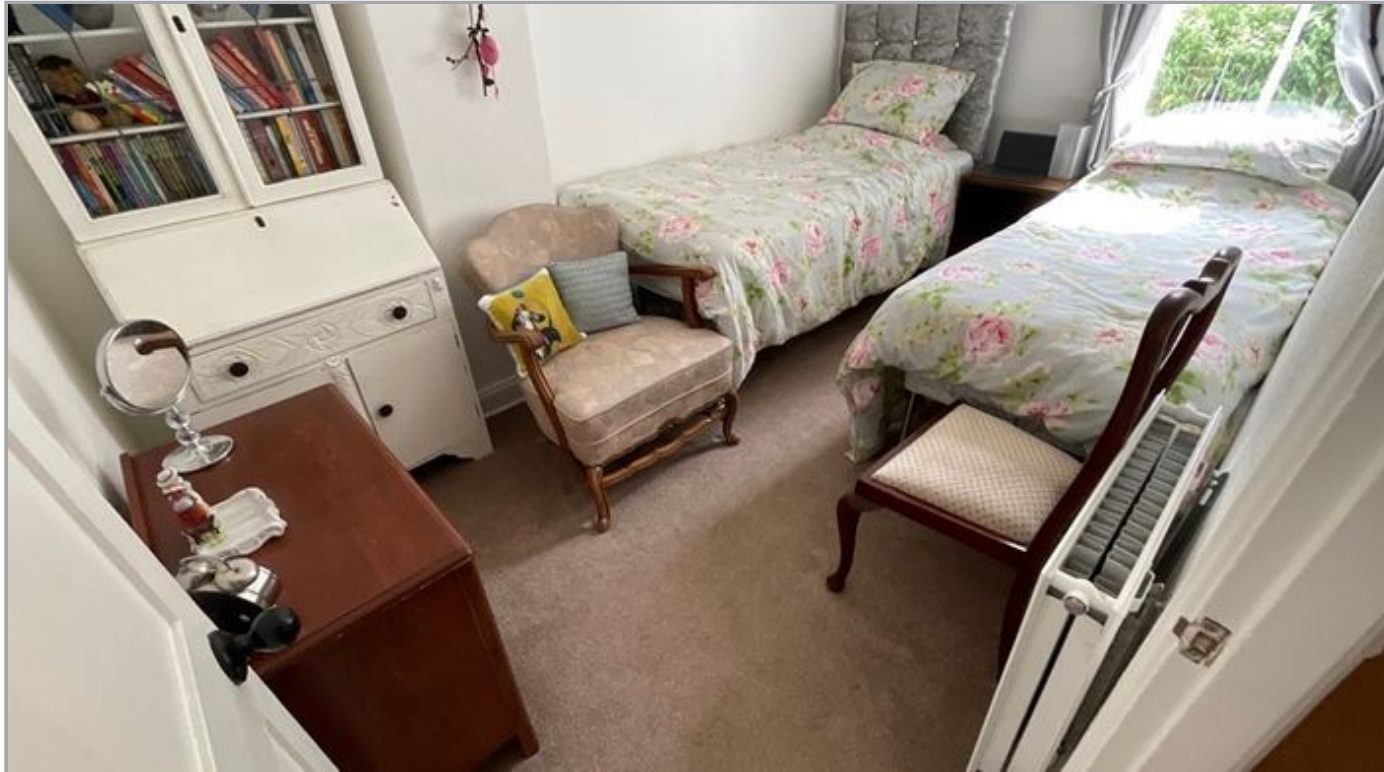
The timber floors to the first-floor have noticeable levels of unevenness and sloping, as well as to the staircase. Properties of this type and age tend to demonstrate a degree of movement over time. This is usually caused by an acceptable amount of deflection (bending caused by loading).

Unevenness/Sloping

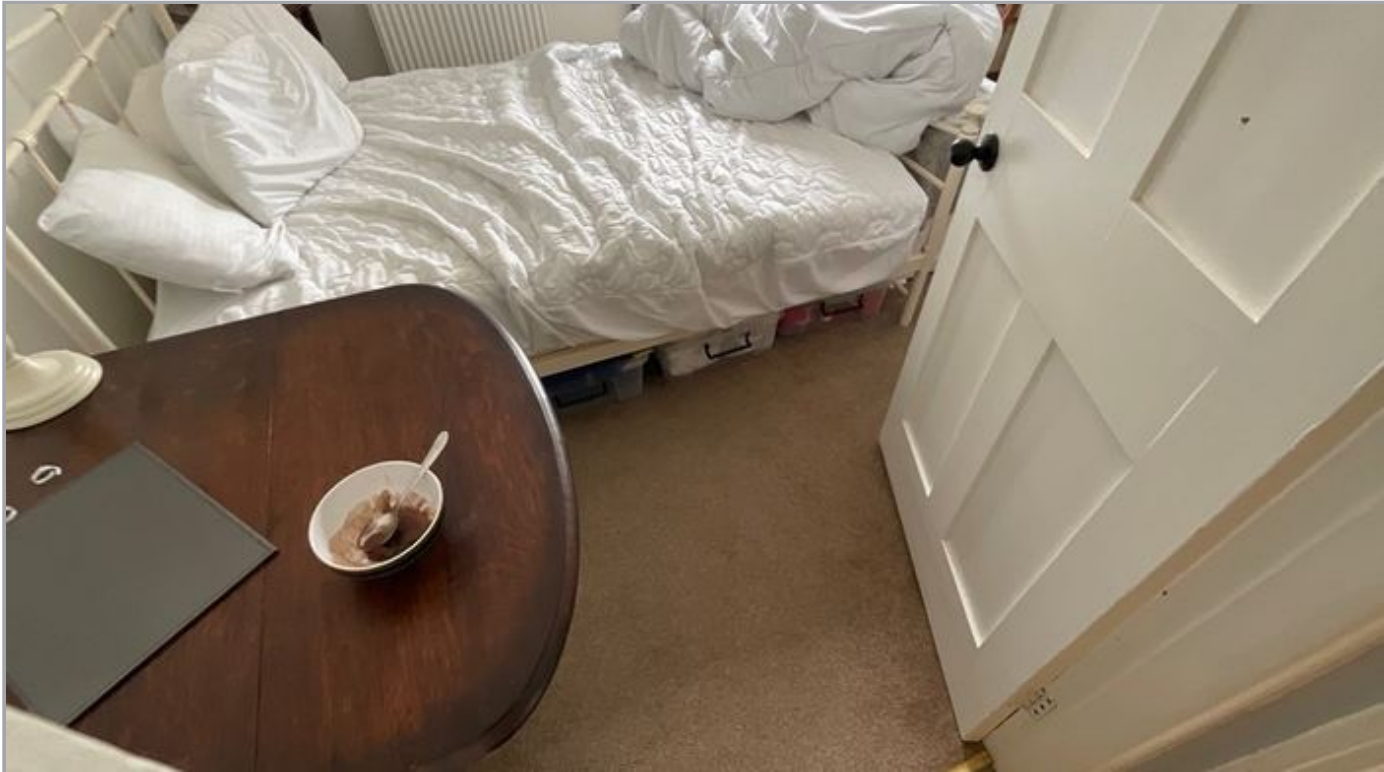
Unevenness/Sloping

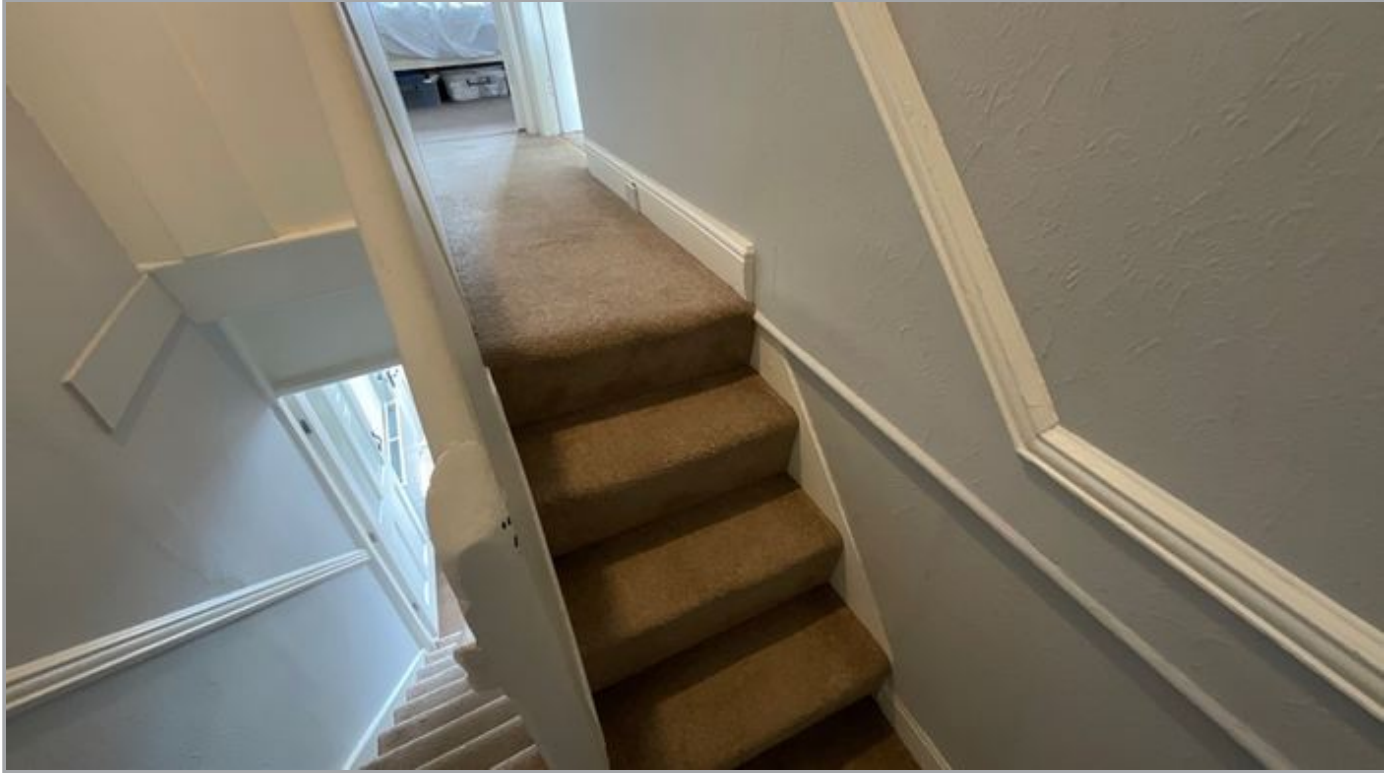
Unevenness/Sloping

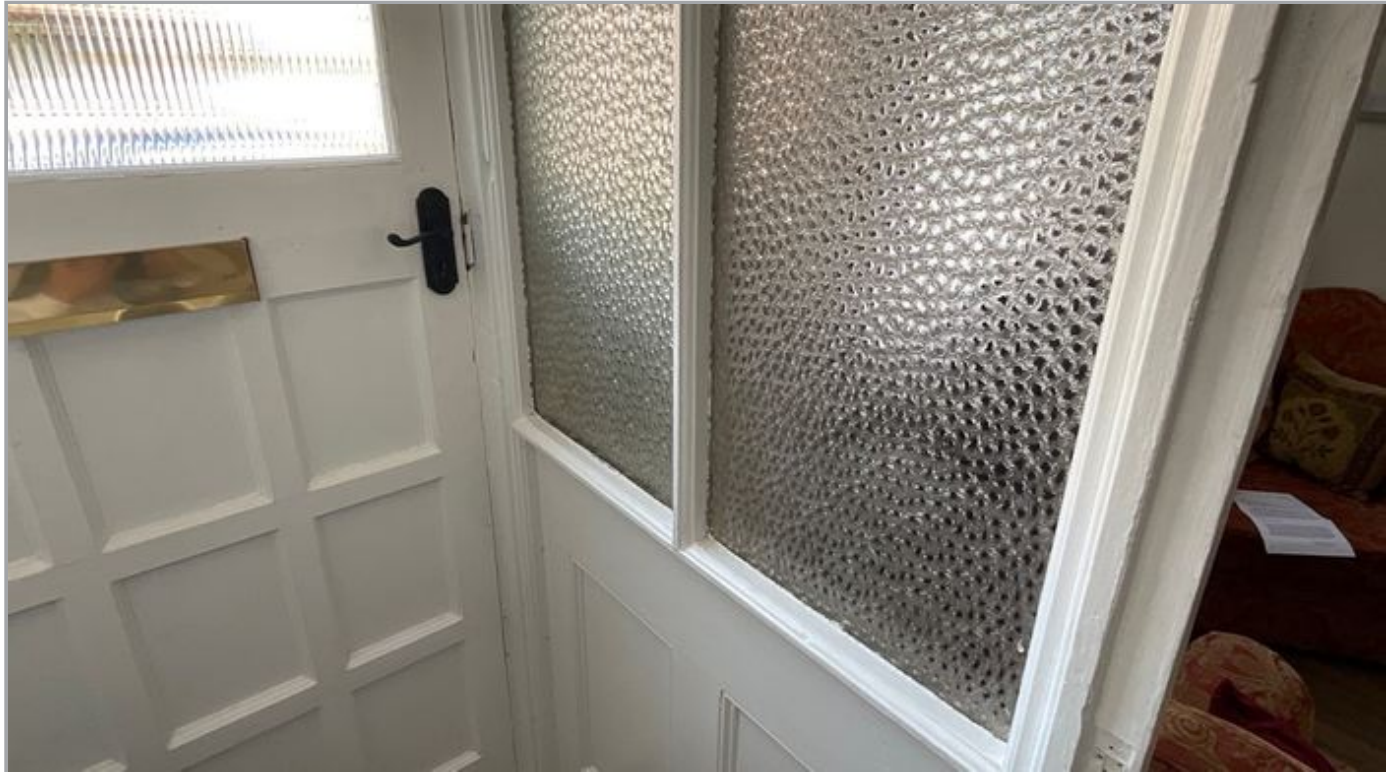
Some of the internal doors contain glass, which does not have a British Standard safety rating. We advise you replace the affected doors for the improved health and safety of any occupants. This is a risk to persons, and we refer you to our comments in Section I.

Safety Glass

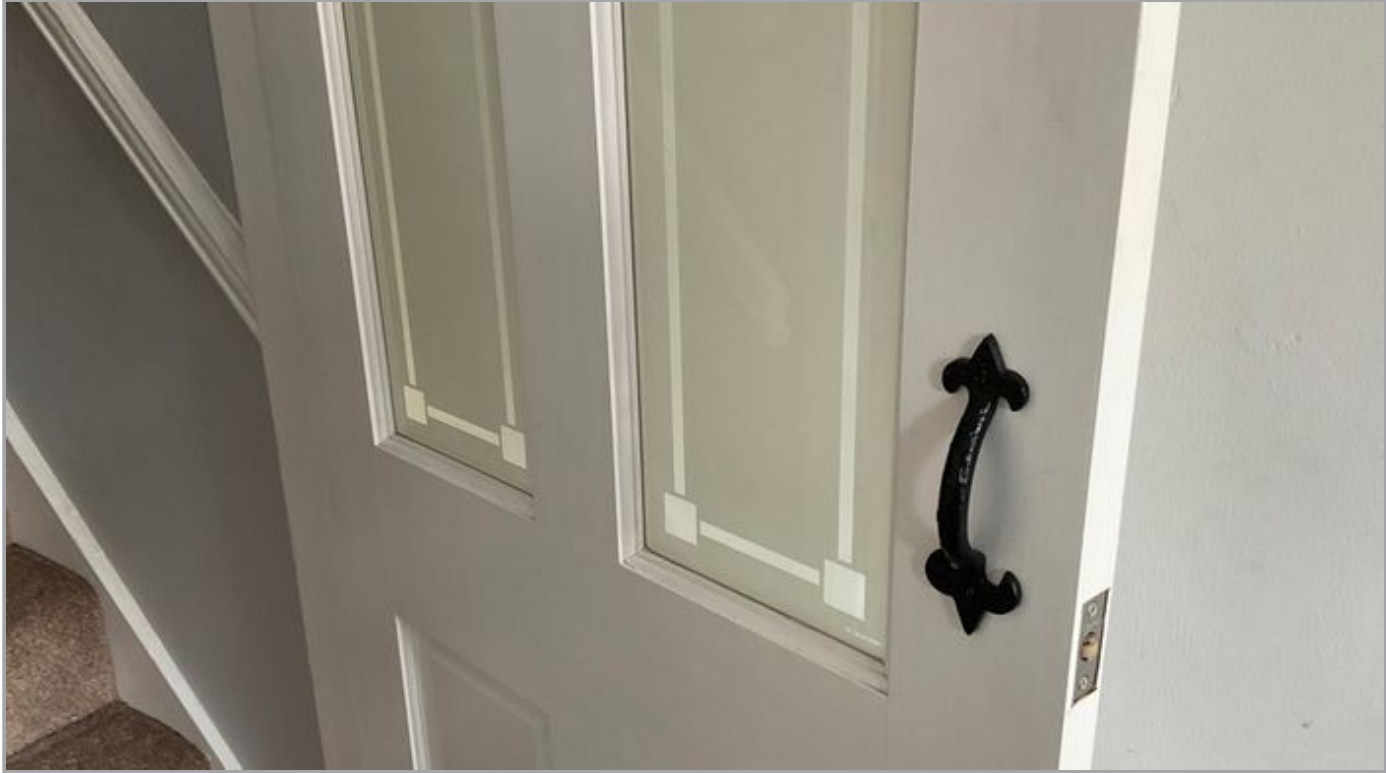
Safety Glass

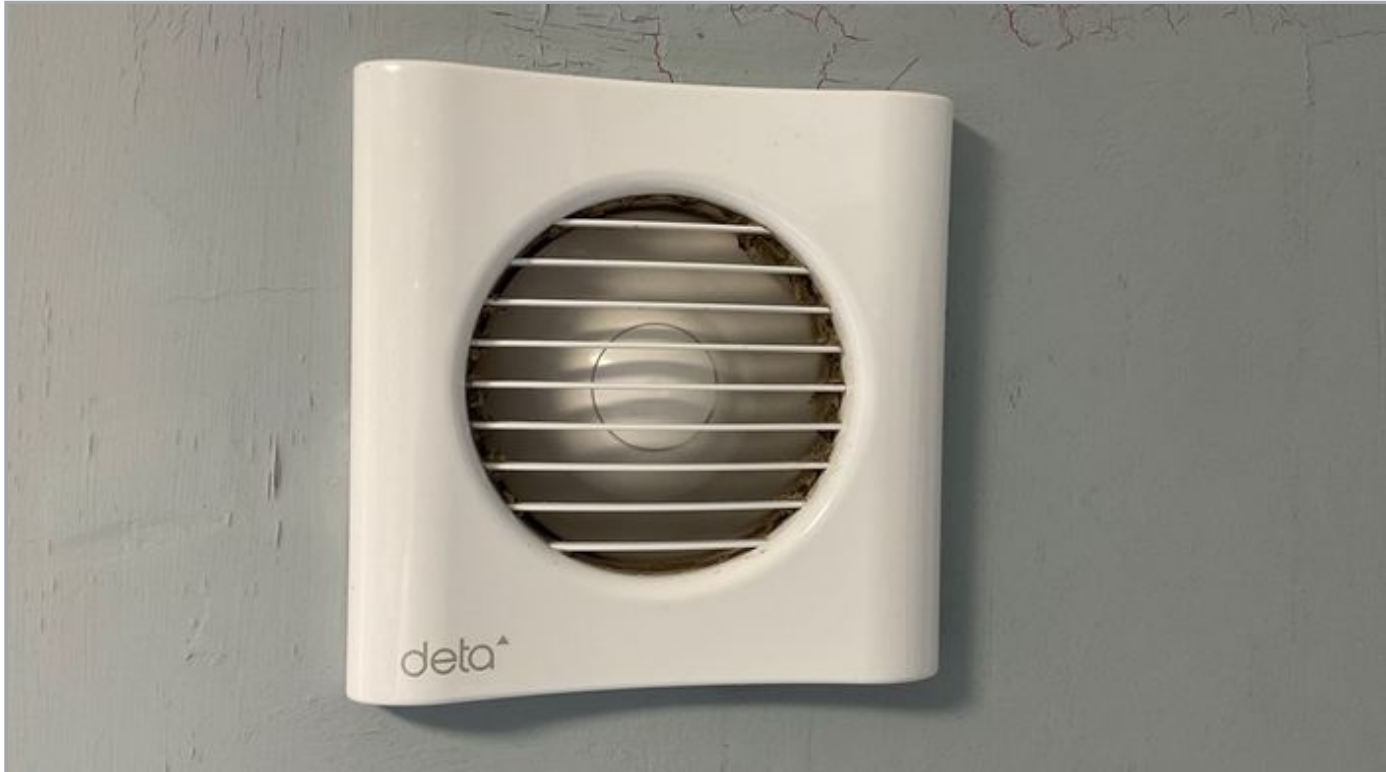
Dust

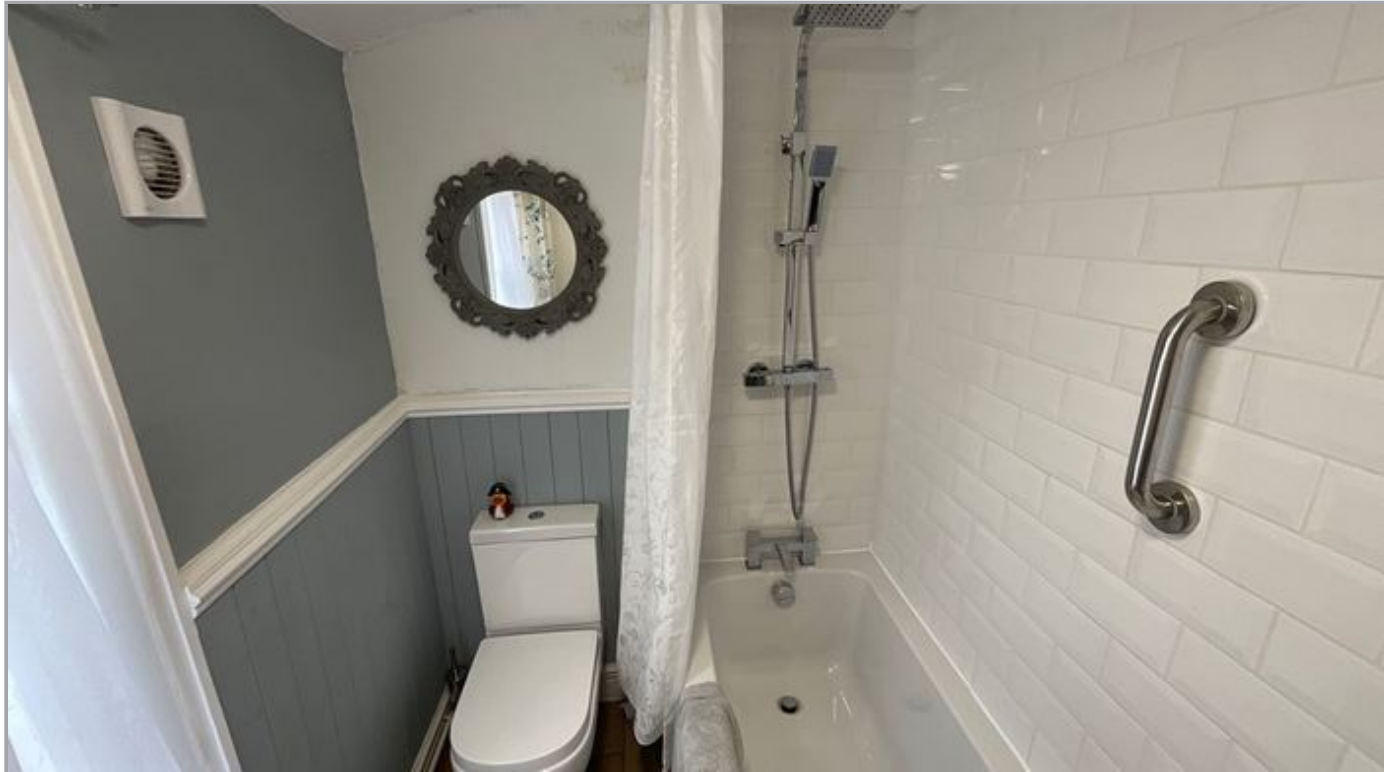
The lack of a proper enclosure to the shower over the bath will cause excessive spillage, resulting in the disrepair of the fitted units and flooring, therefore the shower curtain should be replaced with a fixed shower enclosure.

Shower Enclosure

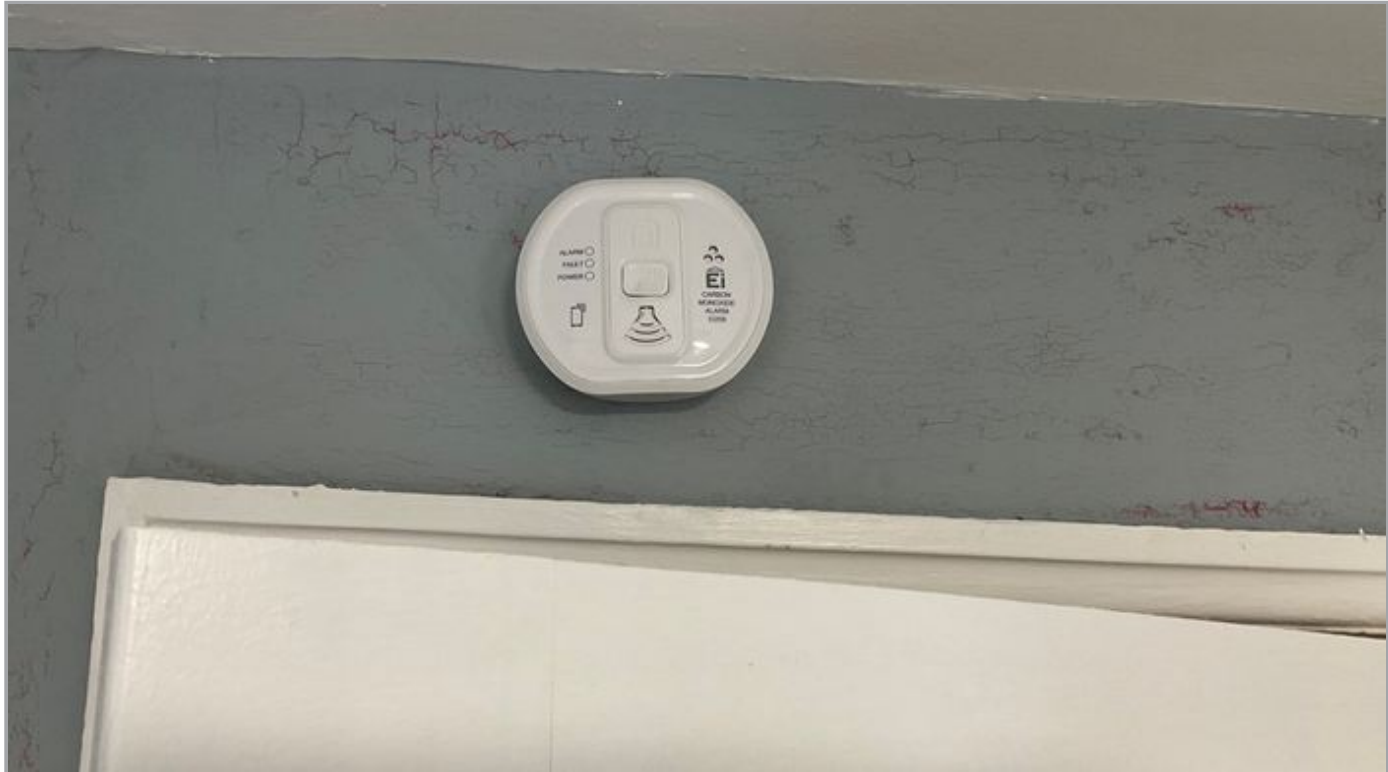
Mains Alarms
