LEVEL 2

Your survey report

Inspection date

21 July 2023

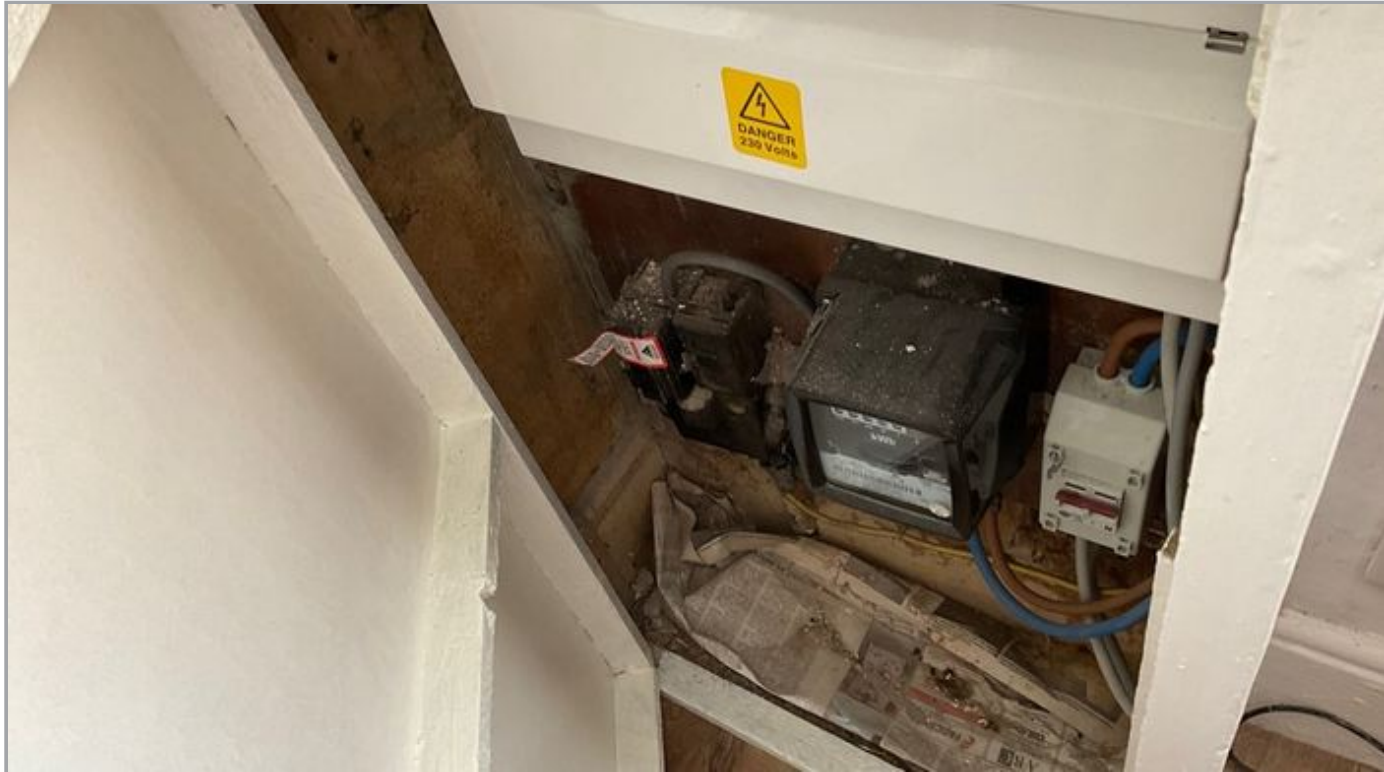
Electric Meter/Consumer Unit

Your legal adviser should check the validity of any test certification for the installation. We refer you to our comments in Section H. Until the installation has been tested and certified as safe, it should not be used.

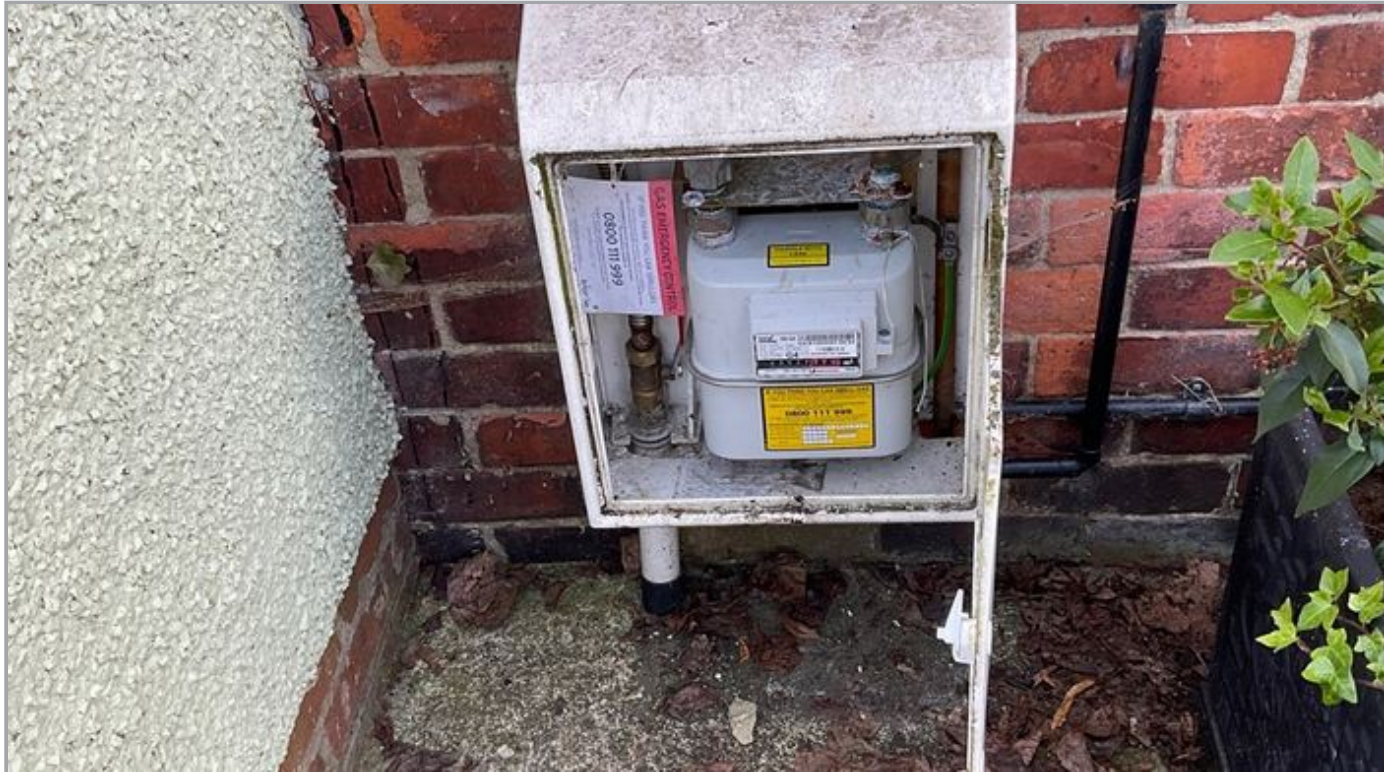
Gas Meter

Your legal adviser should check the validity of any test certification for the installation, and we refer you to Section H. The installation should be inspected and tested every 12 months. If it has not been inspected within the last 12 months, then it should not be used until a full test of the system has been carried out and any faults/shortcomings rectified.

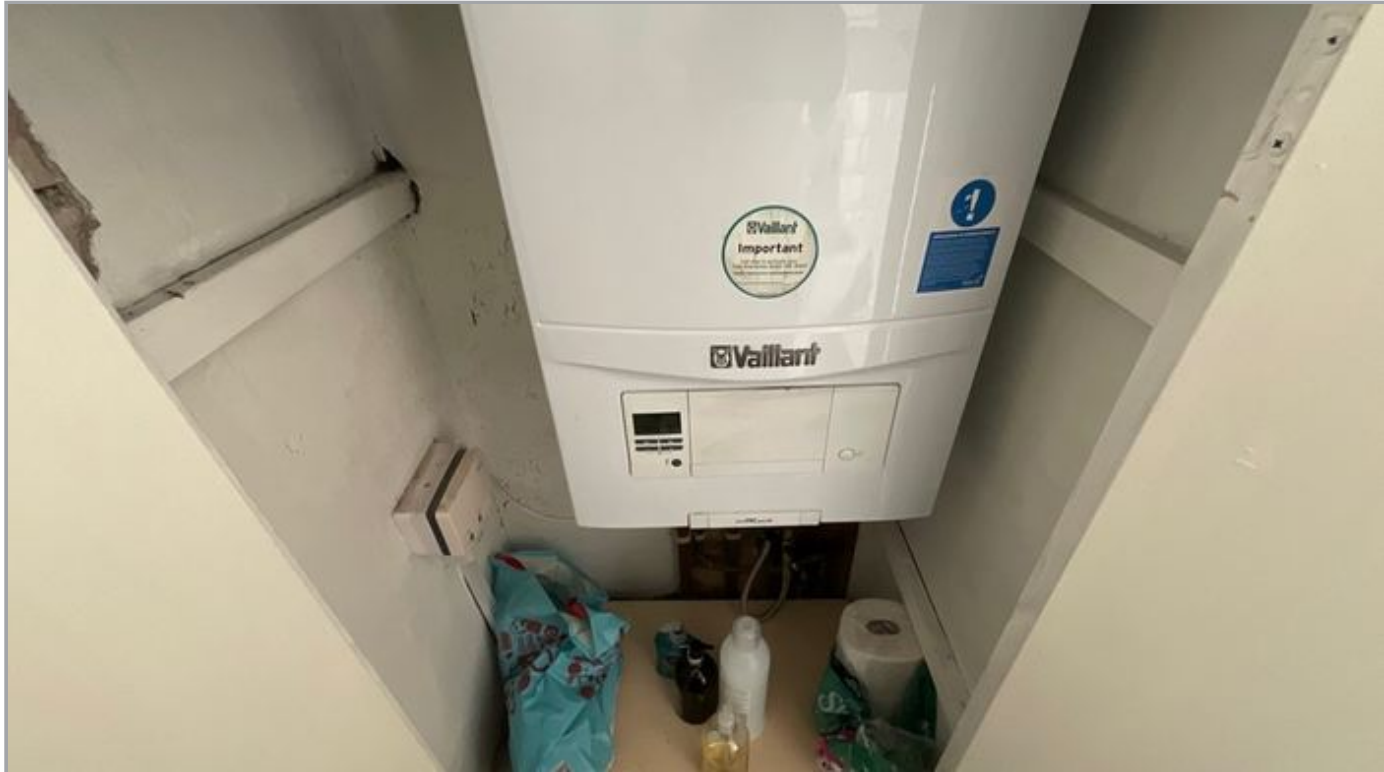
Gas Boiler

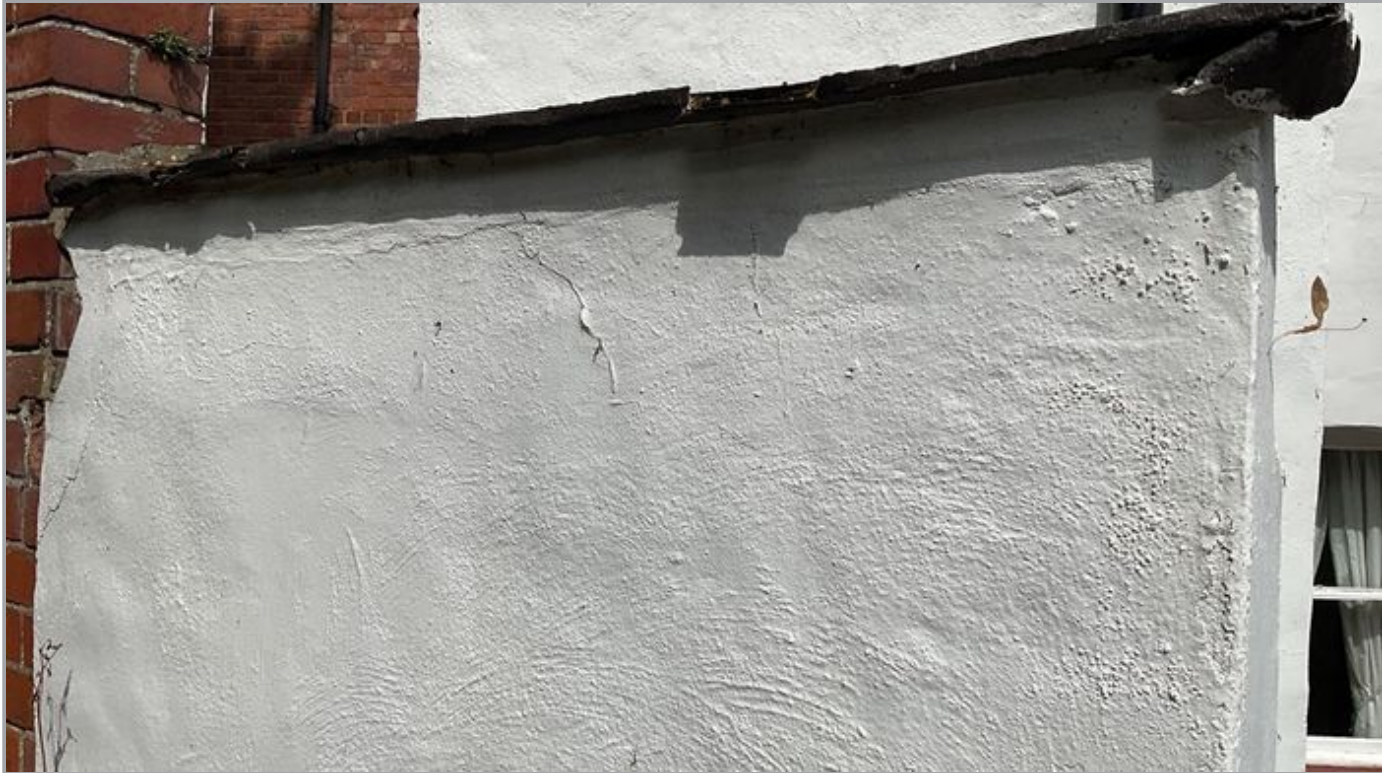
Efflorescence/Paintwork
